Photos Taken for Week Ended 11-07-08

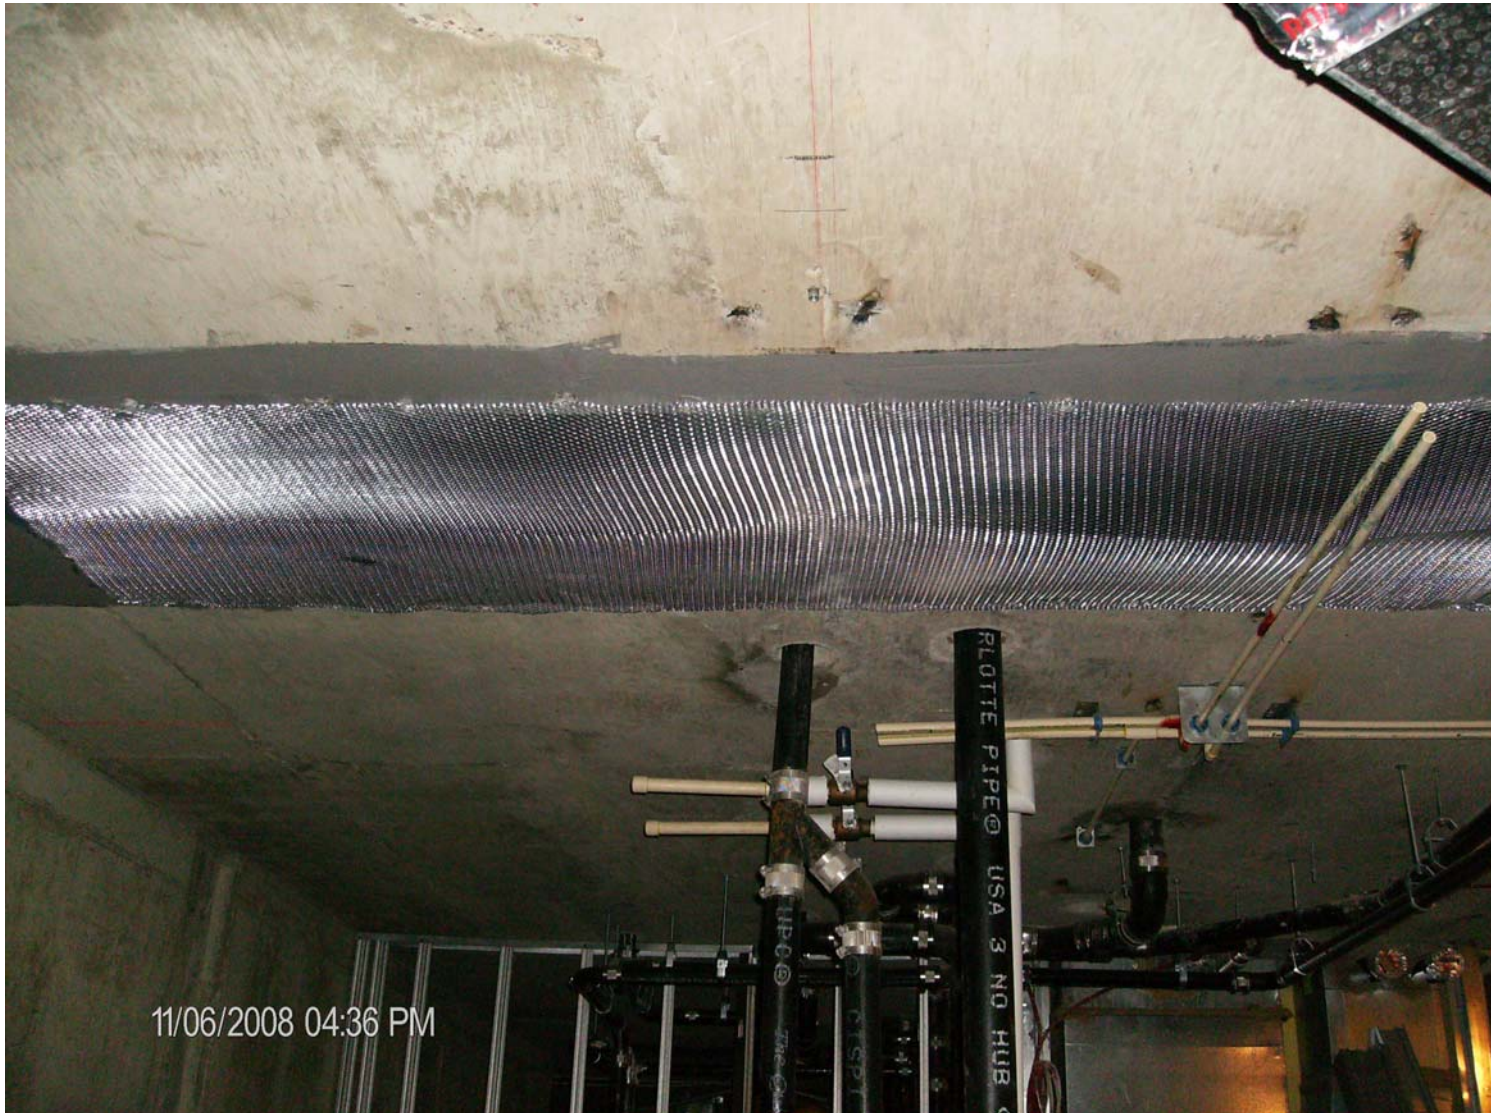
**10<sup>th</sup> Floor – Metal Lathe over CFRP on Slab**

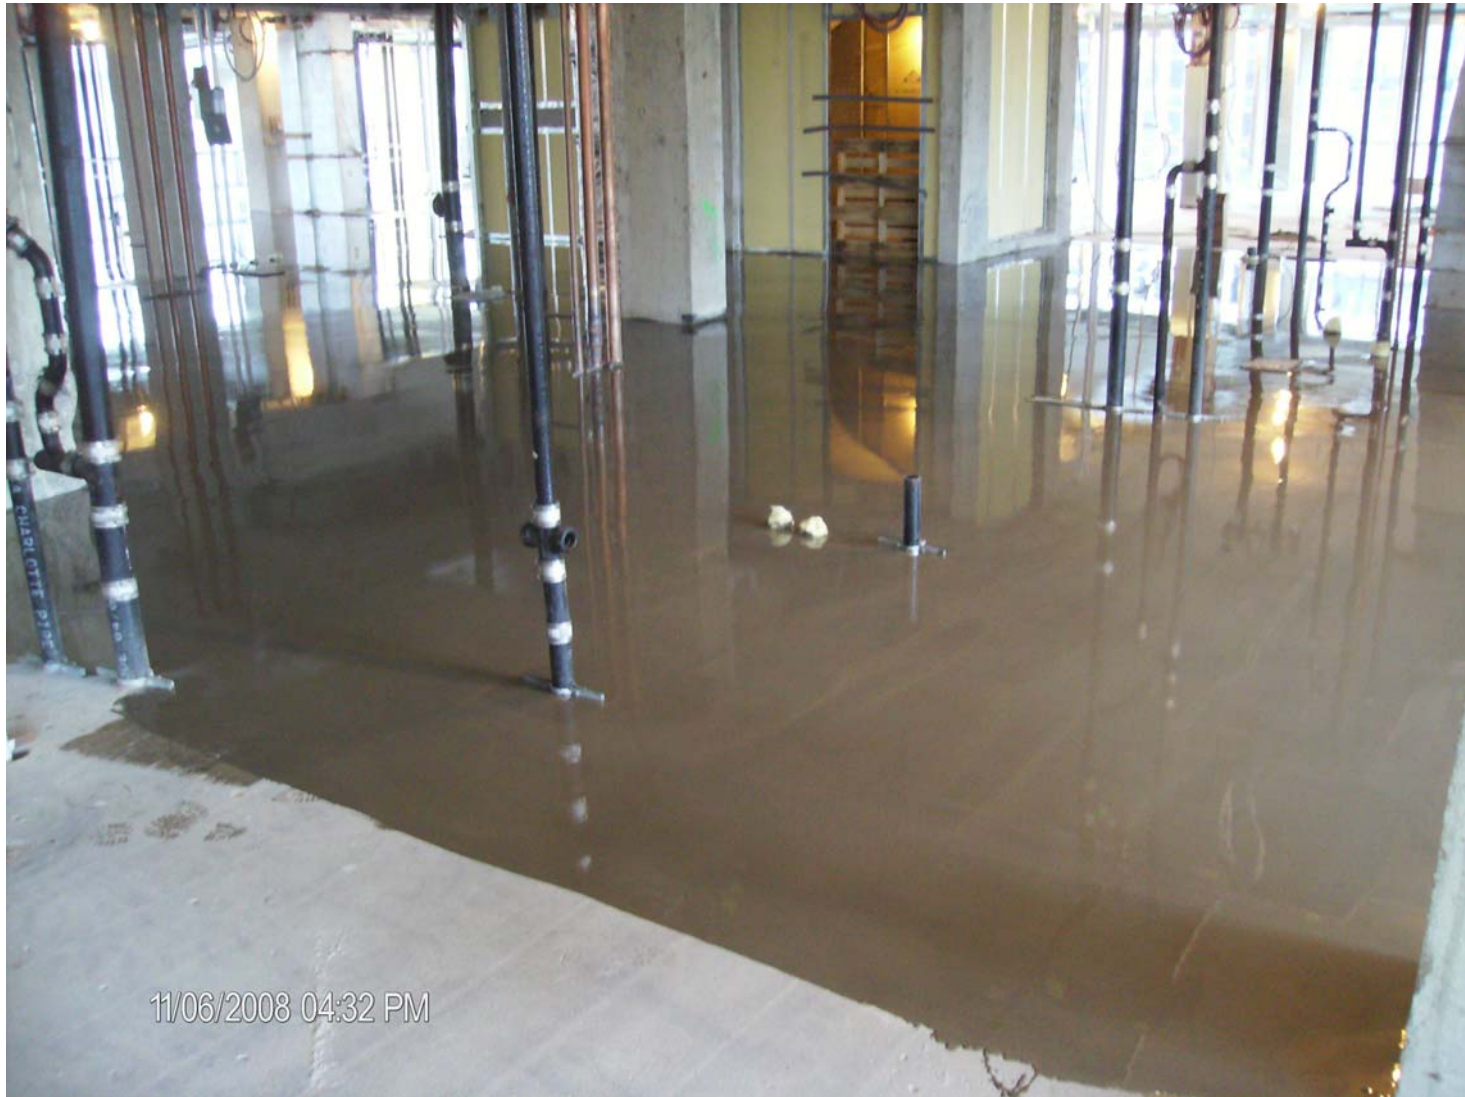
**11<sup>th</sup> Floor – Floor Leveling**

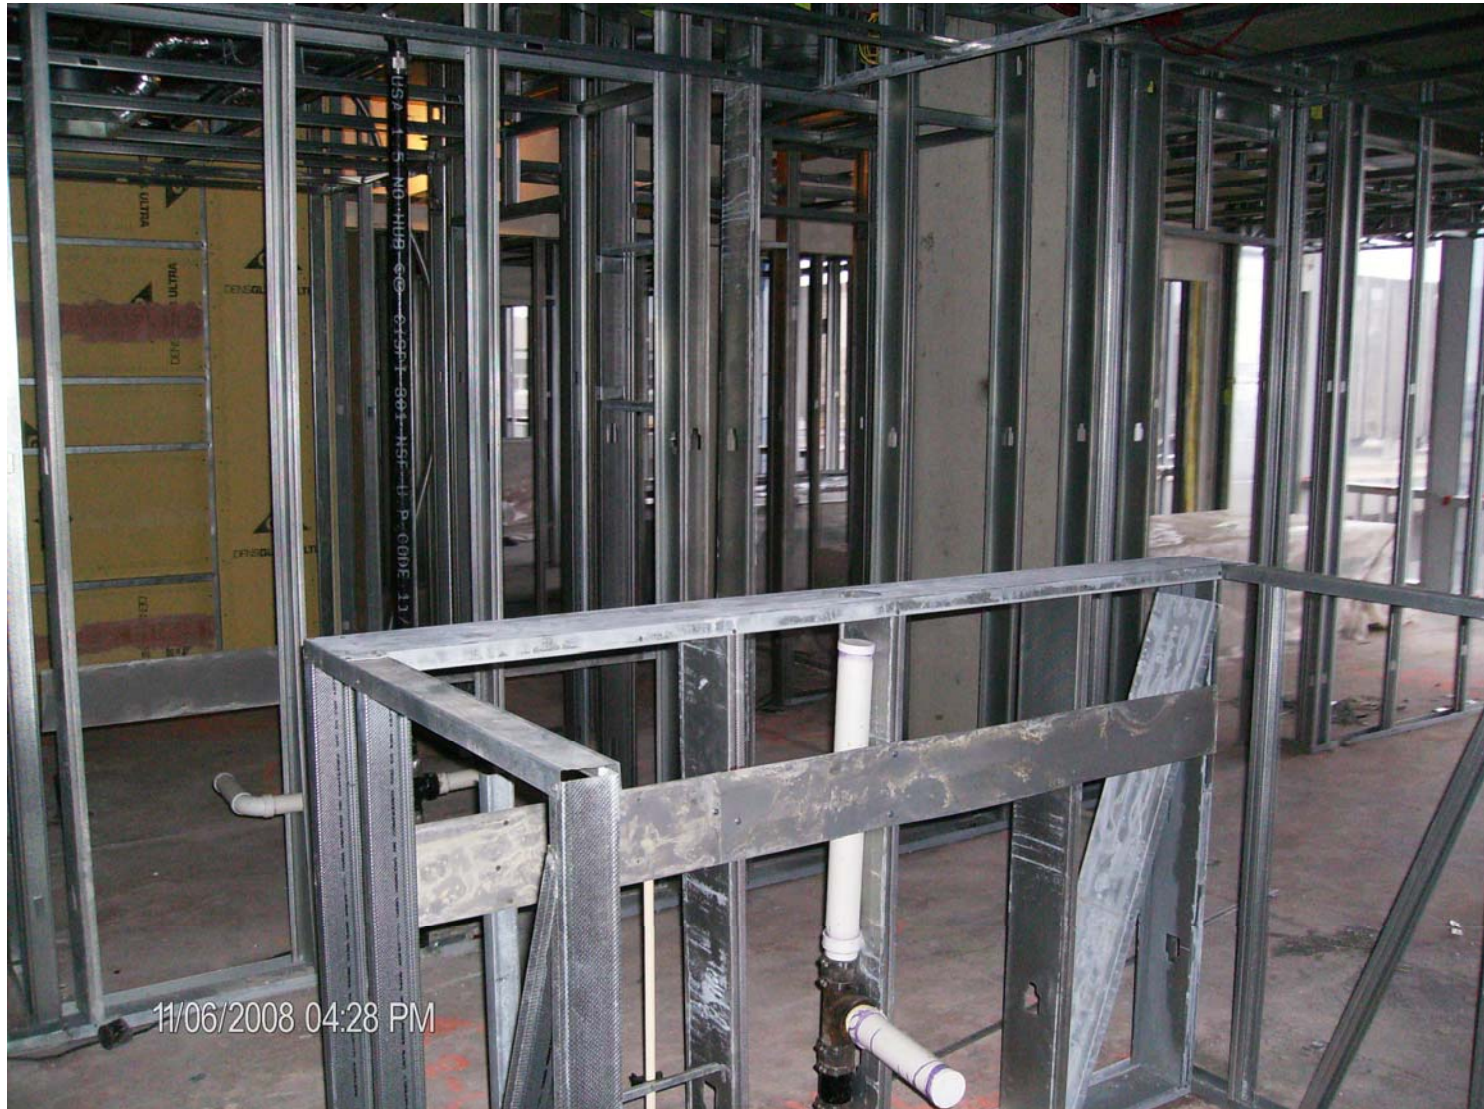
**15<sup>th</sup> Floor – Framing**
