Photos Taken for Week Ended 10-03-08

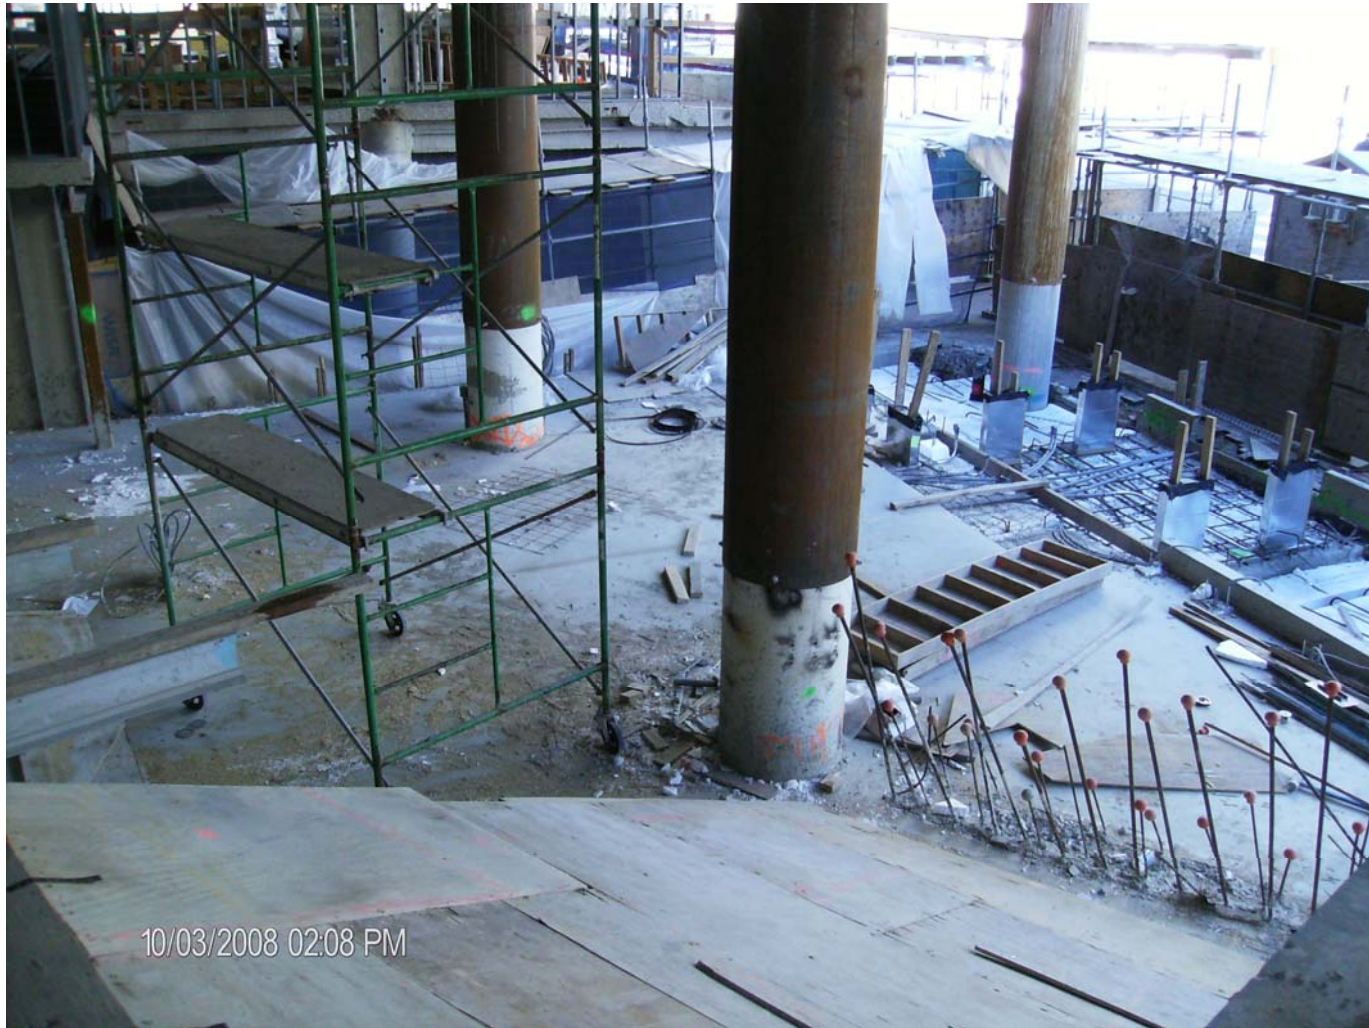
1st Floor Lobby – Framing Stair C

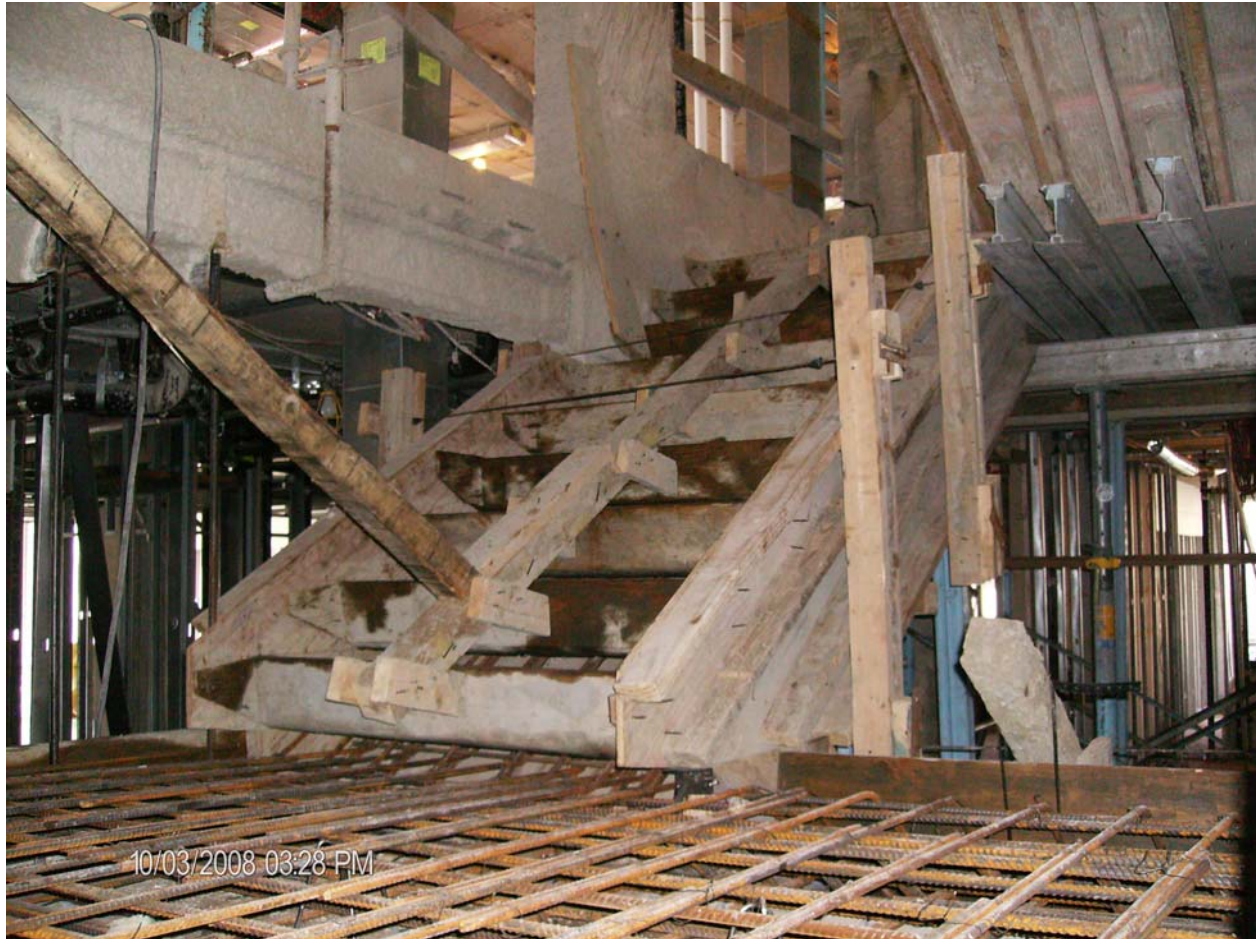
6th Floor – Stair B Framing (Poured Through 6th Floor)

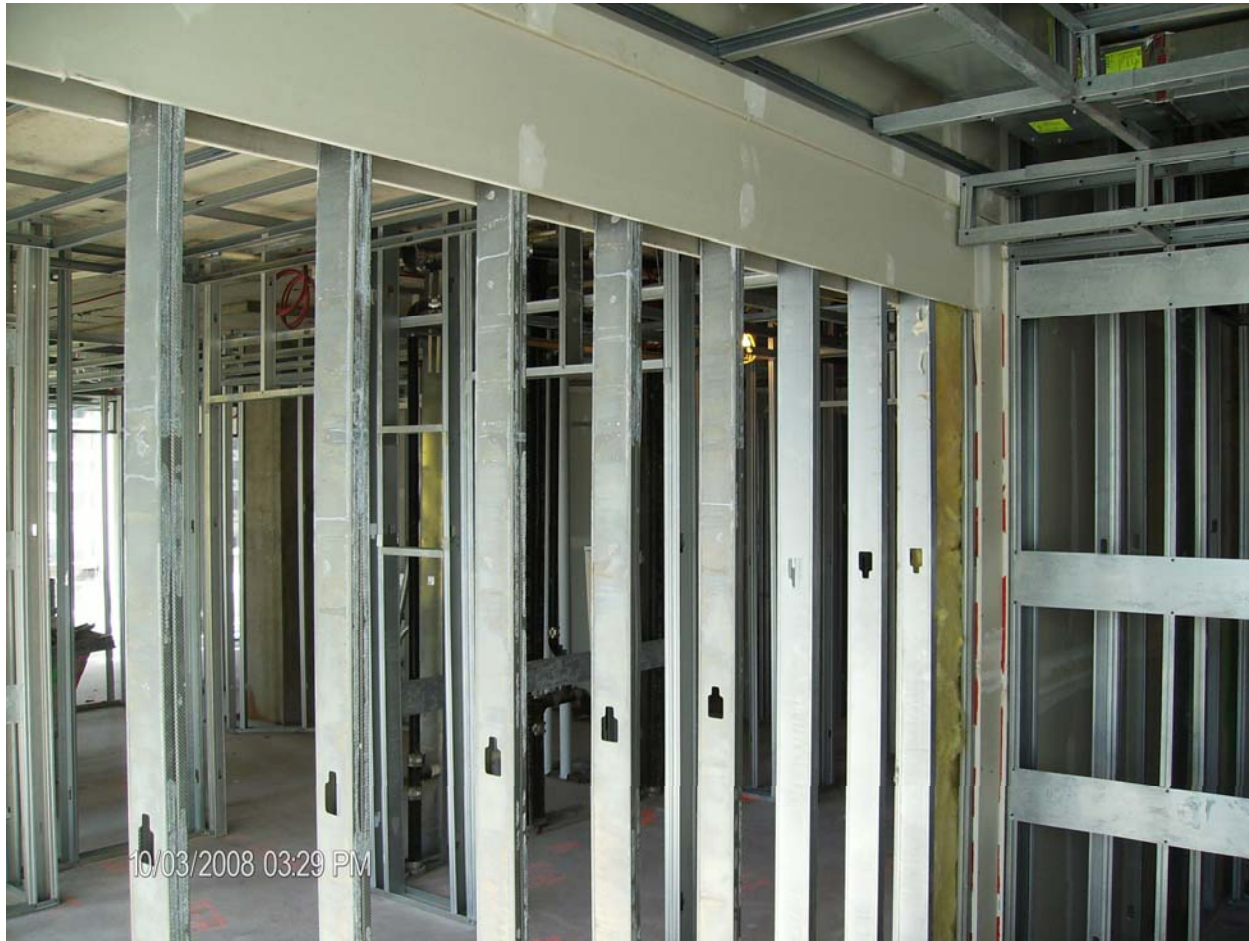
6th Floor – Framing Demising Walls

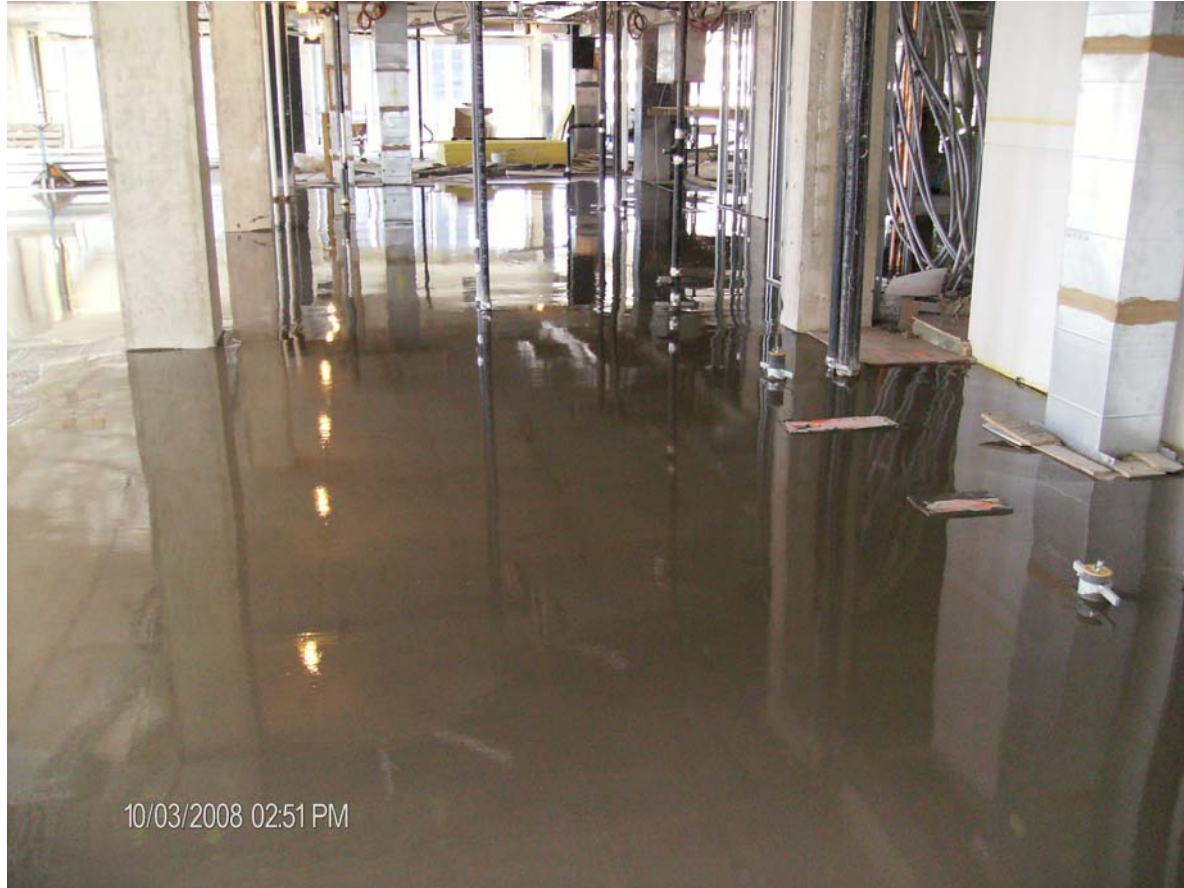
8th Floor – Floor Leveling

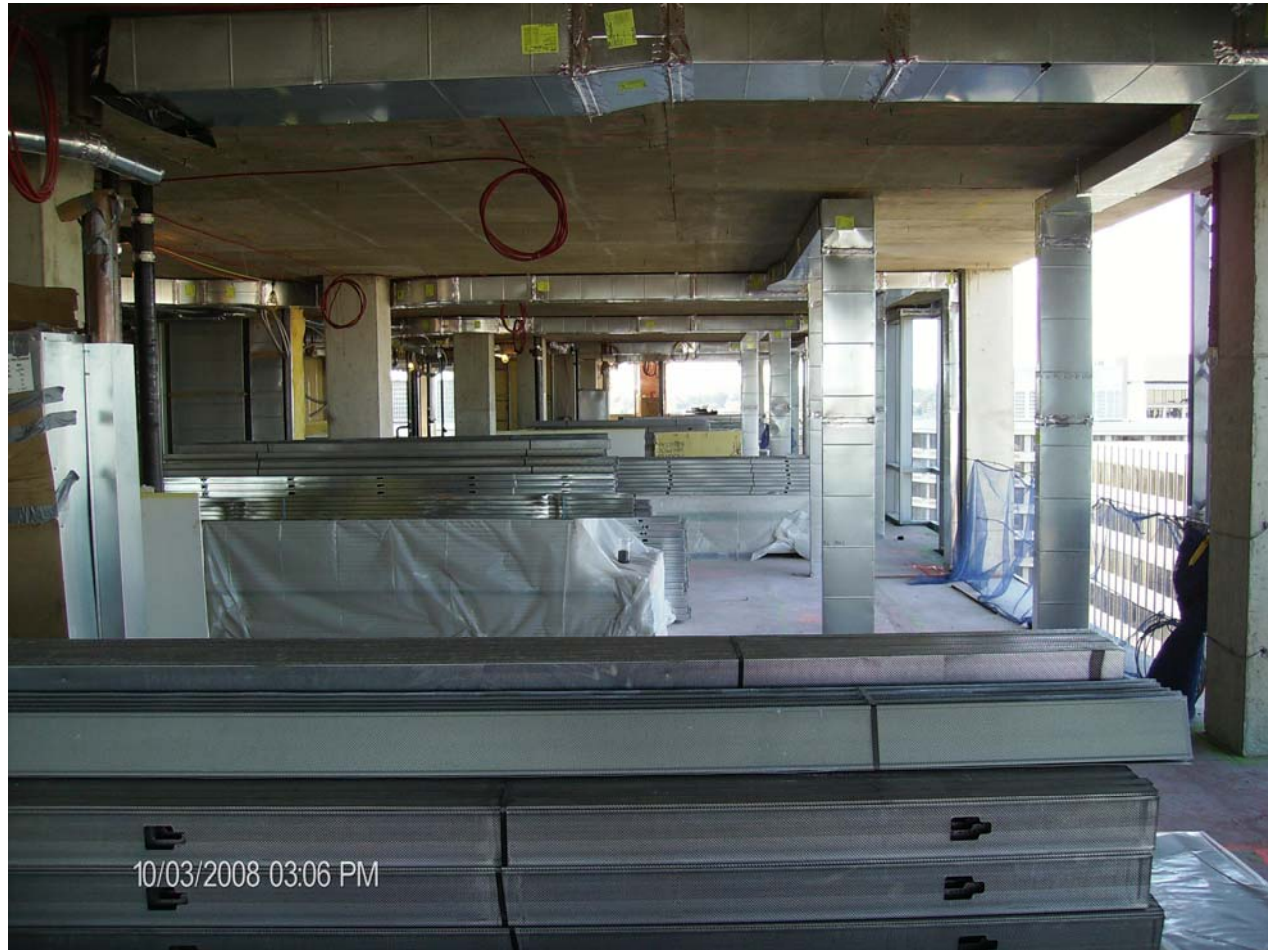
15th Floor – Stocking Floor

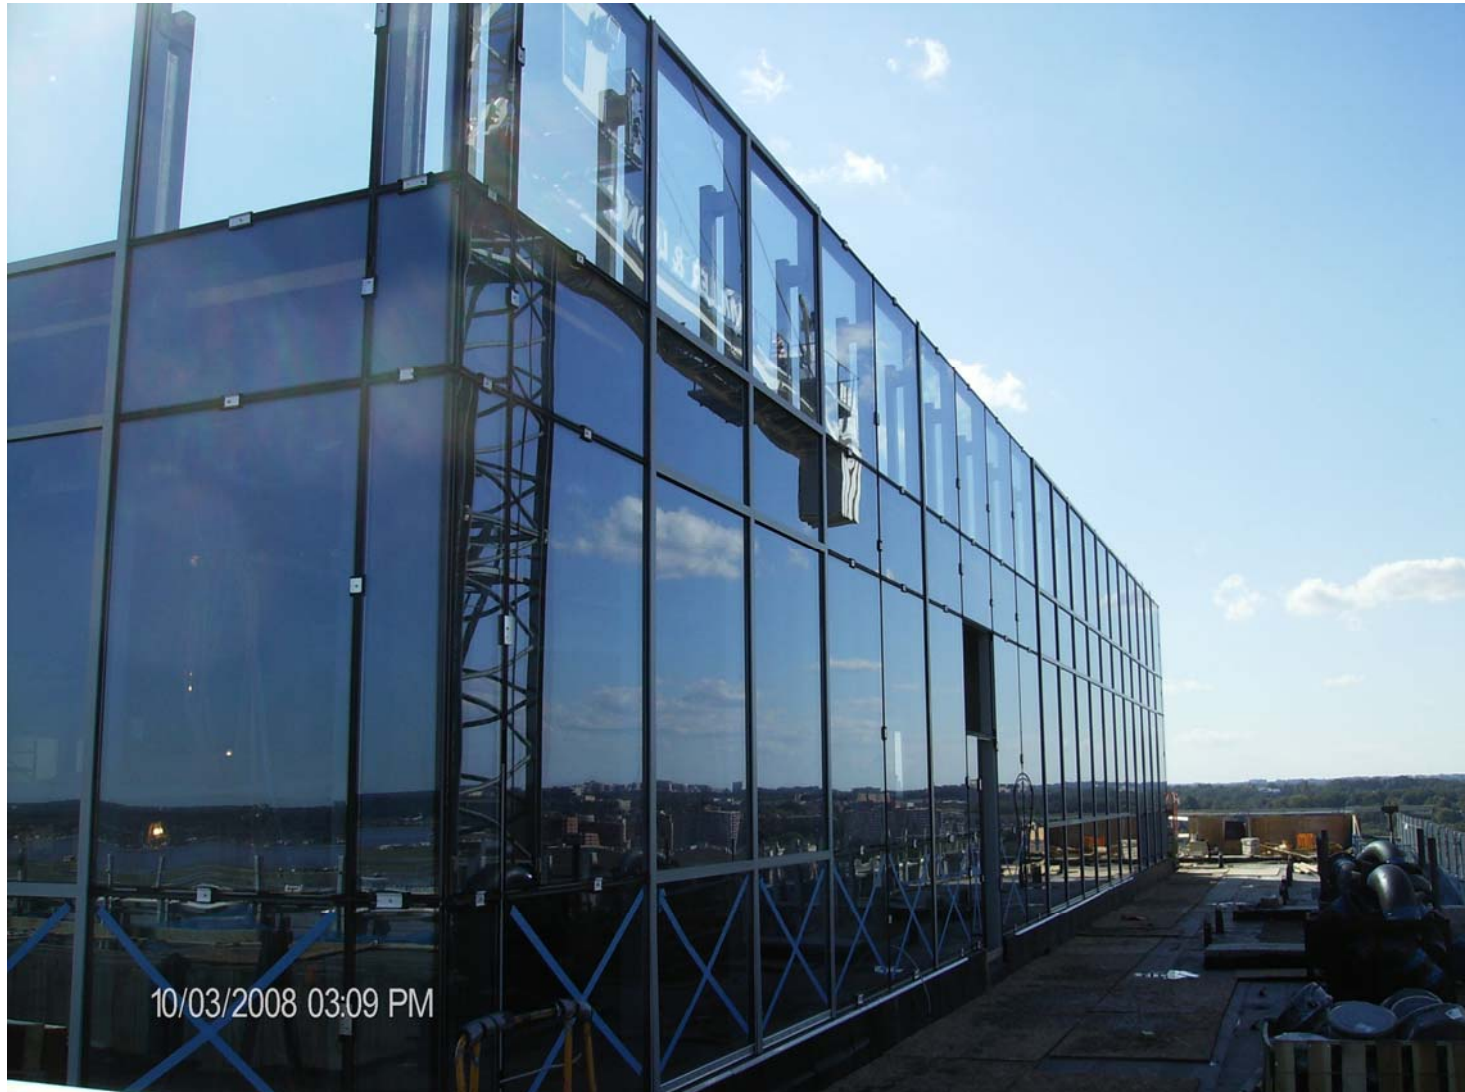
19th Floor Storefront – NE Façade
