Photos Taken for Week Ended 10-31-08

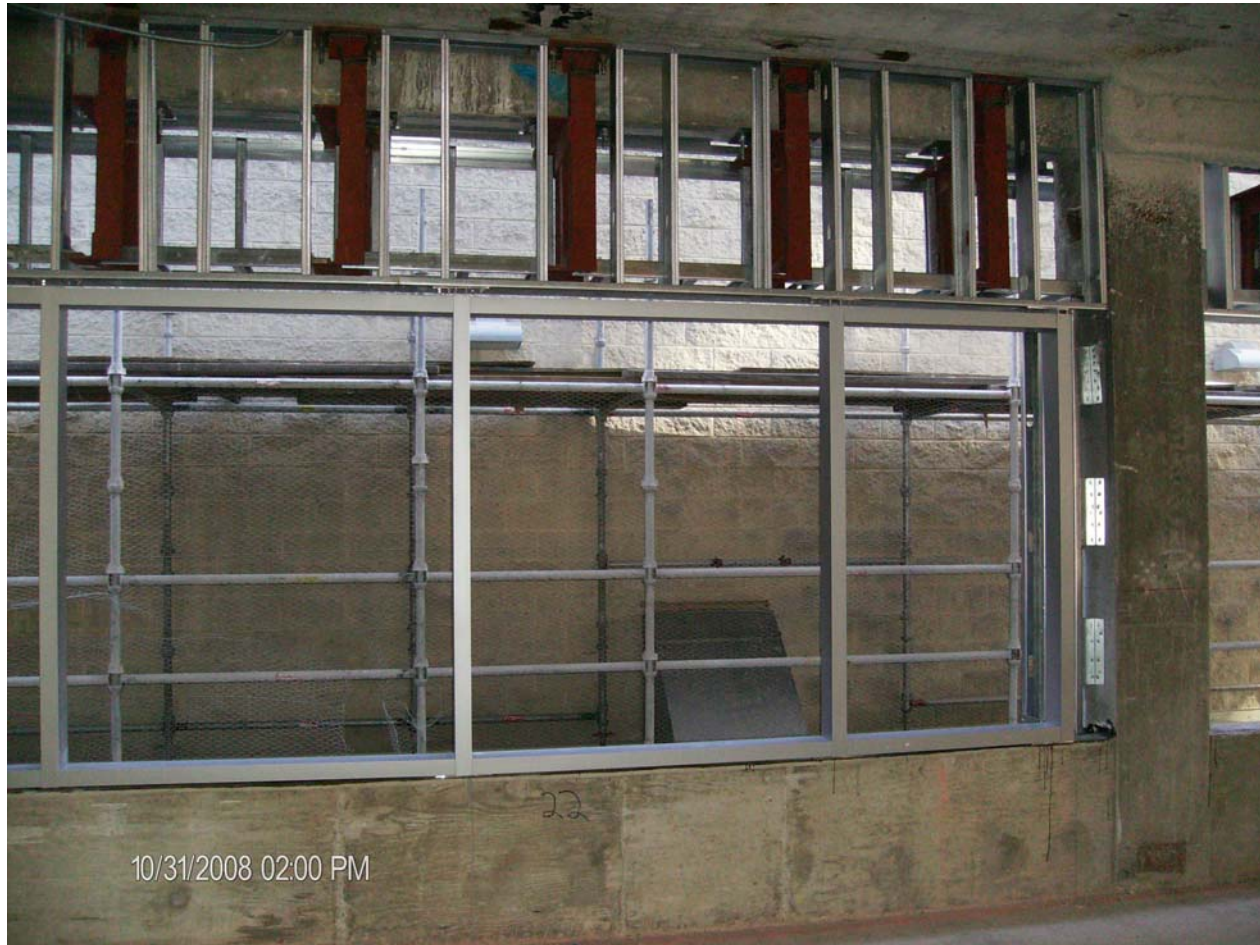
2nd Floor (East) – Store Front Mullions/Stone Support Brackets

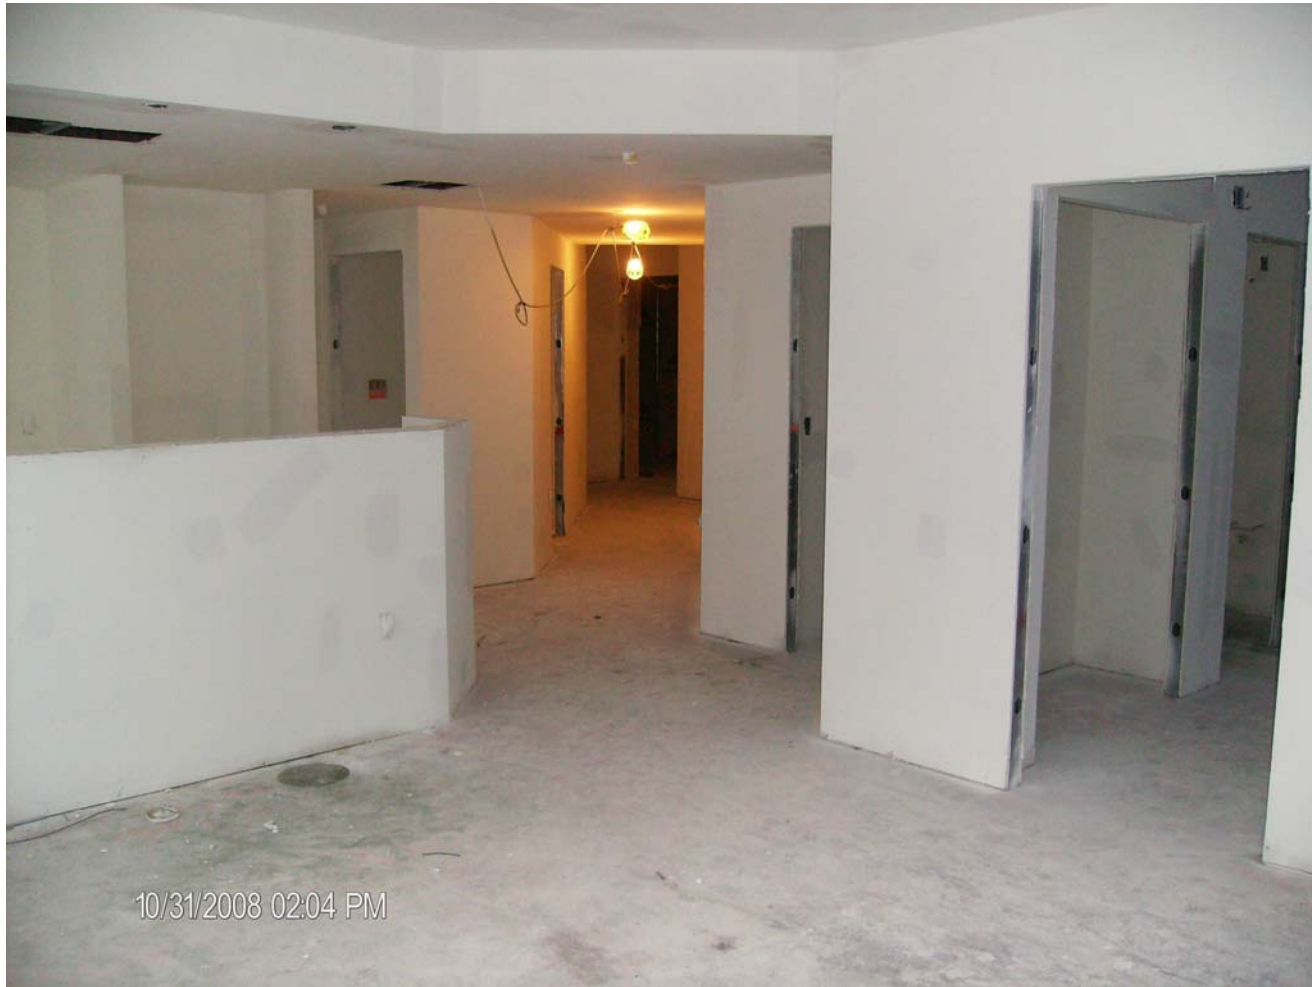
Mockup Unit 304 – Prime Coat

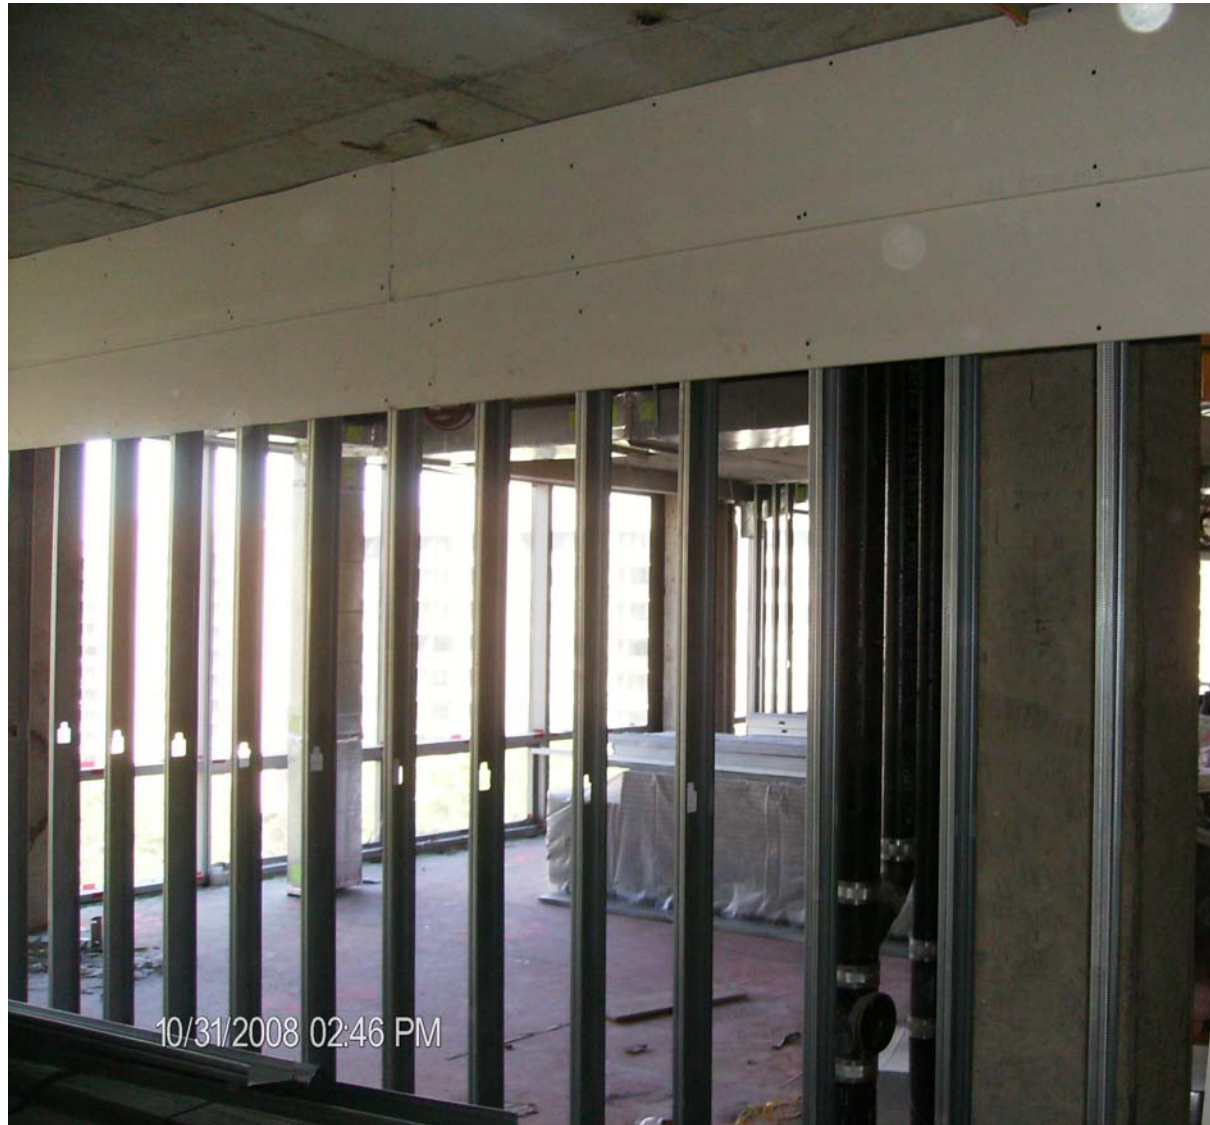
9th Floor – Demising Wall (D-E Line)

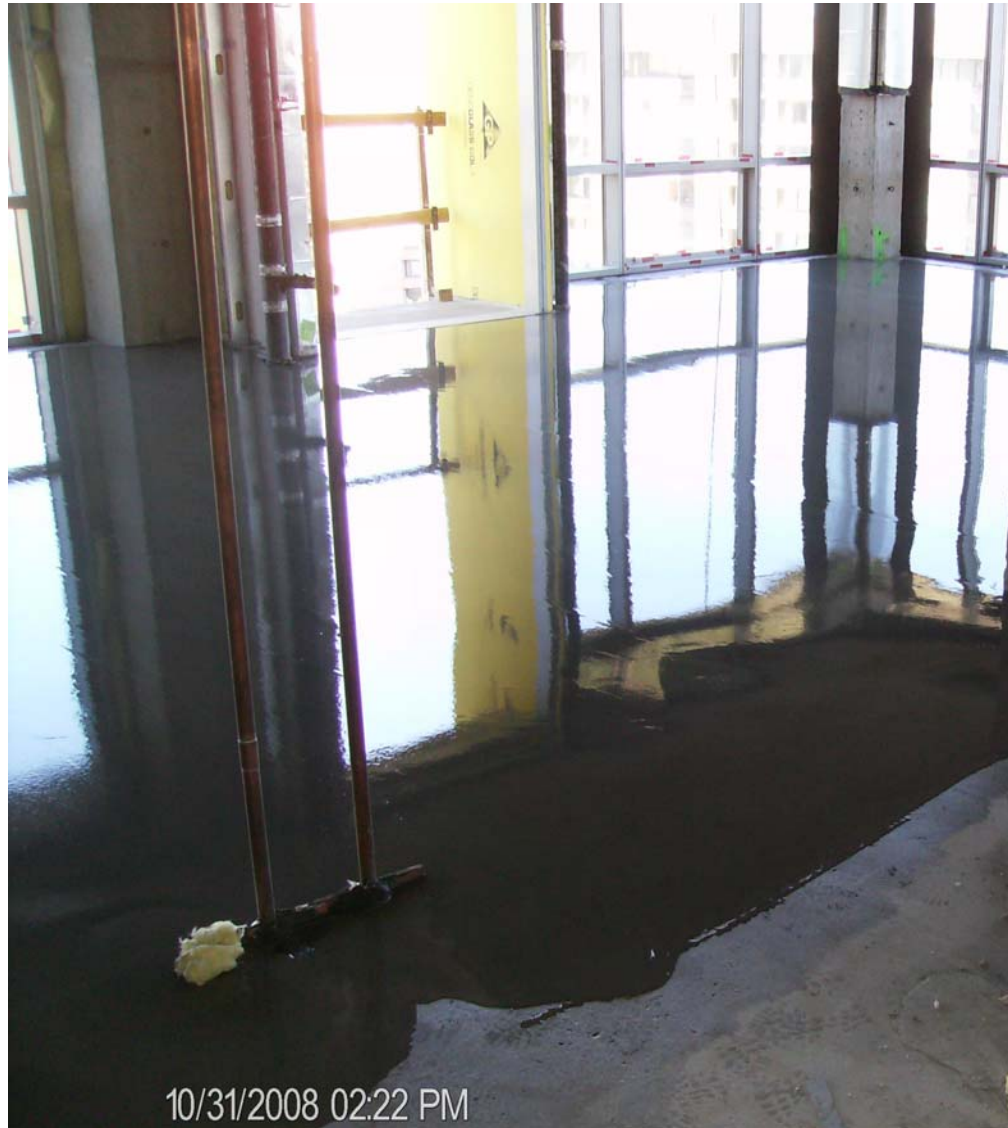
11th Floor – Floor Leveling (North Side)

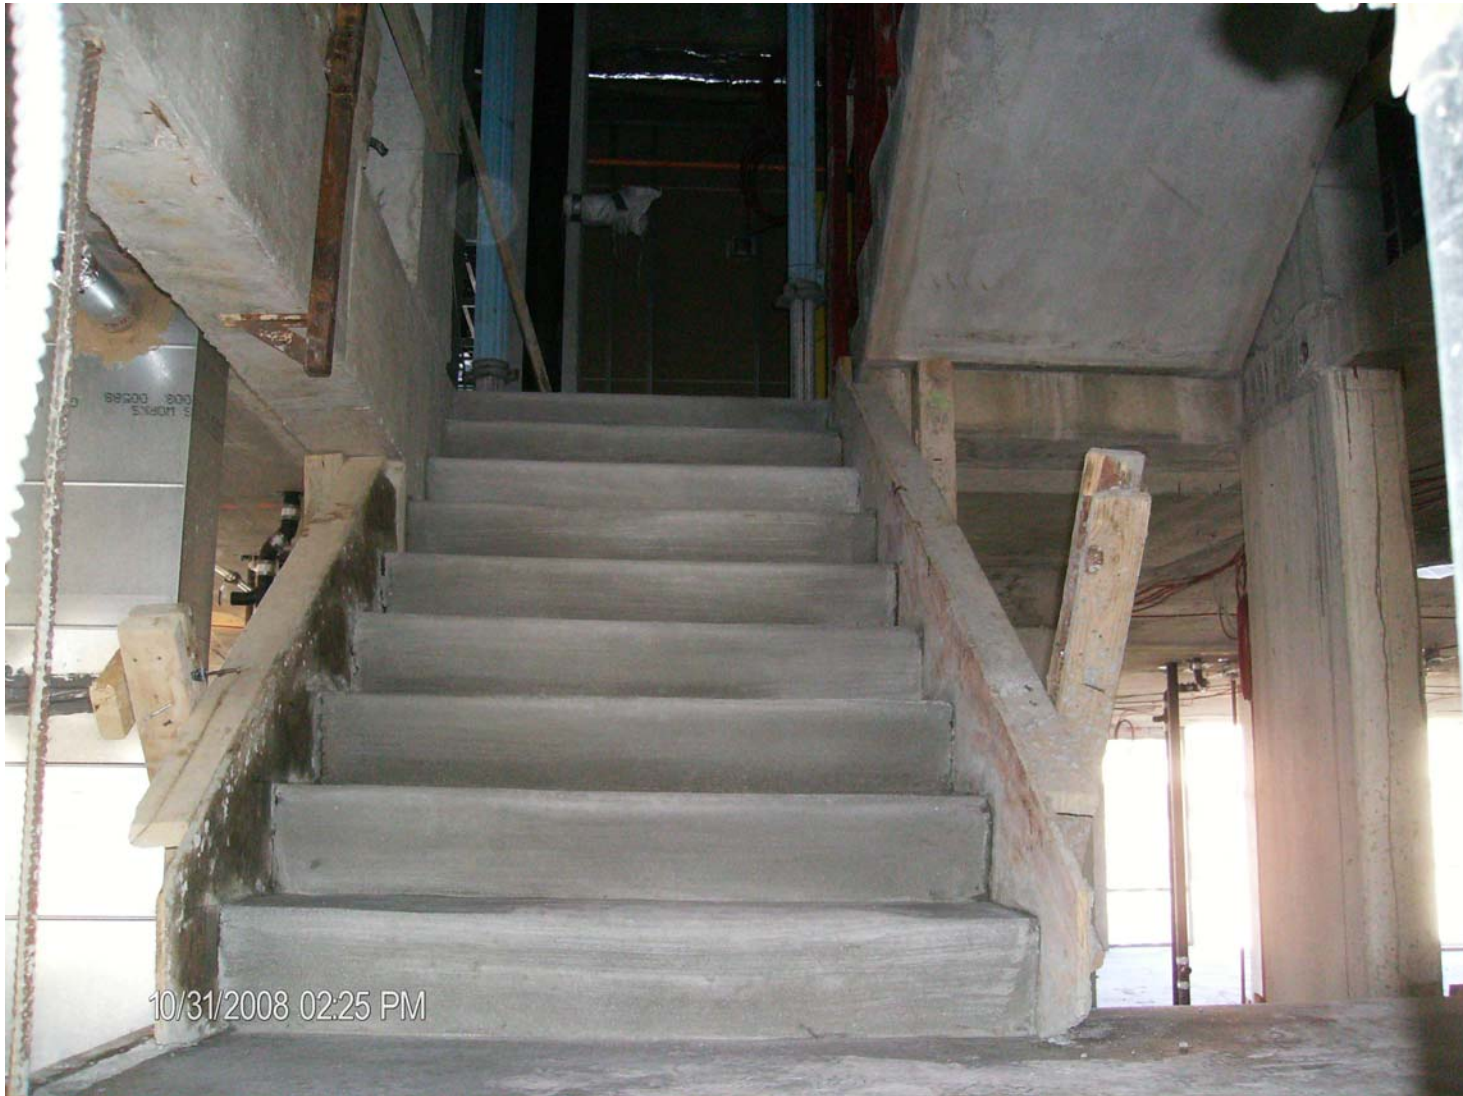
12th Floor – Stair B Poured to 13th Floor
