## 7.0 Analysis 3: Case Study - Concrete Over-pour on Decks Due to Steel Deflection (Structural Breath)

### 7.1 Background

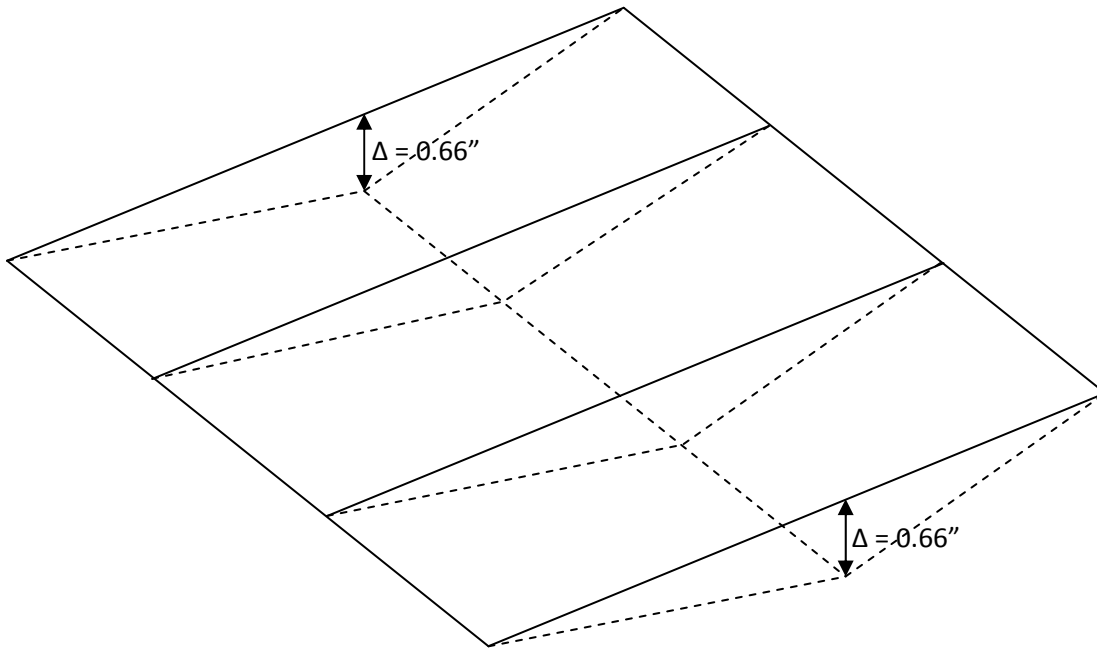
*Figure 28: Illustration of Beam Deflection (No Girder Deflection Shown)*

Beam Deflection = 1.41" – 0.75" (camber) = 0.66" (See Figure 28 below)

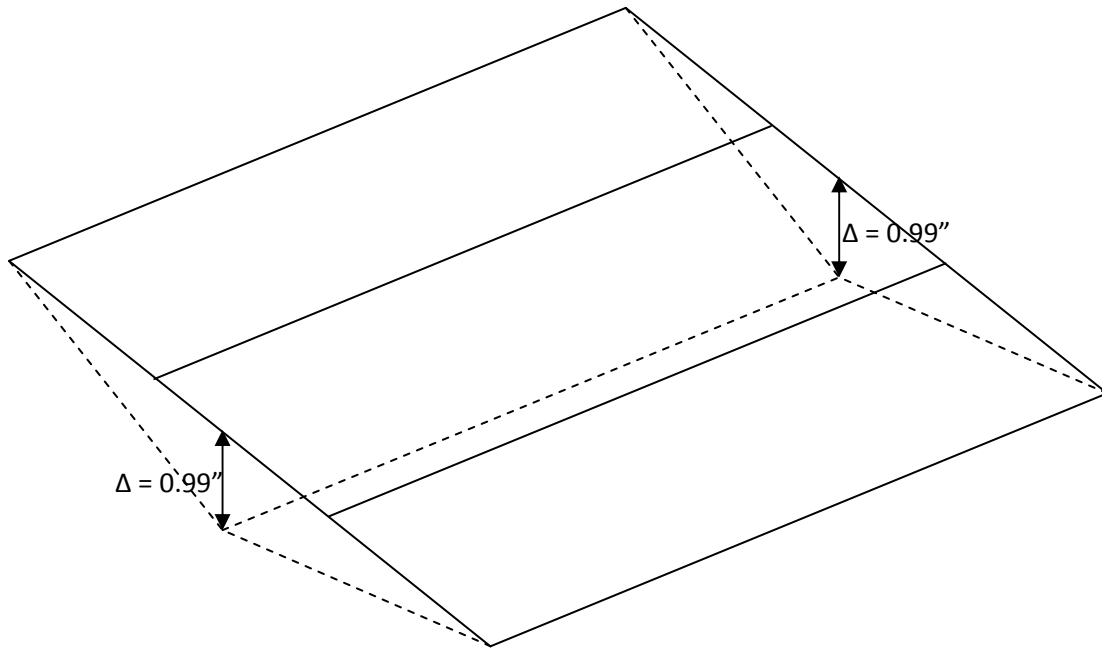
Figure 29: Illustration of Girder Deflection (No Beam Deflection Shown)

Girder Deflection = 0.99" (See Figure 29 on the following page)

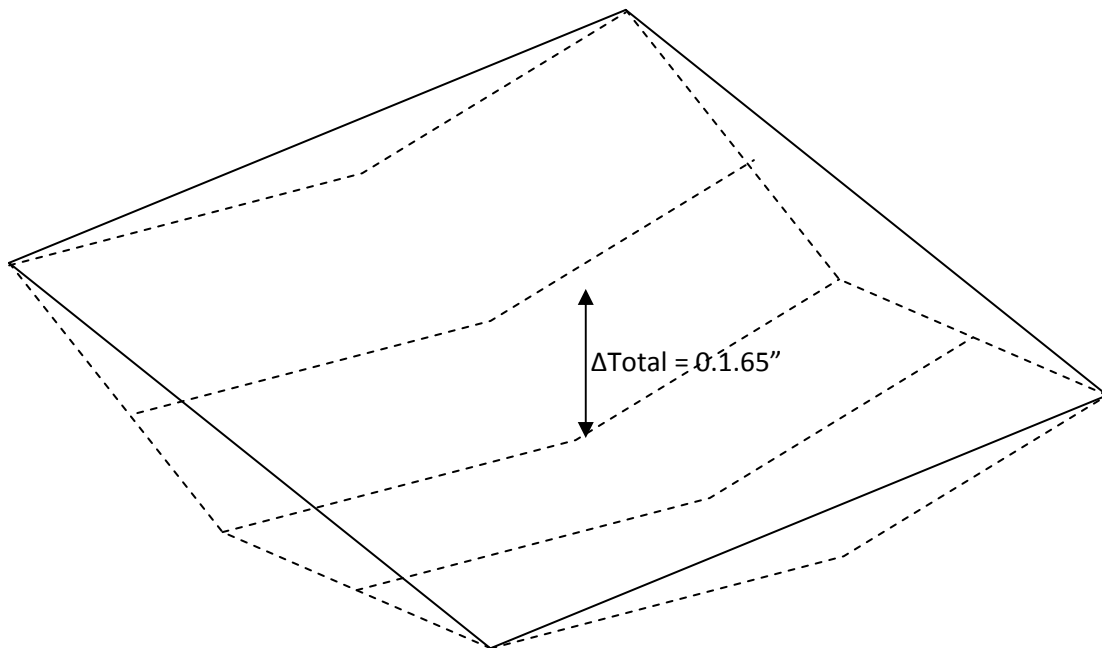
Figure 30: Illustration of Total Deflection (No Center Beams Shown for Visualization)

Total Deflection in the Center of the Bay = 1.65" (See Figure 30 on the following page)

Total Volume =  $39,052 + 58,578 = 97,630 \text{ in}^3 = 56.5 \text{ ft}^3 = 2.09 \text{ CY}$

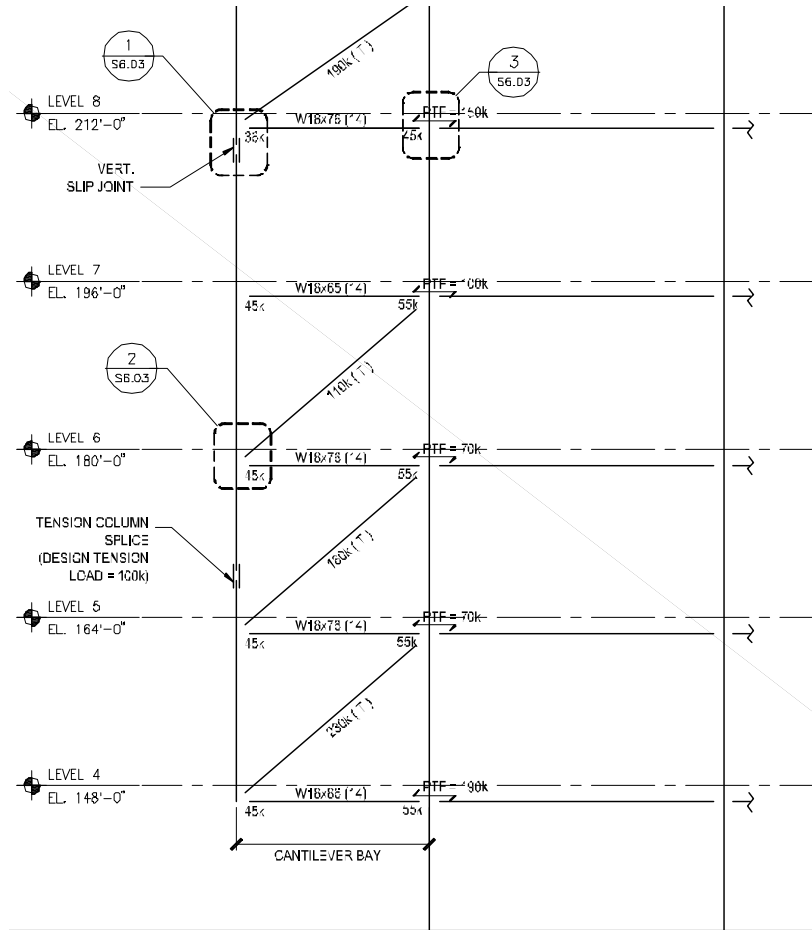
Figure 31: Structural drawing S6.03 depicting the cantilever structure on the south face of the CT

While pouring concrete on the cantilever structure on the south face of the CT, the steel deflection began to become a serious problem. The cantilever structure is a truss system with cross bracing (see Figure 31 on the following page). As the lower levels of the cantilever were poured it became evident that the cantilever was sagging because the steel cross bracing on the floors above were not lining up with their bolt holes.

The connections were slip critical and had slotted bolt holes (see Figure 32 on the following page). A survey later conducted concluded that the steel was set in place by the crane and was not surveyed to make sure the steel was set level. The slotted holes in the connection allowed the steel to sag about  $\frac{1}{4}$ ". It was also found that the columns were set  $\frac{3}{4}$ " low. This could have been caused by settlement or the base plates may not have been grouted correctly. This all added up to a 1" sag in the cantilever.

The structural engineer required additional gusset plates to be welded on the connections to strengthen the structure. The following floors were surveyed during construction so the steel was set correctly.
