CHRISTOPHER R. STULTZ | CONSTRUCTION MANAGEMENT

PROJECT | CRYSTAL PLAZA II

LOCATION ARLINGTON VA

TECHNICAL REPORT II COST AND SCHEDULE ANALYSIS

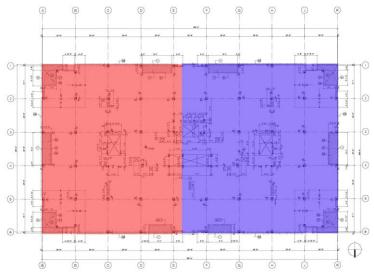
Typical slab pour sequence with area/pour 1 in red and area/pour 2 in blue.

An area of key interest is the sequencing of pours for the 8 new floors and roof (9 total stories). Given the limitations of a 200 activity schedule, the phasing of the pours is difficult to visualize. Floors were broken into two pour sections to allow material staging and lay down on one side as work was being completed on the other. After the concrete was placed and work began on the second area, bracing, shoring, and formwork began erection over area one. The floor break/pour sequence is illustrated below. The formwork for the pour was left in place until the concrete reached 75% of its 28 day strength. Re-shores were also used three floors below the active pour for four total levels of shoring to provide support of the construction loads, and the post tension cables were stressed when the concrete strength reached 3000 psi.

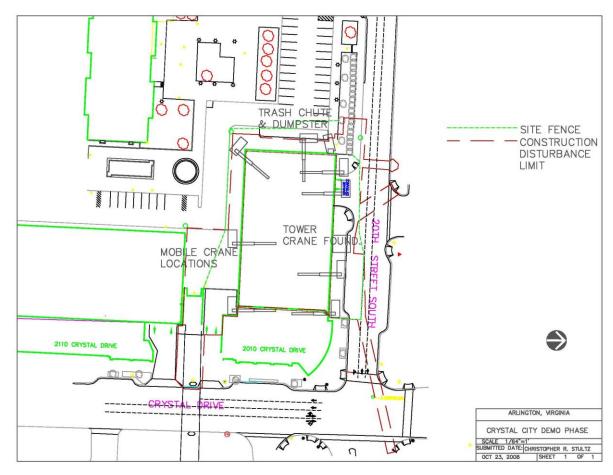
The first point to mention is the location of the site disturbance area and site fence. While not as crucial in this phase, the maximum area for lay down and storage becomes increasingly important as the project progresses. In this phase the precast façade is being removed, foundation work for the tower crane is under way, and demolition of building systems and interiors has begun. Of high concern is the precast façade elements located outside the mobile crane's reach on the east side of the building. These members will remain in place until the tower crane is erected and can remove them as its first objective. The mechanical equipment on the roof can also be removed by the mobile crane.

The first phase at Crystal Plaza is different from the common phase associated with construction. There is no excavation on the project as it is a renovation and addition to an existing building, with all the addition in new floors constructed on the existing structure. The plan, seen below and in full size in Appendix A, has a few key elements to discuss.

This is also the phase when trades begin to mobilize and set up job trailers on site. The owner has agreed, as part of the contract, to allow the contractors to use the first level, G1, of parking for office setup and as a limited storage area. As so, the contractors constructed temporary offices rather than set up mobile office trailers. This is all contained under the building footprint.

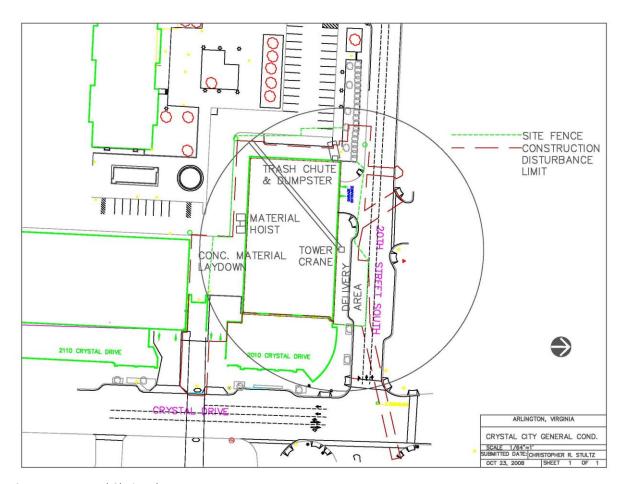
Superstructure and Glazing Phase

This is the phase were all available lay down and staging is taken advantage of. The site fence is moved to its maximum allowable location that still allows pedestrian flow around the site. A delivery area is set up for concrete at the north side of the project. Closure of one lane of South 20th Street is also apparent for this delivery area. This allows incoming concrete deliveries to be close to the tower crane in attempt to limit the cycling time between bucket pours. Also new to the site are material hoists on the south side. These are necessary as the existing vertical transportation system has been removed and a majority of the work and need for materials are on upper floors. Throughout these first two phases all material deliveries are to one of two areas, either the material lay down area on the south side or the delivery area on the north.

The construction of the superstructure and glazing is the next phase of construction at Crystal Plaza II. This phase encompasses the construction of the nine additional floors and the erection of the curtain wall system. The floor construction uses the tower crane as its primary mode of transporting materials for construction, while the curtain wall has its own system of swing stages, lifts, and jib cranes that are contained within the building to place the unitized pieces in place. The plan can be seen below and in full size in Appendix A.

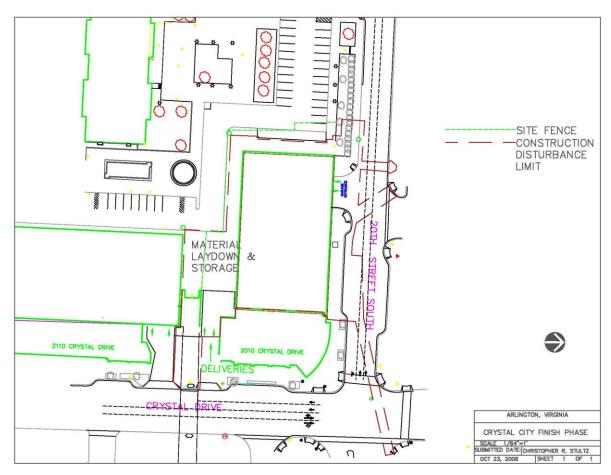
Finishing Phase

As the project moves towards substantial completion, there are key differences on the site plan. The tower crane and material hoist have been removed and the previous concrete lay down area has been converted to a general material storage area. Site fencing on the north side of the project has been removed as the owner begins occupancy of the lower floors and the leasing office. Without the delivery area on the north side, all deliveries are now to the permanent loading dock located on the east side of the building. This dock is shared with neighboring buildings; therefore careful sequencing of deliveries requiring the dock is of vital importance. Use of the centralized trash system is also in effect as the trash chute has been removed. The site offices are still located beneath the structure, but are in limited space as residents begin to rent parking.

After the installation of the curtain wall system and roof top mechanical components the tower crane is removed from the site, thus beginning the finishing phase. Also to be removed is the material hoist as the single bay service elevator becomes operational. The finish phase continues the construction process to closeout with the temporary facilities still housed in the G1 level of the parking garage below the structure. Many of the small, 3rd tier subcontractors do not have offices and utilize the subcontractor's office of the contractor that oversees them. Parking during this phase becomes a greater issue as more finish trades begin work. Strict parking regulations must be enforced to provide space for storage and site offices. The finishing plan can be seen below and in full size in Appendix A.
