MONONGALIA GENERAL HOSPITAL 1200 J.D. ANDERSON DRIVE, MORGANTOWN, WEST VIRGINIA

STRUCTURAL CONCEPTS AND EXISTING CONDITIONS REPORT

THE PENNSYLVANIA STATE UNIVERSITY DEPARTMENT OF ARCHITECTURAL ENGINEERING SENIOR THESIS 2008-2009

HIROKI OTA STRUCTURAL

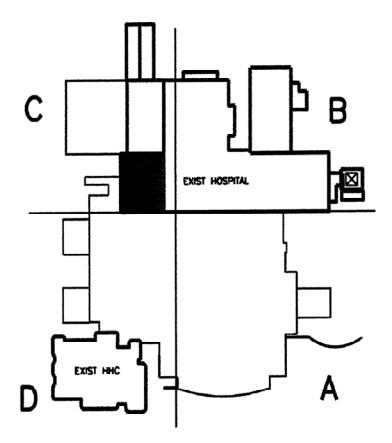
Figure 1: Hospital Divided in Four Quads

The Monongalia General Hospital's plan can be divided into four different quads, A, B, C, and D (Figure 1). The first floor of the Monongalia General Hospital occupies 92,086 square feet and houses a boiler/chiller room, electrical rooms, doctors' offices, labs, nurse stations, storage spaces, and a dining space equipped with a food services kitchen. The second floor follows a similar layout but provides more space for examination rooms as well as a gift shop and café on the southern face of Quad A. The third floor mainly consists of patient rooms with the central part of the plan dedicated to operation rooms. The third floor has a reduced square footage compared to those of the floors below with an area of 80,882 square feet; the western section of Quad D does not continue up to the third floor as patient room spaces but provides housing for two air handling units. The fourth floor sees an even less square footage on plan at 53,833 square feet, with the western section of Quad D no longer existing at this elevation. This floor only houses private patient rooms, each equipped with a private toilet and shower. The square footage of the fourth floor continues up to the fifth, housing more private patient rooms as well as a Labor, Delivery, Recovery, and Postpartum (LDRP) rooms in Quad B and C. The sixth floor sees nearly a fifty percent reduction in square footage from the fifth floor with only Quads B and C serving rooms for private patients. The rooftop at Quad A is located at this elevation and houses five air handling units. Acoustic ceiling systems are utilized on each floor to provide

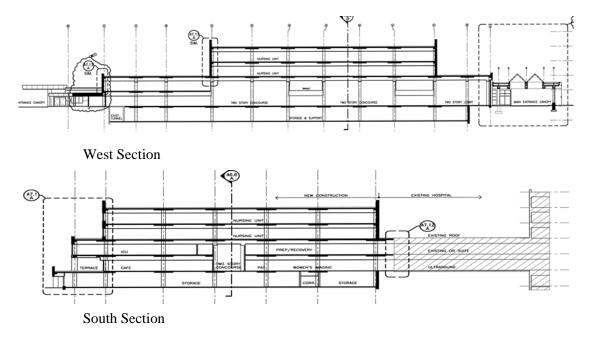
Figure 2: Cross Section of the Monongalia General Hospital

acoustic insulation. The rooftop of the Monongalia General Hospital is used primarily to house mechanical equipment. Two different types of roof systems are utilized: an adhered roof system and a ballasted roof system. The ballasted roof system is only present on the rooftop of Quad A and all other roofs utilize the adhered roof system. (Refer to Figure 2 for building cross section)

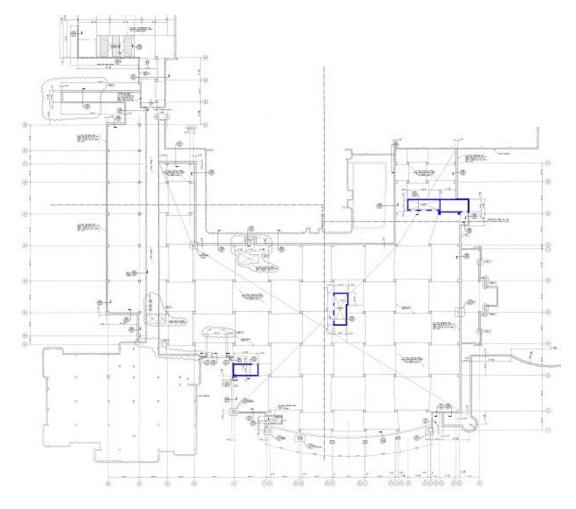
Figure 3: Location of Shear Walls (Colored in blue)

There are twelve lateral force resisting shear walls present in the Hospital (Figure 3). All of these are variable sizes ranging in height and width, the most representative shear wall being a $52'-9-1/8'' \times 70'$ wall with two sets of eight #5 bars used at each floor level.

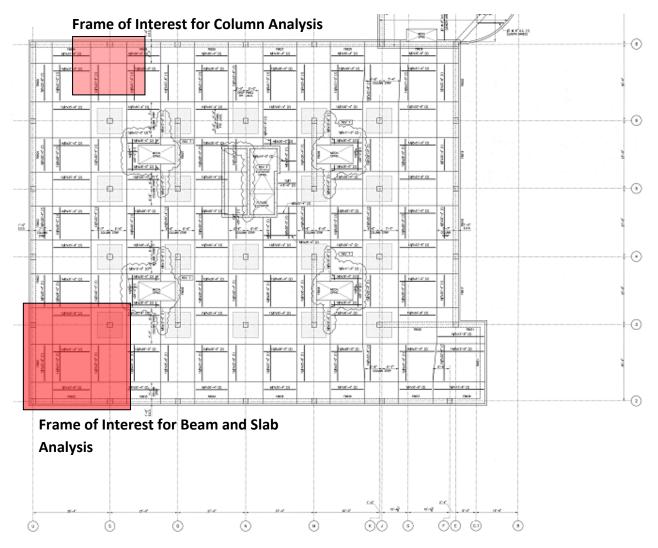
Figure 4: Typical Framing Plan (Taken from Quad A)

For the beam analysis, Beam FB601 was taken and studied. This beam is an edge beam supporting a slab on the sixth floor. The existing design was a 24" x 18" reinforced concrete beam with #7 bars as reinforcement. A frame analysis as per ACI 318-08 was conducted for the slab and the beam to calculate the required moment. Through the computations, the existing beam design proved to be more than adequate to resist the loads.

The analysis of the slab was done simultaneously with beam FB601 (Figures 4, 5) as per ACI 318-08. The slab is an 8 inch thick slab with dimensions of 30'-4" x 30'-4" and proved more than adequate to carry the required moment.

Column S8 was analyzed for its structural stability (Figure 4). This column, like many others in the Hospital is a typical 24" x 24" column. During this analysis, a simple assumption was made: a short column. For the analysis, the column was analyzed in two different floors. First on the fifth floor holding up the roof, and another time on the first floor holding up 4 floors above it. Through both of these analyses, the column proved to be adequate to hold the loads.

Please refer to the calculations in Appendix F. Please refer to Figures 4 and 5 for the plan.

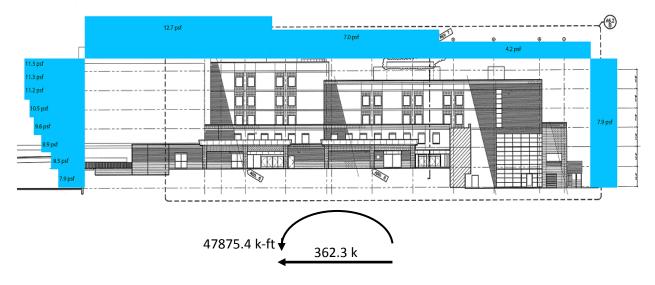
Figure 6: Wind Loading – North to South

Wind Loads				
	North to South Wind Pressure East to West W				
	Height (ft)	Pressure (PSF)	Height	Pressure (PSF)	
	0-15	7.9	0-15	7.9	
	20	8.5	20	8.5	
	25	8.9	25	8.9	
Windward	30	9.6	30	9.6	
	40	10.5	40	10.5	
	50	11.2	50	11.2	
	60	11.3	60	11.3	
	70	11.3	70	11.3	
Leeward	All	-8.3	All	-7.9	
	Base Shear (kips)	362.3	Base Shear	362.3	
	Overturning		Overturning		
	Moment (k-ft)	47875.4	Moment (k-ft)	47875.4	
	Windward to 90°	-12.7	Windward to 90°	-12.7	
Roof	90°-180°	-7.0	90°-180°	-7.0	
	180° to Leeward	-4.2	180° to Leeward	-4.2

(Refer to Figure 6 and 7 for Wind Loading Diagram)

(See Figure 6 for Wind Loading Diagram)

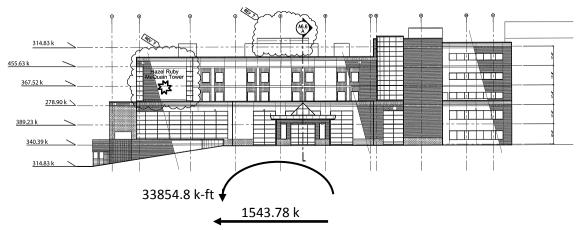
Figure 8: Seismic Loading

Seismic Loads			
Floor	Height (ft)	F_x (kips)	
1	0	314.83	
2	12	340.39	
3	24	389.23	
4	35.5	278.90	
5	47	367.52	
6	58.5	455.63	
Roof	70	314.83	
Seismic Base	Shear (kips)	1543.78	
Overturning .	Moment (k-ft)	33854.8

(Refer to Figure 8 for Seismic Loading Diagram)

Seism	ic Loads Distribute	d per Floor	
Floor	Height (ft.)	Weight (Kips)	Cvx	Fx (kips)
Roof	70	1115.96	0.20	314.83
6	58.5	5924.01	0.30	455.63
5	47.0	5947.62	0.24	367.52
4	35.5	5975.52	0.18	278.90
3	24.0	8694.82	0.25	389.23
2	12	10609.08	0.22	340.39
1	0	10097.11	0.20	314.83
Tota	l Weight	48364.124	Total Shear	483.64124
Overturning	g Moment (k-ft)	33854.8	Base Shear	1543.78

(See Figure 8 for Loading Diagram)

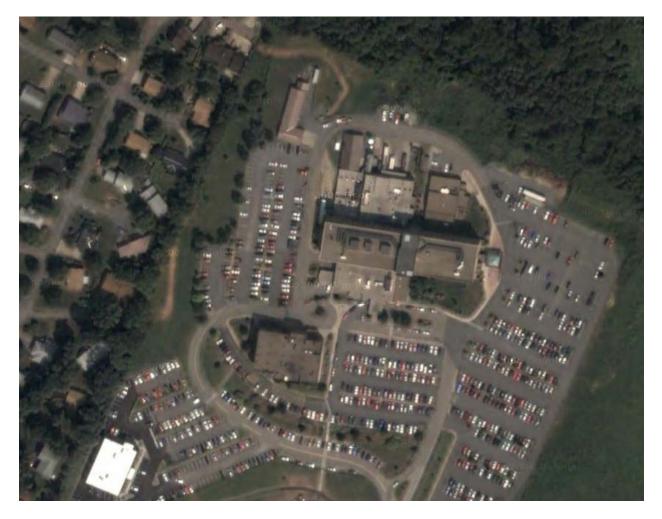
Photograph 2: Aerial Photo of the Monongalia General Hospital

The Monongalia General Hospital is located on 1200 J.D. Anderson Drive, West Virginia (Photograph 2 for aerial view). The current project the Hospital is going through is a 340,000 square foot expansion and renovation named the Hazel Ruby McQuain Tower, this new addition will provide more various facilities and departments to the Hospital. The construction started on June of 2006 and is scheduled to be completed on May of 2009 with a design-build contract with a guaranteed maximum price set at an estimated \$69,000,000 by the Turner Construction Company. The Tower has been designed by Freeman White, Inc. from North Carolina and the structure designed by Atlantic Engineering Services from Pittsburgh. (See Appendix A for Project Team Directory)

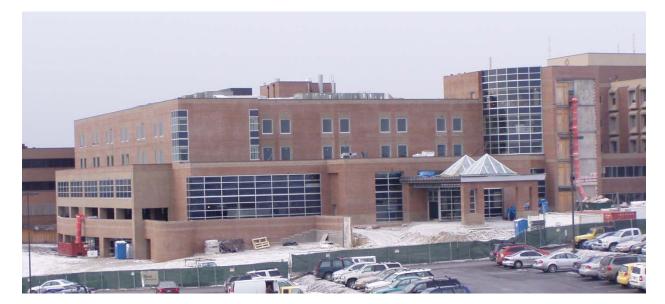
Photograph 3: View from South-East showing the brick façade and curtain walls

The exterior façade of the Monongalia General Hospital is a brick façade tied to 8" structural concrete walls with openings for punch windows and curtain wall systems. Windows are typically aluminum punch window units and located where there are offices and patient rooms, located on the third floor and up. Aluminum curtain wall systems can be seen all around the Hospital, oriented around lobbies and other major openings on plan (Photograph 1 and 3). The system consists of insulated tempered spandrel glass framed by aluminum mullions which is tied into the concrete structural system. Two inch rigid insulation is provided all around the building for insulation.
