Technical Assignment 1

Construction Project Management
September 29, 2008

Integrated Science Center

College of William & Mary
Williamsburg, Virginia

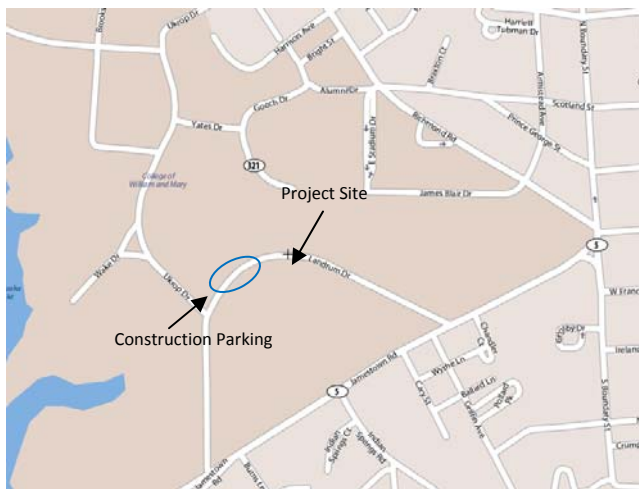
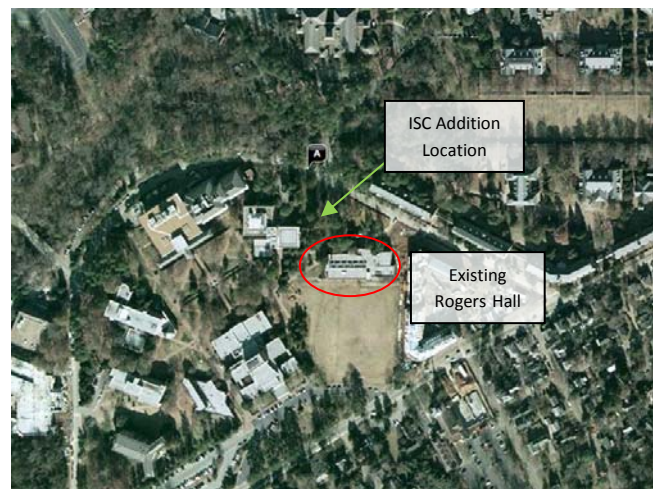
- **General Boundaries** - The site is generally bounded by Landrum Drive to the north, Jamestown Road to the south, Rogers Hall to the east and Millington Hall to the west.
- **Surface Conditions** – The project site was sparsely wooded and contains pedestrian walkways. An existing ravine is present along the north side of the site.

- **Site Soil Types** – The borings showed layers of varying mixtures of sands, silts, and clays.
- **Subsurface Conditions** – Groundwater level was below the bottom of the piezometer at the time of the study. This level was therefore evaluated by visually judging the moisture content of the silt-spoon samples and determined to be at a depth of 14 feet to 23 feet below existing ground surface. The contractor was prepared to possibly encounter subsurface water if construction extended below the planned basement subgrade elevation.
- **Construction Parking** – Parking near the site was rather limited. Landrum Drive was restricted to W&M students and staff parking only. It was agreed on to close a portion of Landrum road (see figure above) for convenient parking. This closed the current Landrum Drive loop but did not prevent access to any part of campus.

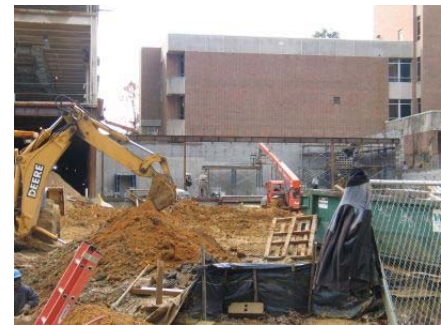
Demolition

- This project includes the demolition of interior partitions, ceiling assemblies, casework, and flooring materials in the existing Roger’s Hall (except in the auditorium area).
- Coordination between demolition work and new work is required for the structural, plumbing, mechanical, and electrical systems
- Demolition and removal of partitions, columns, and exterior walls are necessary without jeopardizing the structural integrity of the building.
- Asbestos was detected in samples of vinyl floor tile, black duct mastic, panels of a laboratory fume hood, white pipe mastic, and corrugated cementitious panel from the rooftop HVAC cooling tower.
- Abatement is required before commencing work.
- Lead paint was not detected in the building.

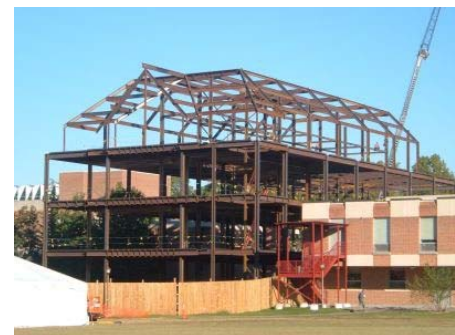
Structural Steel Frame

- No bracing is used in this structure. The interior steel frame is simply supported by load bearing masonry and columns.
- The supported floor system consists of a 5” lightweight concrete slab on a 1-1/2” 22 gauge composite deck.
- Currently in the process of receiving crawler crane size and information. See site plan for crane locations.

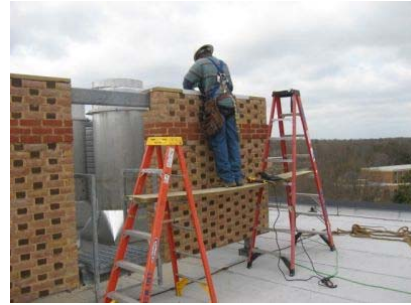
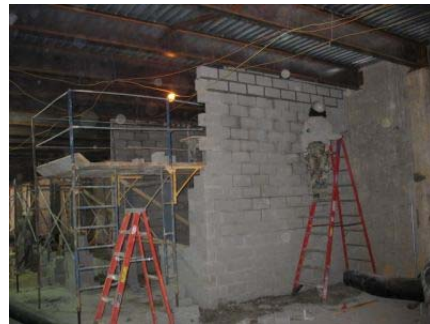
Masonry

- This building has brick veneer/metal stud exterior walls.
- The brick for the Phase I addition is a Flemish Bond pattern to match the adjacent dorm construction.
- The brick for the Phase II renovation is also a Flemish Bond pattern to match the existing Roger's Hall.
- Masonry ties at 1'-4" O.C. secure the brick veneer to the backup system.
- Galvanized steel shelf angles transfers the weight of the masonry back to the structural frame.
- Ground floor vivarium contains 6" CMU interior partitions.
