ANALYSIS 3: CURTAIN WALL INSTALLATION PROCEDURES

MAE Graduate-Level Component

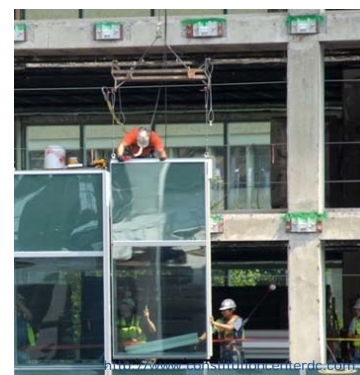
Figure 21: Photograph showing the installation of a curtain wall panel

1. Boot span between frames at sill starter chicken head
2. Hook up lifting lug to picking bar
3. QC unit (check that gaskets are installed, gaskets are long enough, all access holes are sealed, ab clips are installed and not damaged)
4. Lift frame vertically and wait for top half of crew is ready for installation
5. Align frame male leg of set frame and female leg of frame being installed.
6. Snap female leg and male leg together
7. Make sure ab clips did not snap on the outside of the female leg
8. Slide frame over the two alignment bars (stab bars)
9. Shoot the frames height and engage the set screw to maintain the frame height.

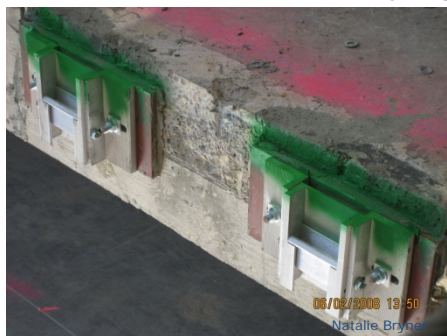
Figure 23: Curtainwall panel's anchors

actual temperature, precipitation and wind were a factor for delay. Both of these delays can be found in Tables 21 and 22. Overall, weather is typically a factor for delay in any construction project. Another delay was when rebar interfered with the anchors that had to be updated to support the panels. Since the waffle slabs have tensioned rebar from the original construction, it was a concern when rebar was struck during the installation of the new anchors. These anchors are shown in Figure 20 to the right. As one can see, there are typically two bolts need to secure the anchors, however, if rebar was encountered, then three or more bolts would be necessary to properly fasten the anchors. Another typical delay on projects is when other trades are working in the
