Technical Assignment 3

Construction Project Management

Shane Flynn
Construction Management
Dr. Magent

700 6th Street
Washington, DC

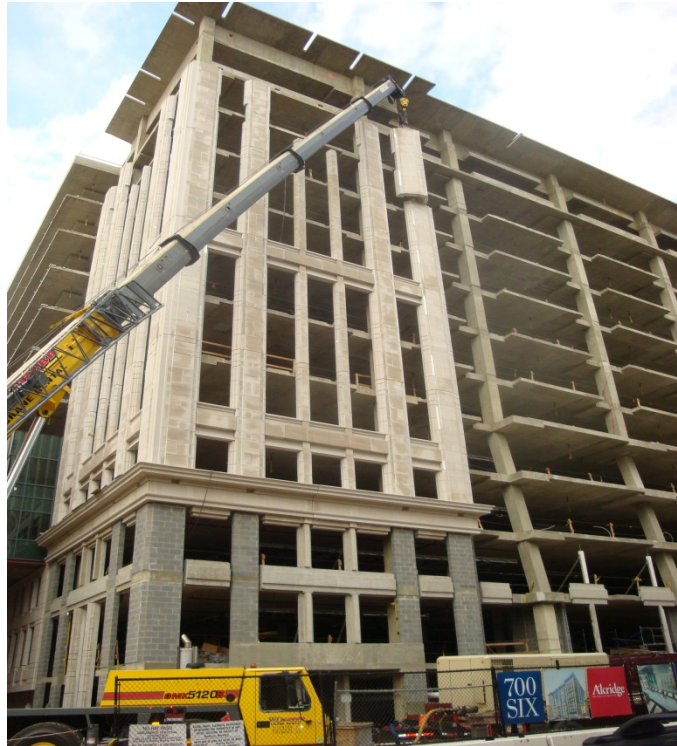
Picture 2.1-Concrete Superstructure

Another obstacle that needed to be overcome was installing precast cornice 12 stories up with a ~10 foot cant (overhang). Refer to Picture 2.1. These precast pieces were some of the largest pieces erected. Special permits were needed for the crane because it was so large. The concrete was already poured before the precast cornice was hung.

- Had to design slots in cast in place concrete cant (cant becomes cantilever with slots)
 - Structural engineer needed to be brought in to design cant
 1. The rebar had to be redesigned
- Have to coordinate slot placement with cables erecting precast pieces
 - Location of slots
 - How deep slots
 - How wide
 - Tolerances

Another obstacle that needed to be overcome was installing precast cornice 12 stories up with a ~10 foot cant (overhang). These precast pieces were some of the largest pieces erected. Special permits were needed for the crane because it was so large. The concrete was already poured before the precast cornice was hung.

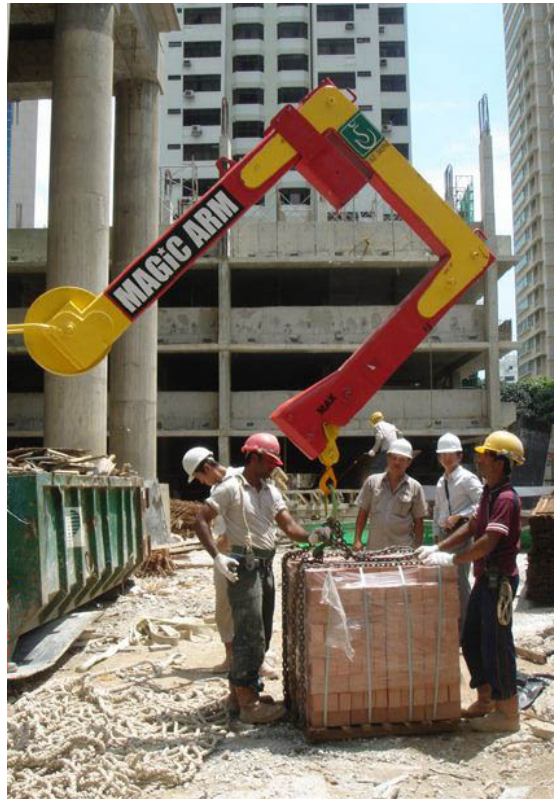
Picture 2.2-Magic Arm

The Magic Arm features a lifting hook and C-shape double pulley to allow operators to deliver construction loads directly to workers on elevated floors without the use of scaffolding or platforms. The Magic Arm can position a loaded pallet directly onto any floor by enabling the crane operator to maneuver the top arm onto the upper floor until it lies flush. The load is then gently lowered onto the floor below. With its sophisticated pulley structure attached to the crane cable, the Magic Arm ensures load weight is carried by the crane's cable and not by the arm itself.

- Better solution than building a cantilever platform
 - A lot quicker
 - Can go anywhere
 - Picks material right off truck
 - More room on site because of this
 - Building was water tight a lot sooner because of magic arm

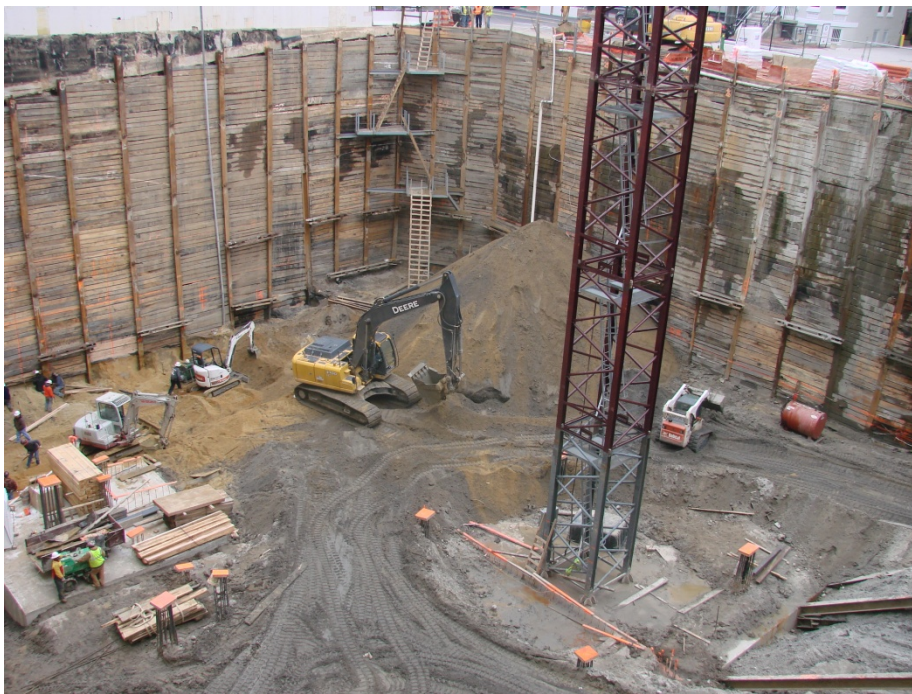
Picture 3.1-Excavation

- Excavation
 - Lost a lot of time with subsurface
 - Piles took longer than expected
 - A lot of sheathing was needed for this project
 - Unforeseen conditions
 - Water table higher than calculated
 - Had to redesign pumping system
 - Poor soil

Getting this job out of the ground was difficult to do with the poor soil and the unforeseen conditions. Time was lost during this phase but that time and then some was made up later in the project through schedule accelerations.

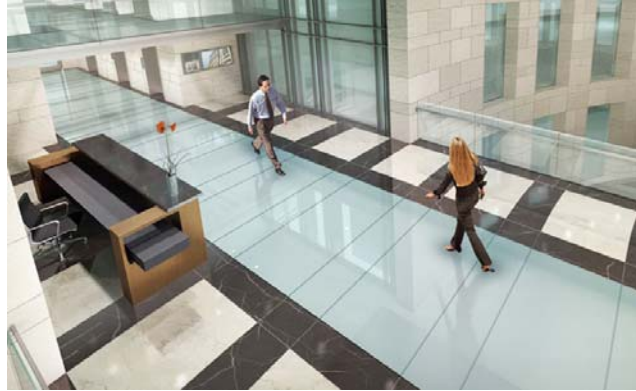
Picture-5.1

In the main lobby there is a glass bridge and glass floors. The problem with having a glass floor is it is very delicate. A week after the glass floor was installed a screw driver was dropped on the glass causing it to spider crack all the way through the glass. The screw driver was dropped from a distance of 4 feet, which should show you how delicate the glass is. Each glass panel is approximately 10 feet x 4 feet. These panels are

20,000 dollars each and are only produced by 2 manufacturers. The lead time for these panels is months and is not easy to replace. These panels need extra protection so they are not damaged during everyday use or they could be replaced with another material. Refer to picture-5.1.

The glass bridge built in 700 6th Street was very expensive because of the large sheets of glass. My research would consist of possibly decreasing the size of each glass panel. Instead of 1 large piece 2 could be used. This should decrease the cost of the glass significantly and should also decrease the shipping and installation costs. Another research area could be changing the material of the bridge to something stronger and less likely to break or researching a material to cover the glass and make it stronger. The glass bridge is not a critical item on the schedule so a comparison in how long each method would take would not be effective. A cost comparison of each method would be most appropriate.
