CAMPUS SQUARE BUILDING

1426 North Third Street, Harrisburg, PA

Andrew Martin
Construction Management

Technical Assignment #3
December 1, 2009
Dr. Chris Magent

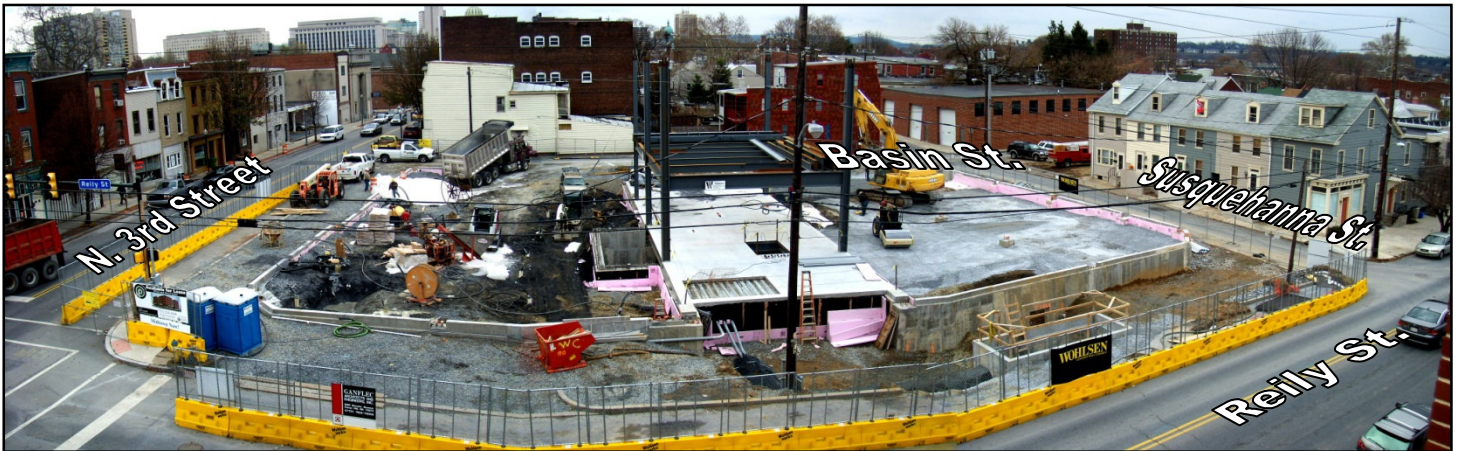
In order to provide additional movement and storage/lay-down space within the confines of the site, Wohlsen was able to extend the site fence partially out into the surrounding streets. As seen below in the site photo, barriers and fencing was used to secure the site from the public, as well as protect the workers within the site. This strategy permitted public pedestrian and vehicle traffic along to be maintained along the surrounding streets throughout all phases of construction.

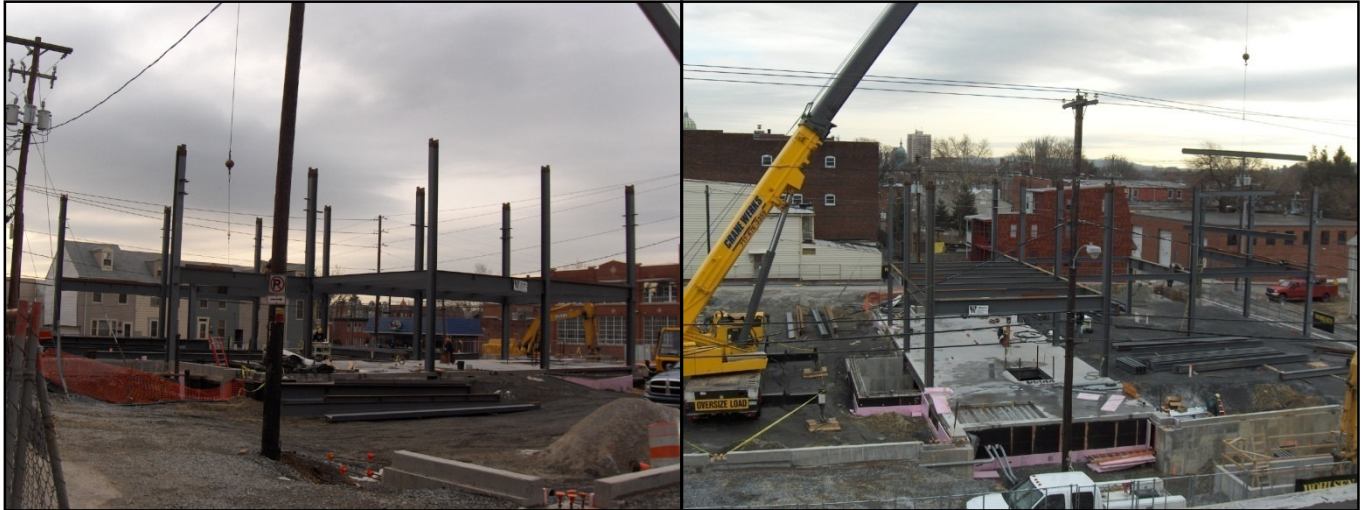
Figure 3 – Existing Utility Poles and Power Lines

Existing overhead power lines ran along the existing sidewalk on Reily Street and within the property line of Campus Square on Basin Street. These existing utilities created logistical problems throughout the construction of the building, particularly steel erection and exterior façade work. The two poles with transformers along Basin Street needed to be relocated because they were within the designed footprint of the building. This involved coordination with the local providers in installing the new lines, moving the existing lines, and removing the existing poles. However, Wohlsen's initial scheduled dates and durations for this work was not completed by the utility providers during the planned for dates. This resulted in a two month delay when the steel erector was forced to stop work once the erection sequence reached the utility pole locations, resuming when the utility companies performed the power line relocation.

The lines along Reily Street were required to remain live during construction. Due to OSHA requirements as well as safety measures enforced by Wohlsen, coordination with the power provider was conducted in scheduling temporary outages when facade work was taking place

near the lines, specifically the curtain wall system and masonry work. **Figure 3** below are construction photos of the utility poles along Basin Street (left), and Reily Street (right).

The overhead power lines running parallel with Reily and Basin Streets resulted in numerous logistical problems. For example, steel erection was affected because of the need to use multiple crane locations and mobilizations, as well as costly delays in construction which pushed back the completion date of Campus Square. During preconstruction, moving the existing power lines underground was proposed as an alternative in dealing with the issue. However, the decision was made that it was too costly to perform the aforementioned work, and Wohlsen assumed the coordination issues in dealing with the utility companies and service providers

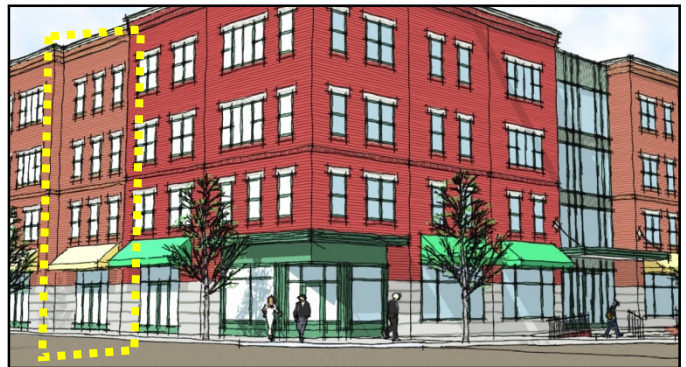
Approximately \$20/SF was reduced in the façade price by eliminating one of the curtain wall systems from the face of the building along Reily Street. Although glazing helps daylighting efforts, it hurts thermal efficiency. However, the curtain wall was eliminated mainly for overall CSF savings.

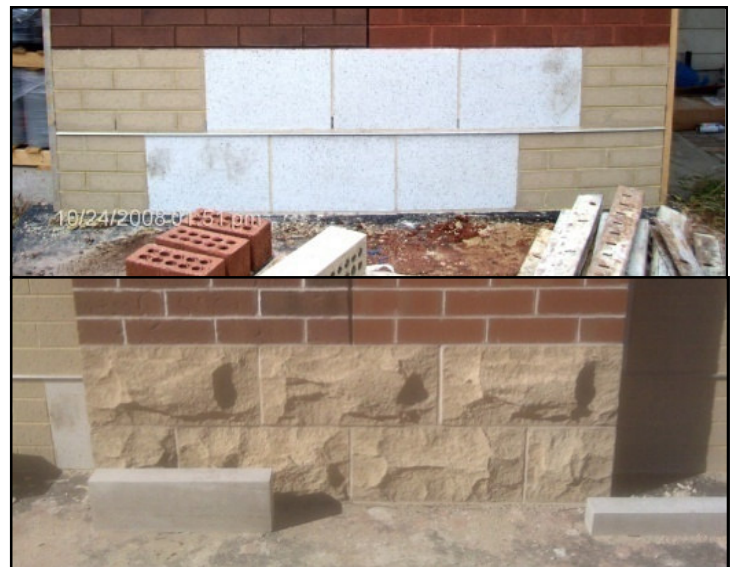
Figure 6 – Masonry Block Mock-Ups

Architectural precast concrete panels were originally designed to be constructed on top of a limestone block base as a historical aesthetic along the street level of the building. An early VE proposal substituted the precast for a masonry block, saving approximately \$60,000. This was later rejected by the owner, and compromise was made with another product, for an approximate savings of \$30,000. **Figure 6** to the right compares the two mock-ups constructed of the two masonry systems. The bottom system was chosen.
