# BUCKHORN MEDICAL OFFICE BUILDING

## *Senior Thesis*

Technical Assignment III

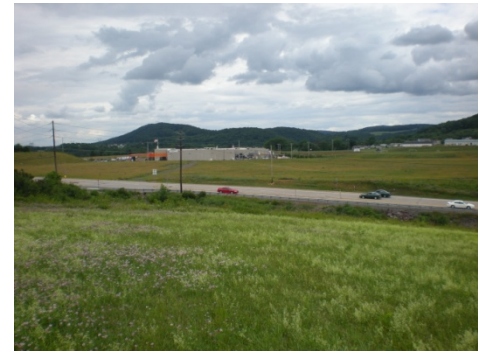
Figure 1: The existing site before excavation

The first geotechnical report was given to Geisinger in January 2008, but only provided a preliminary analysis for the construction of the office building. The geotechnical engineering firm, Geo-Science Engineering Co., Inc., went back to perform a full site investigation in May of 2008. In this second geotechnical report, they found that on the north portion of the site, the fill area suggested +/- 20 feet of fill. In the southern area of the site, there appeared to have been a cut of up to 20 feet to provide some of the soils for the north end fill. In the north end fill, the geotechnical firm found pieces of broken asphalt, poorly graded stone, grasses and other vegetation mixed in with poorly graded silty clay. There was no topsoil layer present and the firm recommended that the fill be removed from the site in order to achieve an acceptable bearing capacity.

To solve this problem, Alexander chose to remove nearly all of the fill located along the northern part of the site and move it off site. They felt that it would be the better decision than having to worry about differential settling after the project due to constructing the building on unsuitable soil. Alexander excavated as much fill as needed until they could achieve proper bearing capacity for the foundations. This involved a significant amount of extra work and resulted in the exceptionally long duration on the schedule for site work. Alexander

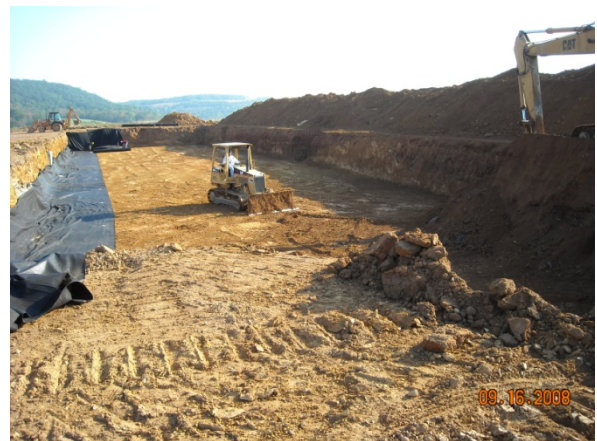
Figure 2: Excavation for the foundation of the building

compared the cost of leaving the bad fill in-place and redesigning the foundation system using deep foundations versus removing the fill and using the existing spread footings. They found that not only would a redesign of the foundation impact the critical path of the schedule, but it would also be more expensive and would require more geotechnical studies.

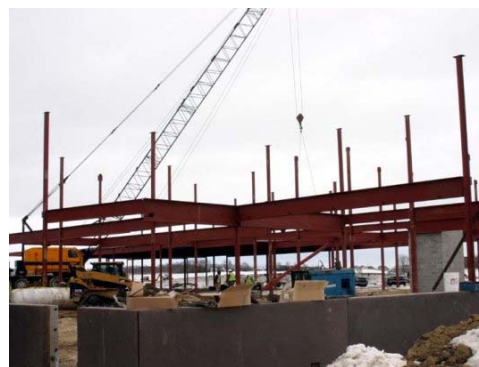
**Figure 3: Steel erection during winter months**

The steel erection operations were also affected by cold weather due to high winds and exposure. The technical aspects of steel erecting were not different for cold weather conditions; however, the erectors had to consider the

expansion and contraction of the steel due to temperature changes that could have affected quality. Several of the steel operations that were affected by weather included welding, laying of metal deck, and high-strength bolting. In very cold weather, the welds had to be preheated to prevent the premature cooling of the deposited metal and steel beams had to have snow and ice removed from the tops before they were covered with decking.

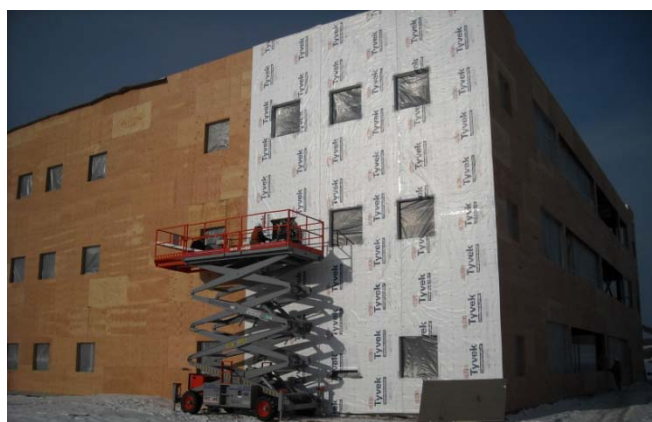
Figure 5: Installation of the Tyvek wrap

Alexander’s biggest challenge was to ensure that the building was water tight through the rainy spring months while the exterior was not completely finished with the metal panels. To prevent water seepage as well as get the building to a point where it could be fully enclosed and heated, Alexander began by sheathing the entire building with the ½” plywood. JLG lifts were used and they worked their way around the building in a clockwise manner. Immediately following the plywood sheathing installation was a crew that covered the sheathing with Tyvek high-density polyethylene fibrous wrap to provide a layer of

moisture protection until the exterior system could be completed. Only once the metal panels arrived on-site did the installation crews remove the Tyvek wrap in sections and install the “Z” channels with the 1” insulation board followed by the metal panels. It was important that the Tyvek was only removed for the sections that were being installed in order to keep the building as water tight as possible.

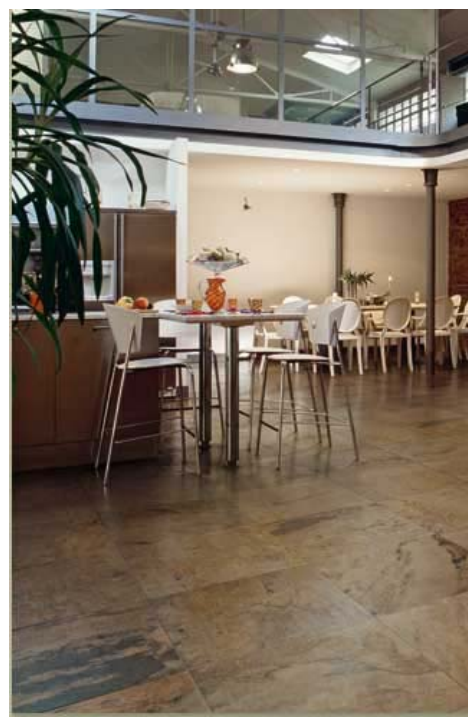
Figure 7: Example of porcelain tile. Courtesy of [tilemarblegallery.com](http://tilemarblegallery.com)

One major finish item that was considered during the value engineering process was using a recycled rubber composite tile instead of porcelain. Porcelain tile flooring is extremely hard and is highly resistant to stain, scratch, and moisture. It is also more resistant to harsh cleaning agents and needs no polishing, waxing, or sealing. The disadvantage of porcelain tile is the high initial cost, the difficulty to match for repair, high repair costs and long installation time. The cost of porcelain tile was approximately \$22/SF and a total cost of \$73,740. On the other hand, the recycled rubber composite tile only cost \$1.47/SF and a total cost of \$4,927. The rubber composite tile came in several colors including the option of creating custom colors. It was also easy to install and easy to repair. The rubber composite tile also satisfied a portion of a LEED credit for using

sustainable/recycled materials on the project. The major setbacks of the rubber tile were that it was less durable, had a higher maintenance cost, and a lifecycle of only about 20 years.

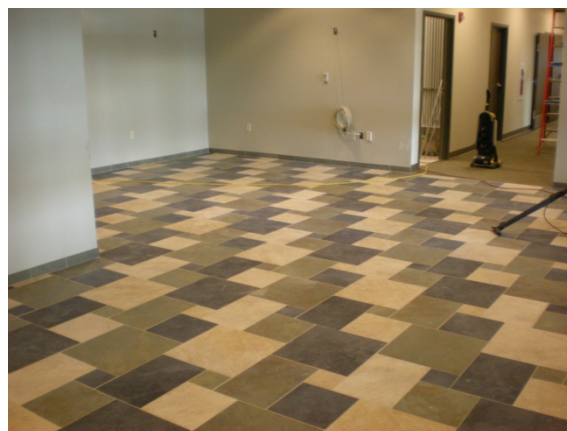
Figure 8: Recycled rubber floor tile at Buckhorn.

Geisinger found the initial cost savings significant enough to warrant not using a more premium, lower life cycle costing floor system. The rubber composite tile also had a coarser texture to it that reduced slippage when the floor surface became wet. Geisinger felt this would be preferable over placing walk out mats over the porcelain tile during the winter months. Geisinger, being a company concerned with health and safety, did not want people falling in the lobby as they entered the building due to slippery floor surfaces.

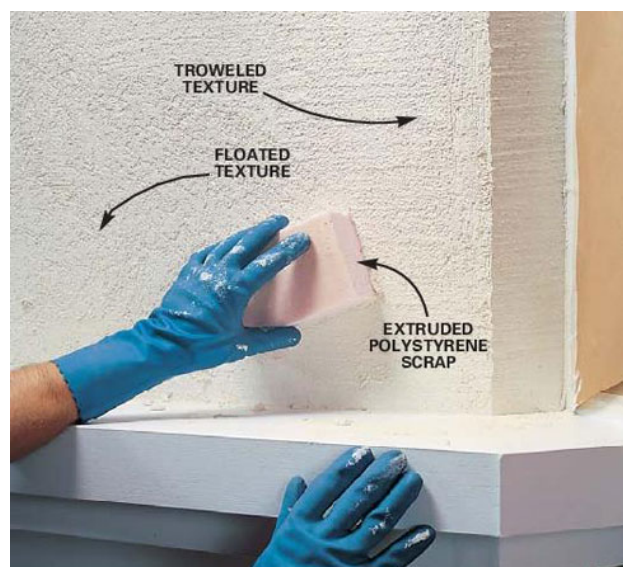
Figure 9: External Insulation Finishing System (EIFS).  
Courtesy of rd.com

Another item that was considered for value engineering of the Buckhorn Medical Office Building was to replace the proposed aluminum metal panel exterior with an exterior insulation finishing system (EIFS). Because the Buckhorn Medical Office Building had a fairly basic exterior skin, the idea of using EIFS instead of aluminum metal paneling was considered. EIFS consists of first placing a layer of foam plastic insulation that comes in sheets of 2' x 4'. Once the foam is applied to the plywood sheathing, a fiberglass reinforcing mesh embedded in a cementitious adhesive is applied onto the face of the insulation with a trowel. Lastly, a topcoat that can be colored and textured is applied with a trowel. EIFS offers many advantages such as its ability to control heat loss through the building envelope; this helps reduce heating and cooling costs. The EIFS system was also much less expensive. EIFS was priced at approximately \$6/SF whereas the aluminum metal panels cost approximately \$24/SF.

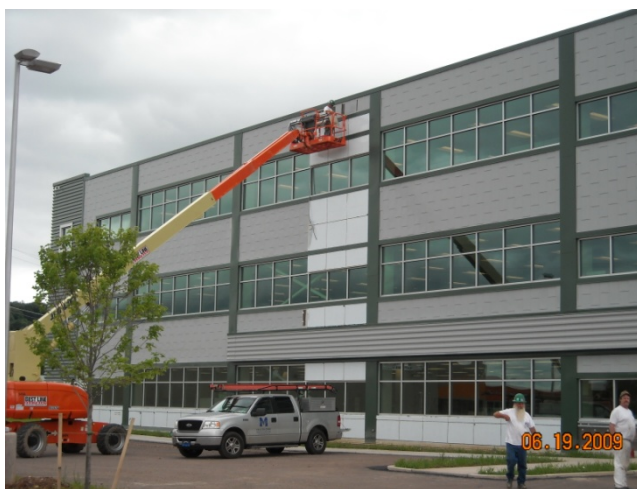
Figure 10: Installation of the aluminum panel system

Geisinger, as well as the architect, did not approve the value engineering idea. The architect did not feel that they could not achieve the same aesthetic appeal using EIFS over the aluminum metal panels. Geisinger also did not approve the value engineering idea due to durability and maintenance costs. Aluminum panels are extremely lightweight, yet exceedingly strong. Aluminum panels are also easy to maintain. There is no painting or refinishing of aluminum products required, and the only cleaning generally required is washing with detergent and water.

Aluminum is also smooth, dense, and corrosion-resistant which minimizes the adhesion of dirt and overall maintenance. Geisinger found these characteristics very attractive due to harsh conditions of northern Pennsylvania.
