# Executive Summary

**Silverado Senior Living**  
1105 Davidson Road  
Brookfield, WI 53095

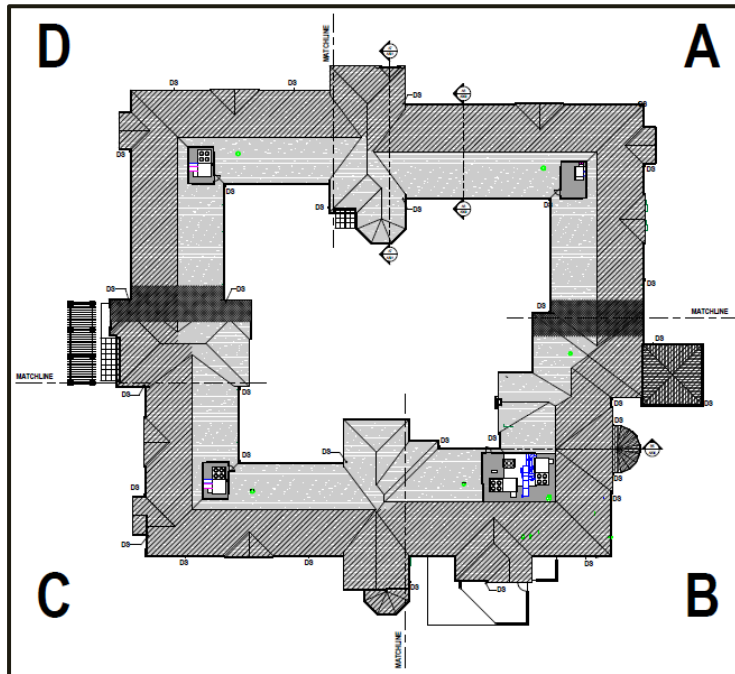
Figure 1 – Building Quadrants

With the foundation and slab on grade complete, the wall panels and trusses could then be erected. The project was split up into four quadrants, and all processes followed the clockwise sequence of B to C to D to A. Also, because there was to be a courtyard in the middle of the facility, a portion of the South East quadrant was left out so the roof top mechanical equipment could be installed and landscaping did not interfere with any of the interior finishes. With the frame almost complete, the natural thin veneer stone could be installed. The City of Brookfield required the predominant exterior façade material to be brick or some kind of masonry veneer. Although not the cheapest option compared to traditional vinyl panels or siding, the owner was willing to pay a higher amount for a better material.
