Lowell Stine CM Dr. Leicht Library in Metropolitan Washington, D.C 10/16/2013

Library in Metropolitan Washington D.C

Technical Assignment 2

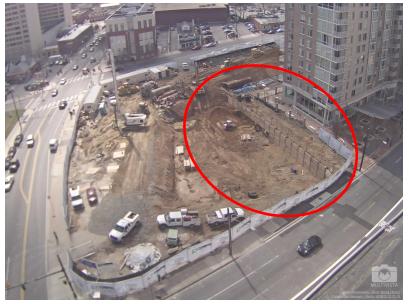
Excavation & Lagging (Provided by Multivista.com)

Excavation for the footings started after site mobilization and caisson testing took place on February 14, 3013. It was required to install lagging and tiebacks to only the west side of the excavation because of the neighboring existing residential tower (As seen in Figure 1 above). Also during excavation water was encountered and had to be removed from the northwest corner of the excavation.

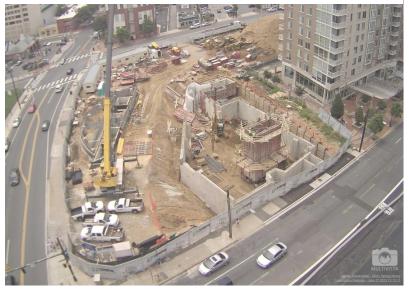
Foundation Walls & Shear Walls Installation (Provided by Multivista.com)

With the finish of the mat foundations, the three concrete shear walls could start to be installed using a system of aluminum forms that inner lock and are self-supporting/ bracing. This process was lengthy and was in progress from mid-May to mid-June because the shear walls needed to be raised one floor at a time with a gap build into the schedule before the next level was started to allow the previous level adequate time to cure and grain strength. These shear walls are the elevator shafts for the building and tie into the rebar in the mat foundations. Concurrently with the shear walls, the concrete foundation walls also were being installed (as seen in Figure 2 above).

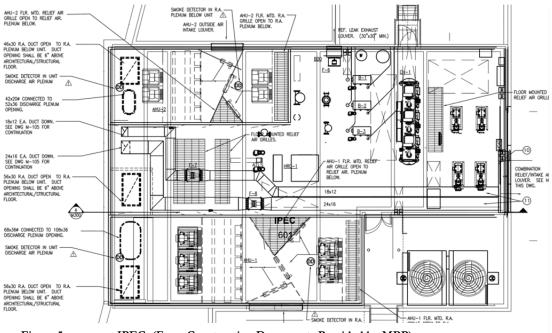
There will be three 800 MBH gas fired boilers in the IPEC with two 143 ton cooling towers and one 226 ton chiller to serve as the primary heating and cooling source for the building. The system is also equipped with a heat exchanger, and an auxiliary heat recovery chiller. Build into the system is also a variety of 13 pumps that

range in size from 1HP to 20 HP. To circulate the required volume of air, two air handler units are incorporated into the IPEC system; one at 40,000 CFM and the other at 16,000 CFM.

Of the assemblies estimates, the mechanical was the most difficult to estimate because much of the mechanical equipment is located in the IPEC (as seen in Figure 5, below), which is a specialty item and therefore has a different price than if all the equipment was installed in a mechanical room. In an effort to estimate the mechanical system each piece of equipment in the IPEC was accounted for in this assembly estimate using the references available. It was reasonable to start with the biggest and most expensive equipment first and then work down to the smallest. In all cases if the exact capacity equipment was not available, then the closest was used for the sake of this estimate.

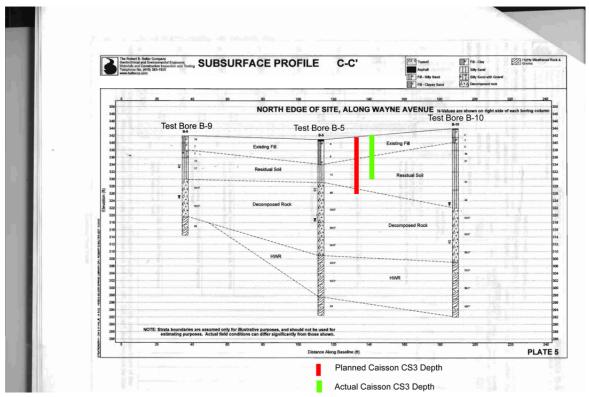
Figure 8 Test Bores B-9, B-5, and B10 Compared to Depth of CS3 (From Geotechnical Report Provided by MBP)

In the Geotechnical report, The Robert B. Balter Company evaluates the feasibility of using shallow and deep foundation types for the library. Shallow foundation types are rules out in the very beginning of the report because of inadequate soiling bearing capacity. Three different types of deep foundations are examined to evaluate which would be more practical for the library; micropiles, caissons, and auger cast piles. However, auger cast piles are also eliminated early on in the report and a detailed evaluation is done on micropiles and caissons. In the end, the foundation type was chosen to be a network of caissons. Also, the geotechnical report states that the first few feet of soil on the side consists of backfilled material and that soil/rock that may be of appropriate bearing capacity varies in depth across the site. On every caisson the planned depth that the caisson would have to penetrate rock was either 5 feet or 6 feet depending on the load being carried and the composition of the nearest test bore. The depth of soil that had to be penetrated was different for each caisson because the rock was thought to be located at a different depth for each. Figure 8 and 9 below shows an example of one such caisson that was 8 feet shorter than originally planned from the test boring log.

When the contractor was having the caissons drilled in the field the actual depth of the unsuitable soil and the actual depth of rock needing to be penetrated for proper bearing capacity was different than what was originally assumed. This was a problem because the rebar cages for each of the caissons was premanufactured and shipped to the site already. Most of the rebar cages were too long or too short for the revised caisson depths. In order to keep work flowing without enormous delays, the contractor, in which was self-performing the concrete and rebar work, altered each rebar cage one at a time to match the revised required caisson length. These still created delays that are felt on the project to this day and that the contractor is still trying made up.

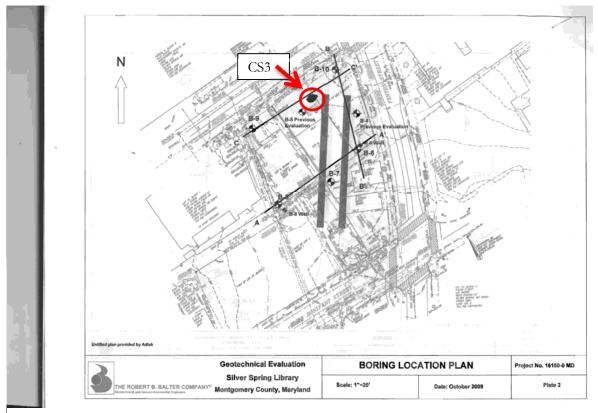
Figure 9 Test Plan Showing B-9, B-5, B10, and CS3 (From Geotechnical Report Provided by MBP)

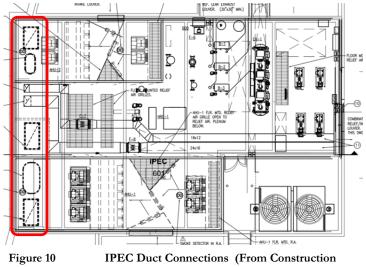
IPEC Duct Connections (From Construction Documents Provided by MBP)

different manufacturer. While coordinating the issues mentioned above, the contractor has been having difficulties acquiring the appropriate information on the IPEC in order to complete these coordination issues. At this point the construction manager has stepped in and is also trying to do the appropriate coordination. Because there are a lot of trades that must line up and coordinate the connections to the IPEC this is still and ongoing issue will be better resolved when MEP rough-in starts. Some of the connections for the ducts in the IPEC are shown above in Figure 10.

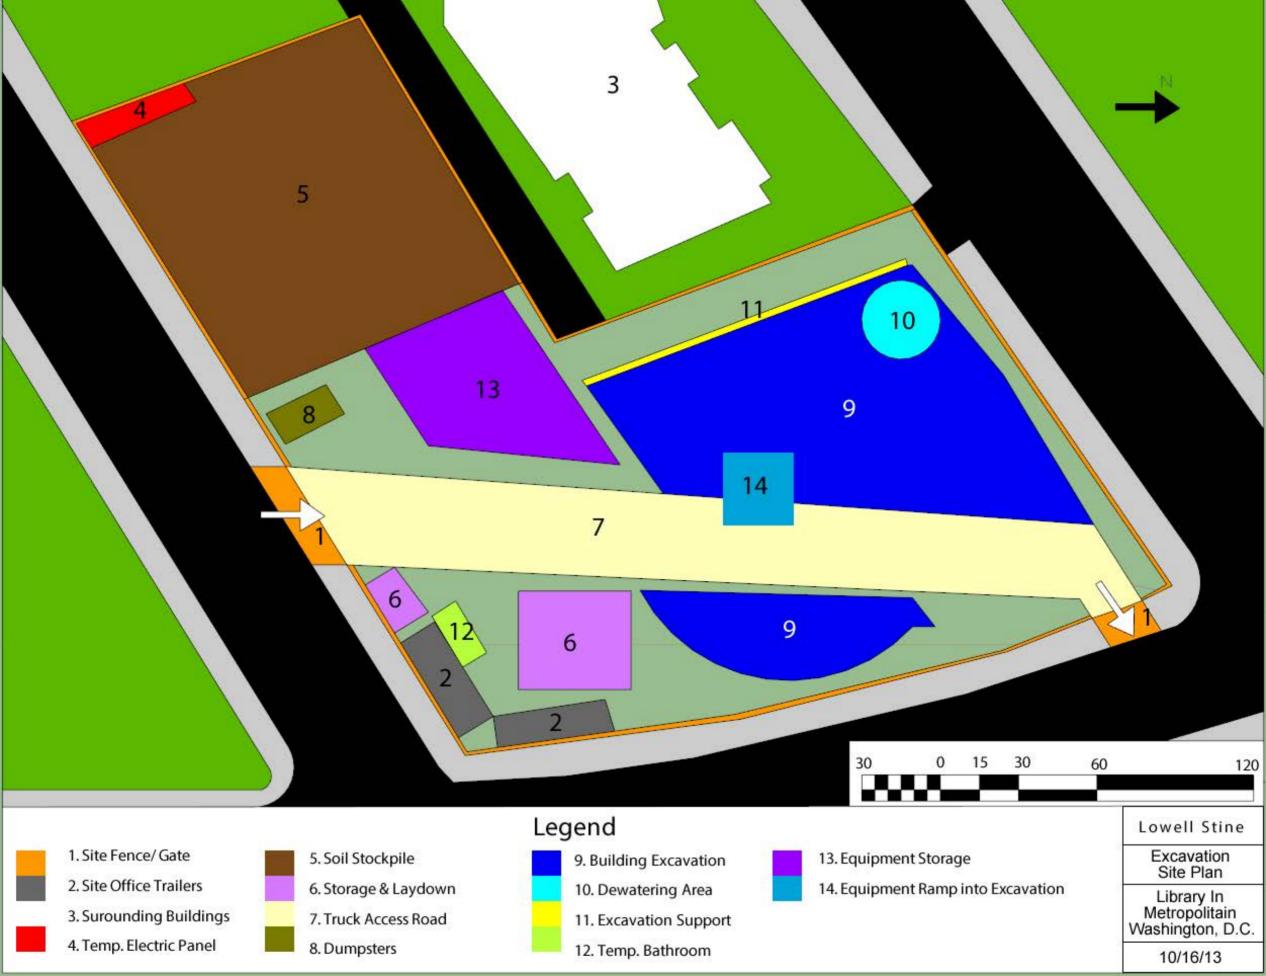
During excavation the truck upload/ load/ drive-in area actually extends between the two building footprint areas and out the other side to allow a straight flow of dump trucks in and out of the site. Top soil will be stored on an adjacent plot of land that is also enclosed with the site fence during the excavation phase and superstructure phase. Bulk excavation will be in the building foot print leaving a ramp for equipment to exit the East side of the excavation. On the west side of the excavation there will be a shoring and lagging effort to ensure proper soil retainage and not to disturb the foundation of the neighboring residential tower. The rest of the excavation did not need such soil retainage because it was adequate room for sloping back. A small isolated ground water problem was encountered in the West corner of the excavation in which pumps had to be set up to remove the water and prevent it from filling the excavation.

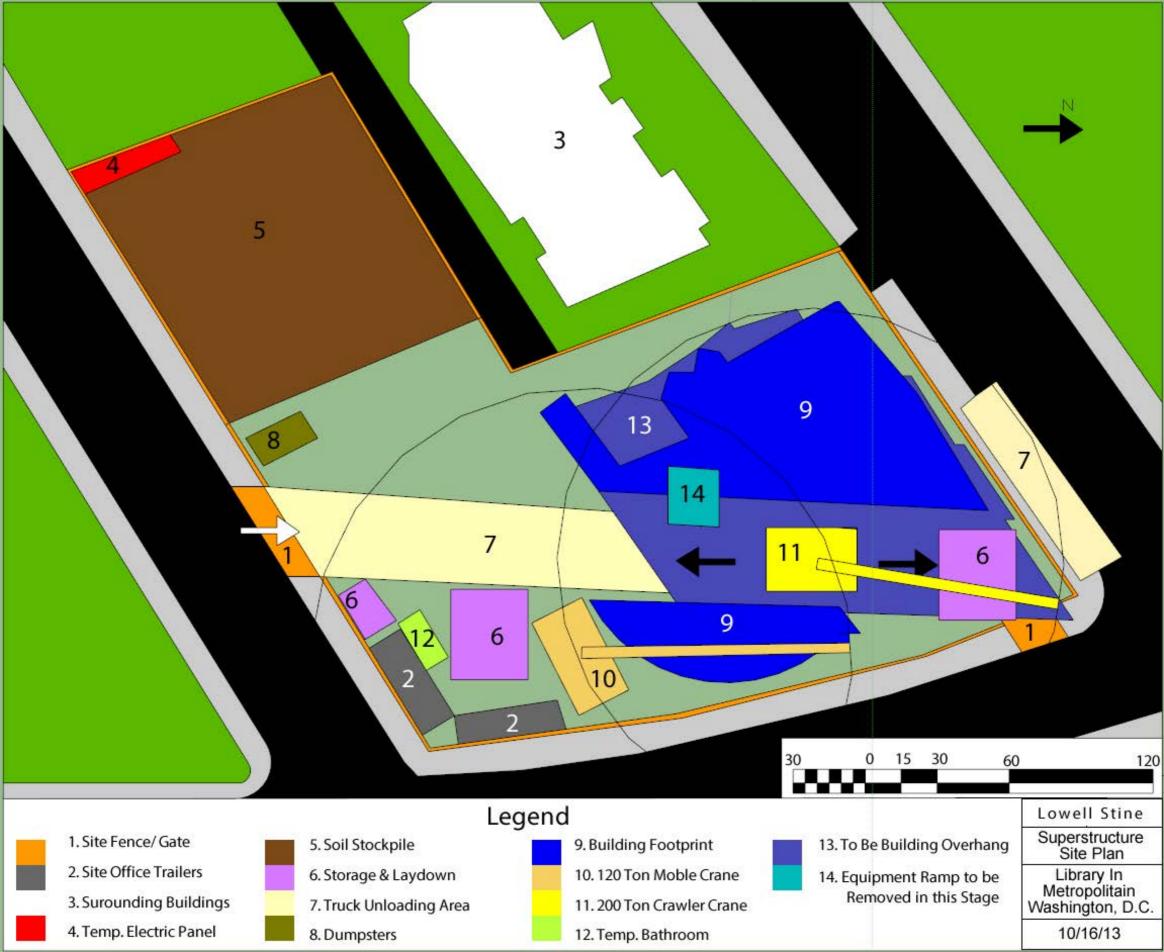
During the superstructure phase two main cranes will be brought in, one 125 ton crane to do general lifting and one 200 ton crane (seen in Figure 7) to place structural steel on the project. The smaller of the two cranes will move from on the future train platform to beside of the pavilion, while the large crane will primarily be on the train platform and has the ability to craw to one side of the building to the other to reach all areas of the building. Eventually the large crane will back out towards the South of where the building over hangs the train platform to place the structure for the overhang. In general, structural steel is complete from level one through five in the

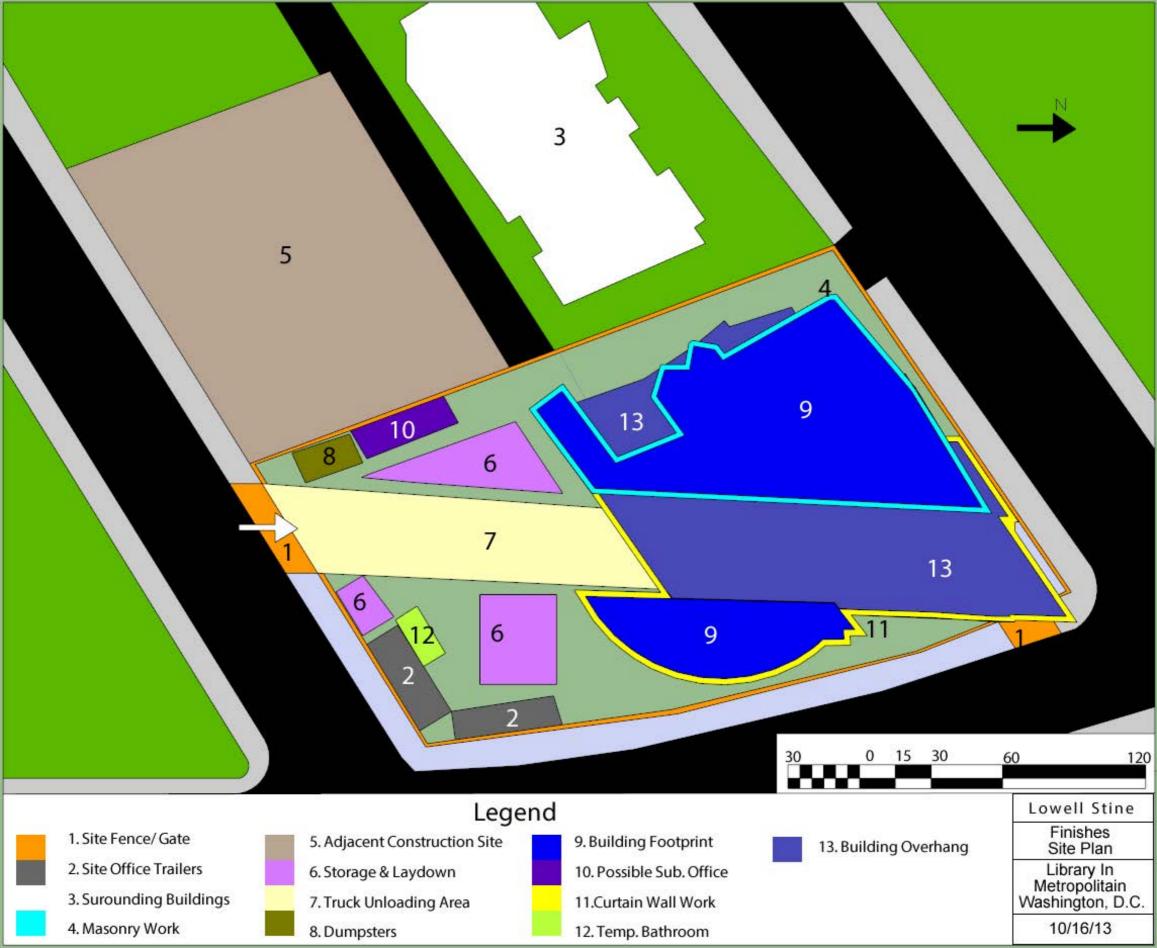
Once the finishes start to go in, the site plan drastically changes in that the adjacent lot that was used to stockpile top soil must be cleared and the site fence must be rerouted as to not include this lot, drastically cutting the size of the site down, because construction of another residential tower will beginning on that lot. By this time in the construction process the building should be on permanent power with no need for a temporary electrical service. Around the exterior of the building there will be masonry and curtain wall work taking place.
