# Sunnyvale Plaza

**Nathan Braskey – Construction Option**

Final Report

Mid-Atlantic Region, United States

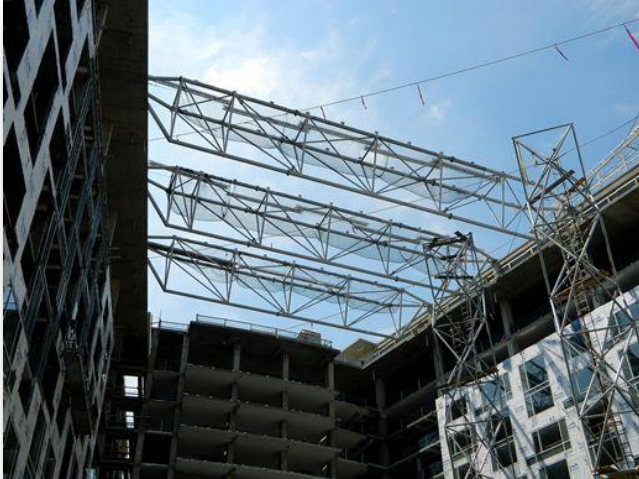
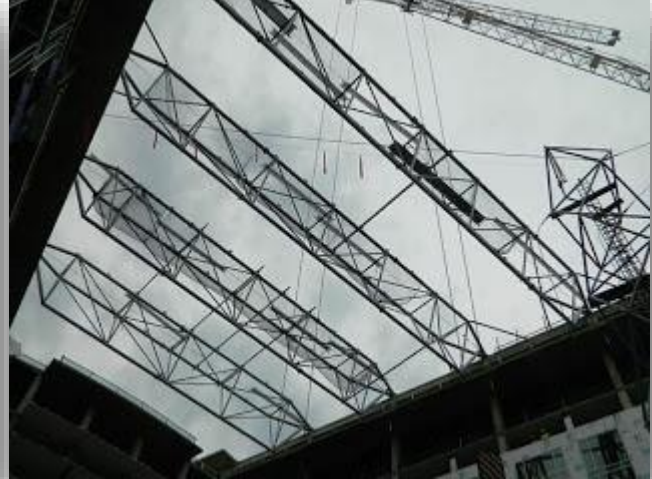
Figure 0-5: Skylight Construction

The skylight structure is also a very important part of the critical path. The structural components of the skylight cannot be installed until the superstructure is complete. Therefore the skylight is the last structural element installed in the superstructure. The finishes for Sunnyvale Plaza cannot be installed until the building is sealed and conditioned. Therefore the final pieces of glass around the perimeter need to be installed before most of the finishes can begin. Due to the installation of the large statue, the

skylight installation is already limited to other activities being completed and must be closely monitored within the schedule.

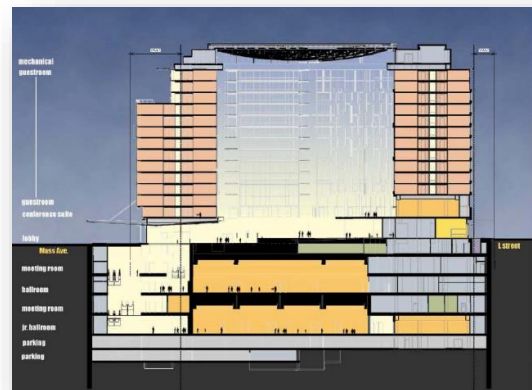
Figure 2-1: Sunnyvale Plaza Elevation

The removal of soil was the most extensive process throughout the entire excavation. Aside from the 135 foot depth of excavation, the soil needed to be removed through a tunneling process. This process was difficult due to unforeseen circumstances throughout each level. The columns that were poured were not perfectly aligned and would not always sit where they were expected to on each floor. This created a guessing game for the tunneling crew while moving throughout each level. As the levels were cleared, the soil was removed through openings within each slab. The first three slabs below grade consisted of four openings to allow for the removal of the soil. All of the levels below the first three only utilized two openings for the soil removal. The soil was lifted from each level utilizing a specially designed bucket via the cranes located on-site. The slow process of removing the soil created a lengthy excavation process.

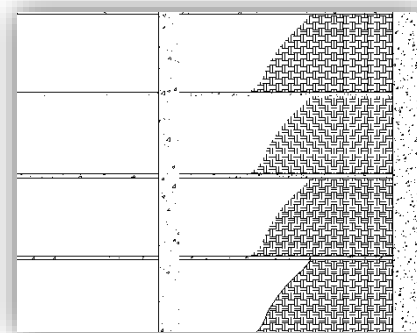
Figure 2-2: Excavation Elevation Detail

Each slab could not be poured until several trades performed work on the in-slab materials. First, structural steel and reinforcing was placed within the building. Once the steel was placed, large steel plates were welded together to create shear studs. Finally, electrical and plumbing trades place in-slab materials.

A large amount of soil was also required to stay at the edge of each slab against the slurry wall. This soil was required until the slabs reached full structural strength. This soil helped retain the slurry wall and hold the slabs while they cured.

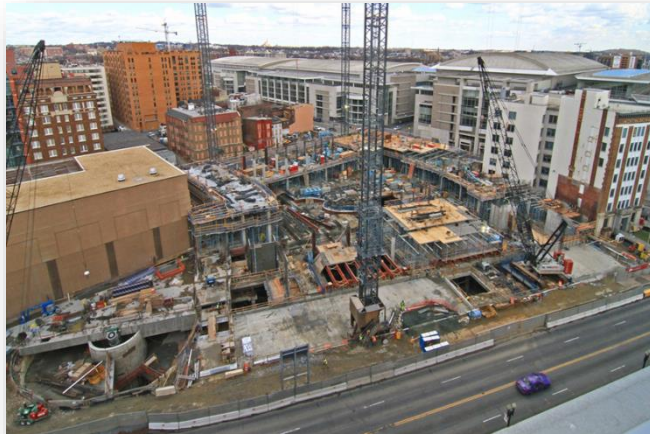
Figure 2.4: Project Site

The slurry wall was also a high risk factor involved in the chosen excavation process. The entire depth of the slurry wall was dug out to fill with reinforcement and concrete. This concluded with a hole that was approximately 135 feet deep and several feet wide. The reinforcing steel was built on site to the full depth, then lowered into the slurry hole. This created a large steel structure within the project site, which was also a safety concern.

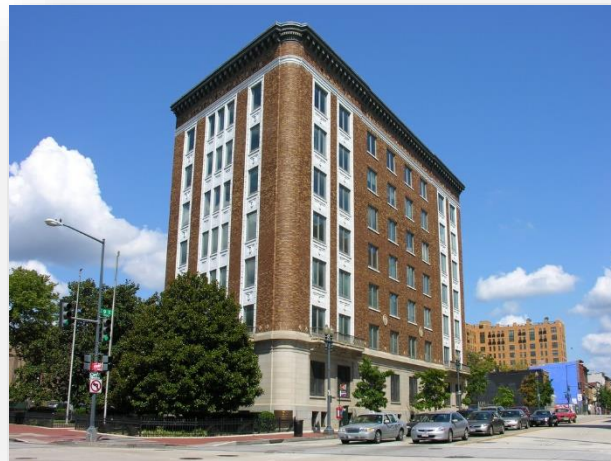
Figure 3-1: Image of Existing Building

The union building was kept as a historic feature of the new hotel. Efforts to keep the façade of the existing building through façade retention will be analyzed to maintain the historic brick feature of the hotel. The building is fairly small, but accounted for a lengthy deconstruction process. Several key additions within the lower floors also took extensive time. This can all be avoided with the construction of a new building.

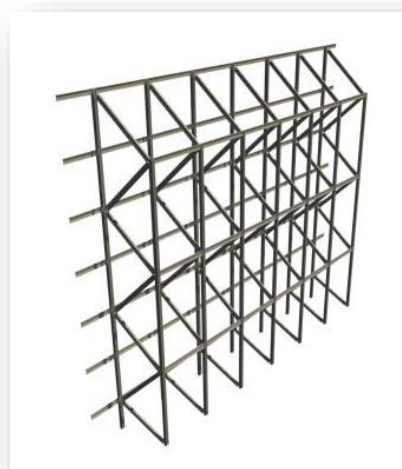
Figure 3-2: Façade Retaining Structure

The façade retention structure consists of horizontal steel beams that are channeled against the exterior and interior faces of the wall across each window level. These beams are connected utilizing a through bolt to grab onto the wall. Vertical steel columns are then connected to the exterior horizontal beams approximately 17 feet apart. The vertical truss system is then connected to the vertical steel columns to create a system of structural bracing elements. This bracing system will transfer the load of the wind to the concrete blocks located on the street.

The horizontal wall span was estimated by utilizing the equivalent distance of the vertical wall spans between each level. It is assumed that if the wall can span that height while being structurally stable, then it can appropriately handle the same horizontal wall span. Therefore the floor to floor height directly relates to the approximate horizontal span of each truss system.

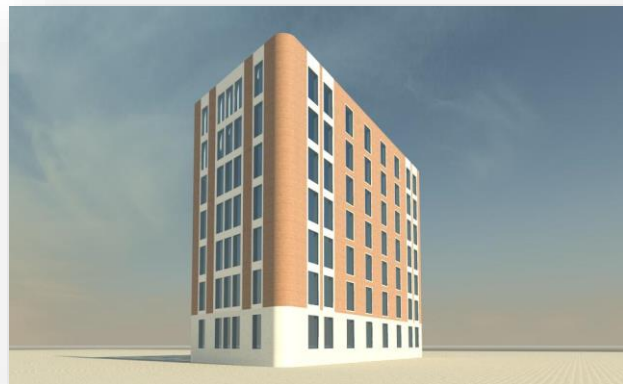
Figure 3-4: Façade Rendering

The total façade that required retention support consisted of a 126 foot wall along the east street and a 53 foot wall along the south street. These walls were made up of four inch red brick on twelve inch concrete masonry units. Both walls are approximately 95 feet tall, and will employ seven occupied levels.

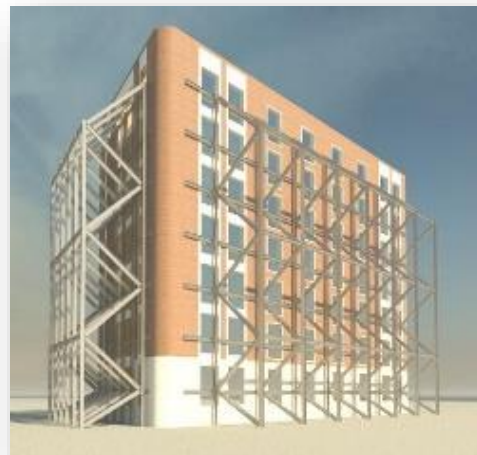
Figure 3-5: Retained Façade Rendering

Horizontal cross beams were placed at each window opening level, at approximately twelve foot intervals. The effective wall area per beam created a total force of approximately 9,000 pounds per cross beam. This force will ultimately transition to the vertical truss sections. The window area was then removed from the effective area to create a total force of 7,900 pounds. Utilizing a safety factor of 1.2 allowed for a load of 9,500 pounds per connection to the truss system.

The general steel length and forces for each member included in the truss framing system is defined in Table 3-1. Utilizing this table allowed for the calculation of total steel needed for estimating purposes. A standard W8x31 steel beam was utilized to fulfill the structural loads within the system. The same beam was utilized to create consistency within the system and to be utilized within the hotel structure once the façade retention is completed.

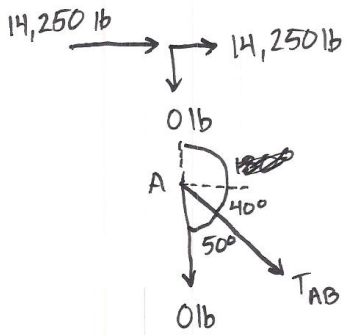
Sections

$$= T_{AB} \sin 40 - T_{AC} \rightarrow T_{AC} = 11,957 \text{ lb}$$

$$\sum F_y = 0 = T_{AB} \sin 40 - T_{AC}$$
