Construction Management

New Moon Area High School/ District Administration Offices

Technical Assignment Three | 12/1/2009

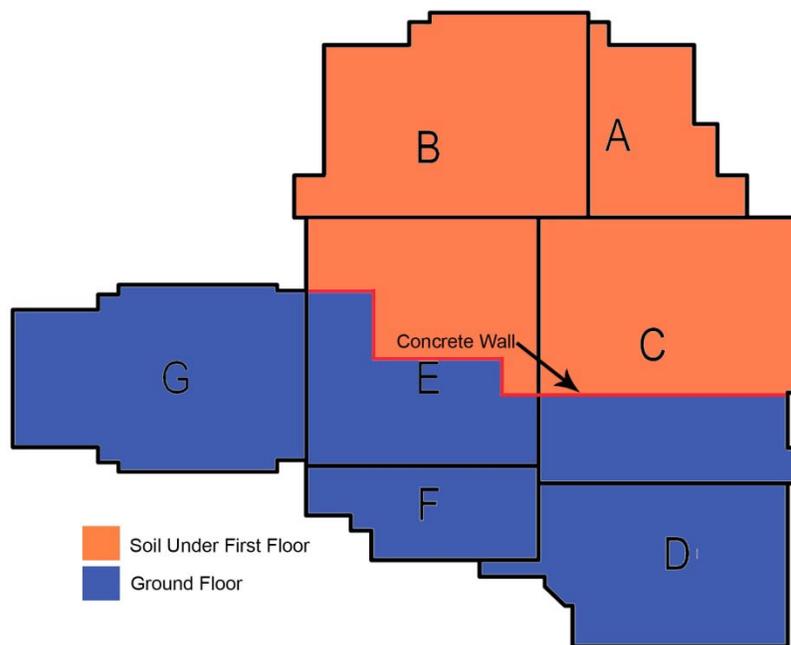
Figure 1: Concrete Wall Location

As a result of the buildings split-level design there is a foundation wall that separates the ground floor of Areas C&E from the soil under the first floor, shown below in *Figure 1*. As designed, the wall could not be backfilled until the steel on the ground floor was set and plumbed and the first floor slab-on-deck was placed. This was a problem because the grade beams under the first floor of Areas C&E tie into the wall and could not be completed until the wall was backfilled. This also prevented the first floor slabs from being placed, which further delayed the installation of the load bearing masonry walls that surround the gymnasium and auditorium. Overall, the any delay in the installation of the wall would have quickly put the entire project behind schedule.

The solution developed by the general contractor was to divide the structure into two separate buildings. Areas A&B and Areas D, F&G were constructed as two standalone structures while the ground floor of Areas C&E were being completed. This allowed for Areas A&B to be constructed all the way to the roof before the concrete wall was ready to be backfilled and for Areas D, F&G to be constructed ahead of Areas C&E. If the general contractor would have waited for work to be complete on the wall the project would have been several months behind schedule.

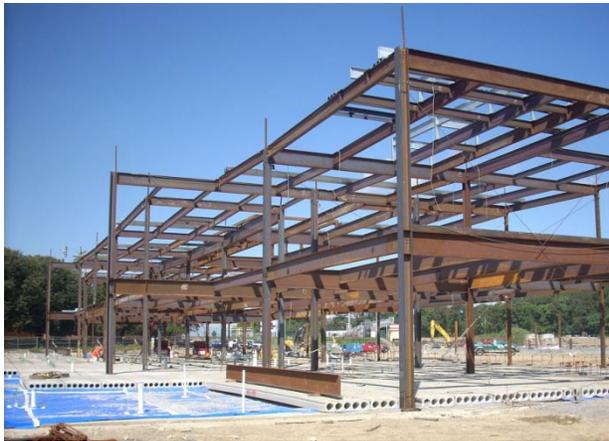
Figure 2: Precast Floor Planks

The location of the new high school is an area where the school district previously had athletic fields and sports facilities. Soils reports indicate that the land was previously filled with unsuitable soil classified as “mine spoils” which was fine for a baseball field but will not work for a three story building. Therefore, the structural engineer designed a stout system of caissons, grade beams and structural ribbed slabs to ensure that the building is properly footed on a sturdy base. The structural slabs were designed to be placed under the first floor of Areas A-C&E because there was a risk for settlement in these areas. It came to the attention of the general contractor that the structural slabs required the use of cardboard void forms. During the summer when the slabs were to be placed the weather was often rainy and there was a concern that the cardboard forms would be ruined in the event of a storm. In an effort to prevent delays and the need for rework on the forms and rebar the general contractor looked for other means of installing the first floor structural slab-on-grade.

The final solution to the problem was to use precast planks for the first floor slab in Areas A-C&E. The precast planks eliminated the risk associated with any rework that could be caused by a rain storm. Also, faster installation of the planks allowed for this section of the schedule to be accelerated. As shown in *Figure 2* above, the planks were simply installed spanning the grade beams that were a part of the original design involving the structural slabs. As the planks were installed the joints between them were grouted, *Figure 3*, and once an entire area is complete a topping slab will be applied to all of the planks to ensure a smooth finish is achieved.

Although the final cost impacts of the installation of the precast planks have yet to be tabulated it is believed that this will save both time and money. The planks can be installed much faster than the original structural slabs and they also require much less manpower to install. Both of these outcomes should result in a cost savings to the owner.
