TECHNICAL REPORT 3

National Intrepid Center of Excellence
Bethesda, MD

12/1/2009
Ronza Abousaid
AE Faculty Consultant: Dr. Christopher Magent
Construction Management

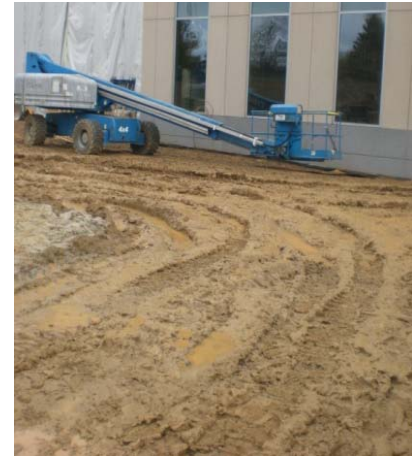
Figure 1 – Muddy Site Conditions

The DC area has been hit with severe weather in the past three months, which has posed as a major challenge to the project on this job. The placement of some surrounding building utility lines have been delayed since the soil has become disturbed due to the rain. Considering the limited budget amount on this project, temporary roads were not built to accommodate the construction process. Therefore, with all the mud on site (figure 1), material staging area has become very limited. Moreover, the building was not fully enclosed and watertight when the bad weather hit the area. The north side of the building enclosure, composed of the curtain wall system, was not in place at this time. Water and mud was constantly sweeping into the building from various locations. Any interior work, which had already begun, had to be ripped and redone. This issue has affected the productivity on this job along with the project schedule.

Even though Turner Construction is currently still dealing with the effects of the weather on this project (figures 3-5), working overtime to make up for any lost time and getting the building enclosed, has been a great start in dealing with the unexpected weather issue.

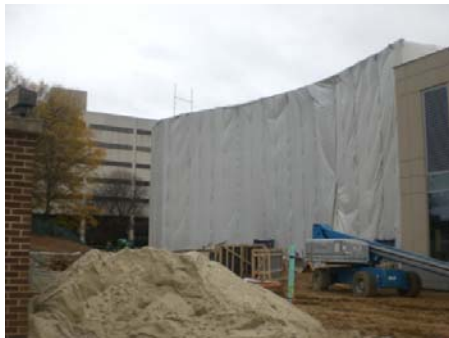
Figure 2-Temporary Building Enclosure

To achieve weather tight conditions in order to begin the interior work, a temporary enclosure has been placed in place of the curtain wall system. The curtain wall system has taken a longer lead time than originally planned for. Therefore, the temporary enclosure has been a remediation for any schedule delays for interior work caused by the curtain wall system lag. Getting the building enclosed has also helped with the material storage area problem. Subcontractors have been able to store most materials inside the building.

One key area that has been used to accelerate the schedule is the temporary building enclosure, which was put up on Nov 5, 2009. It resulted in taking the curtain wall system off of the critical path and achieving watertight status almost 2 months before originally accounted for. Originally the curtain wall system and the interior finishes had a start-finish relationship on the project schedule. Now these two activities are overlapping. As previously stated, the interior finishes are expected to take a long time to install and any time that can be gained is crucial. In addition, once the work moves into the interior, there are going to be very few opportunities to accelerate the schedule by a considerable amount.

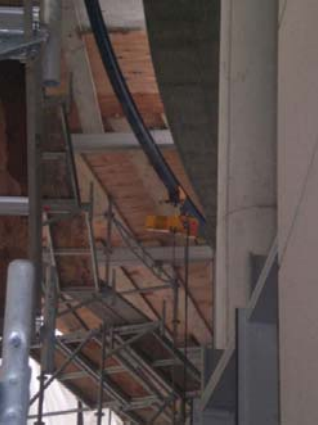
Figure 11- Scaffolding along with a trolley system for the placement of the curtain wall system

Finally, for the placement of the curtain wall, the PM on the job suggested a scaffolding system along with two trolleys to hang along a track around the perimeter of the north side (figure 11). The installation system so far has been a success to the subcontractors and Turner Construction.
