THE PENNSYLVANIA STATE UNIVERSITY
5TH YEAR THESIS

Technical Assignment Three

Alternative Methods Analysis

TIMOTHY CONROY
CONSTRUCTION MANAGEMENT
PROFESSOR CHRIS MAGENT
2175 K STREET NW
WASHINGTON DC
12/1/2009

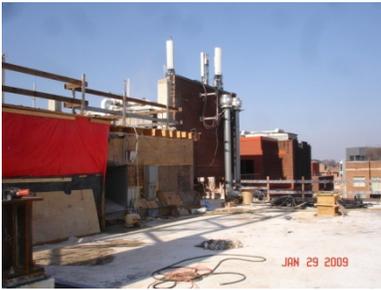
the level 10 slab to help ensure the room stayed dry. The three figures, Figure A.1 through Figure A.3, show the temporary enclosure that was previously mentioned.

In an effort to prevent the issues outlined regarding the existing penthouse, DAVIS constructed a temporary penthouse enclosure with a lower ceiling in order to accommodate the construction of

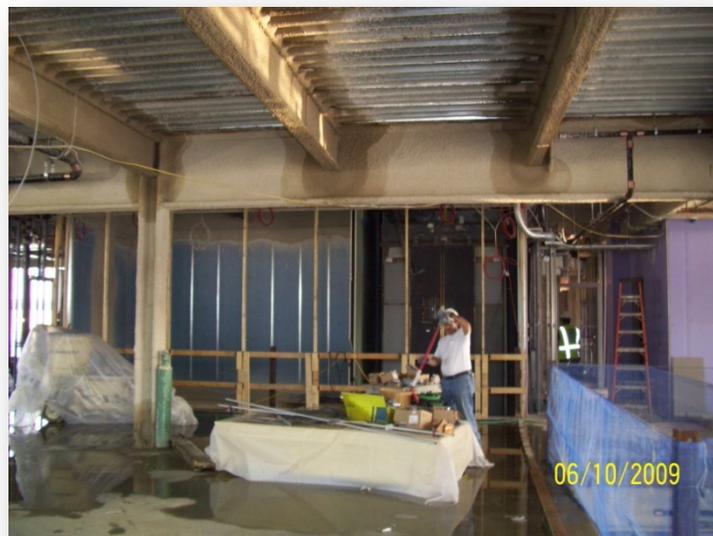
Figure A.4 Temporary Elevator Shaft Separation

As previously mentioned, ensuring the safety of the tenants and the workers within the elevator shaft, was of utmost importance. To do this, a temporary floor was constructed beneath the elevator car being worked on located at the eighth-floor level. This provided not only a safe working platform from which to perform work but it also served to prevent debris from falling down the shaft and potentially having an adverse affect on the other shafts. Additionally, a temporary wall was constructed to separate the shaft under construction from the other two shafts. This barrier ran the entire building height from B3, parking garage level three, up to existing elevator machine room located on the existing roof.

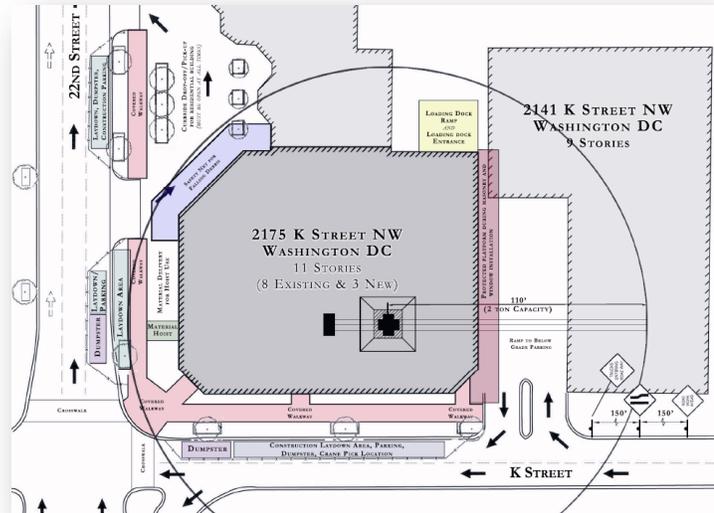
Figure A.5 Site Layout Plan

To allow for the previously mentioned activities, DAVIS obtained a public space permit to allow them to block off a lane of traffic along both K Street and 22nd Street as shown in Figure A.5 Site Layout Plan. These lanes were utilized for deliveries and the necessary pedestrian overhead protection. To solve the crane placement challenge, DAVIS hired a structural engineer to design shoring that would allow the tower crane to be installed on cribbage in the existing roof as shown in Figure A.6 to the right. The location shown above was chosen because of a tenant elevator shaft that was to be installed to service the newly added floors. This decision limited the amount of make-up work that would be need after the crane was removed.

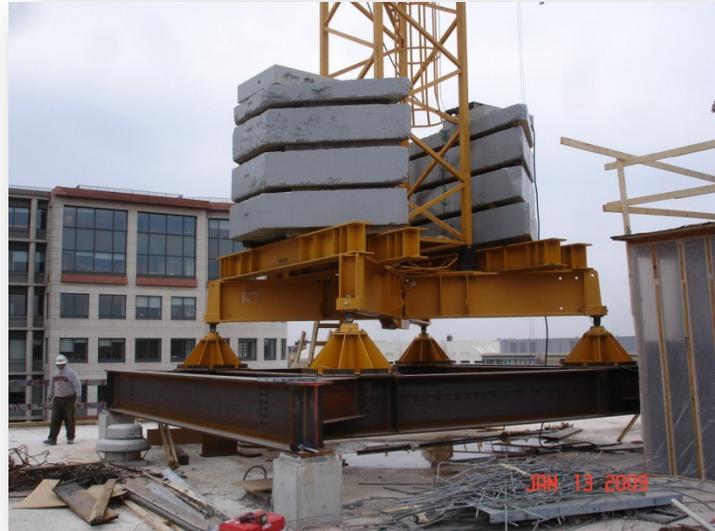
Figure A.6 Tower Crane Base and Cribbage

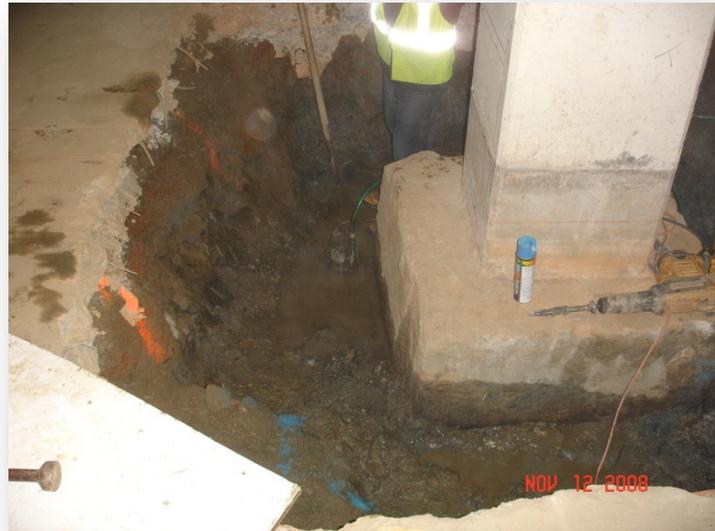
Figure B.1 Foundation Spread Footing Expansion

First on the critical path were the structural improvements to the existing foundation, shown in the figure to the right, and the existing structural concrete columns that were needed to allow the load imposed by the new structural steel to be safely transferred into the bedrock beneath the building. To do this, the project team had to enlarge a number of the buildings spread footings in both the x-direction and the y-direction, the depth could remain the same.

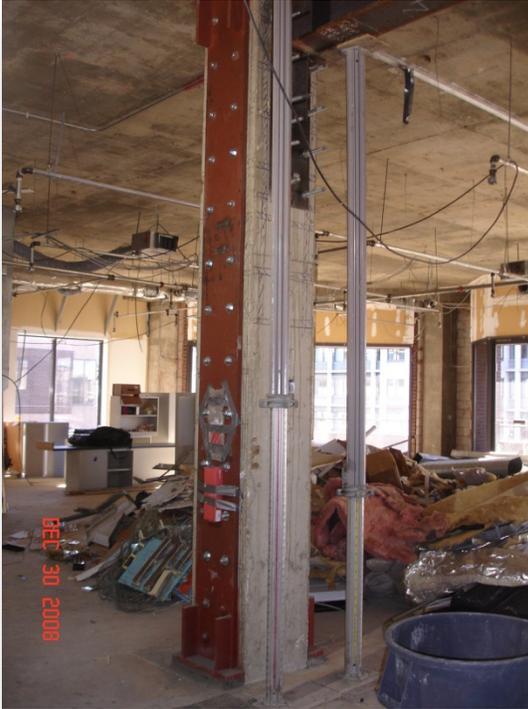
Figure B.2 Column Reinforcing

Subsequently, the team had to install additional reinforcement to key columns within the building to allow them to carry the new load. This was done by installing a system of either steel jackets and/or carbon fiber. Figure B.2 Column Reinforcing, located to the left shows a column that was reinforced with a steel jacket. These systems were designed by a licensed professional engineer and installed accordingly.
