AE 481W

TECHNICAL ASSIGNMENT 1

Executive Summary

The Office Renovation Building is one of the largest civil buildings owned by the General Services Administration. Completed in 1932, the structure houses 1.8 million square feet of office space for a variety of government agencies. Located in a downtown metropolitan area in the northeastern part of the United States, the \$500 million project is scheduled for completion in multiple phases during the next 13 years. While over 3,500 workers continue to occupy the historic building, the project will use a swing space completed in phase 1 of its construction to move employees out of the construction zones. Gilbane Building Company and Grunley Construction have formed a joint venture to act as the project's general contractor for phases 1, 2, and 3.

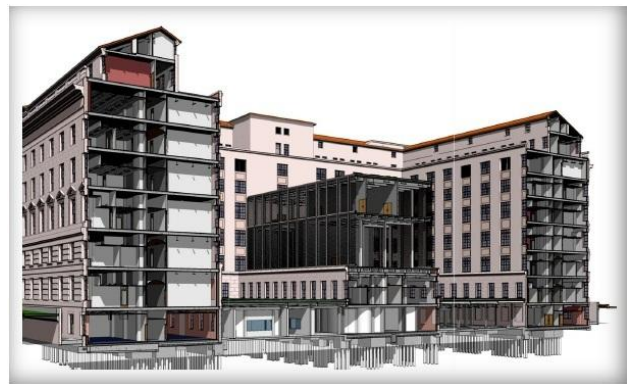
Figure 1: Sectioned rendering of Phase 2 work including the building's Electrical Equipment Enclosure

The Electrical Equipment Enclosure to be built in courtyard 1 is to be erected of structural steel columns and beams and cast in place flat plate slabs.

Two additional floors will be erected on top of an existing structure in courtyard 1. Following the placement of the enclosure's structural steel, CIP flat plate slabs will be placed at the two corresponding floor levels. Horizontal slab formwork consisting of standard plywood sheets will be utilized. This floor structure has been chosen because of the electrical equipment designated for the area. Concrete slabs will be poured via pump. Concrete trucks will utilize the closely located material staging area to park their trucks while pumps will be brought in through the building and into the adjacent courtyard.

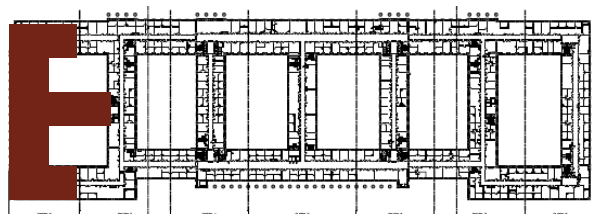
Figure 4: The shaded region represents the main building area specific to Phase 2. The entire building façade restoration is also contracted under Phase 2.

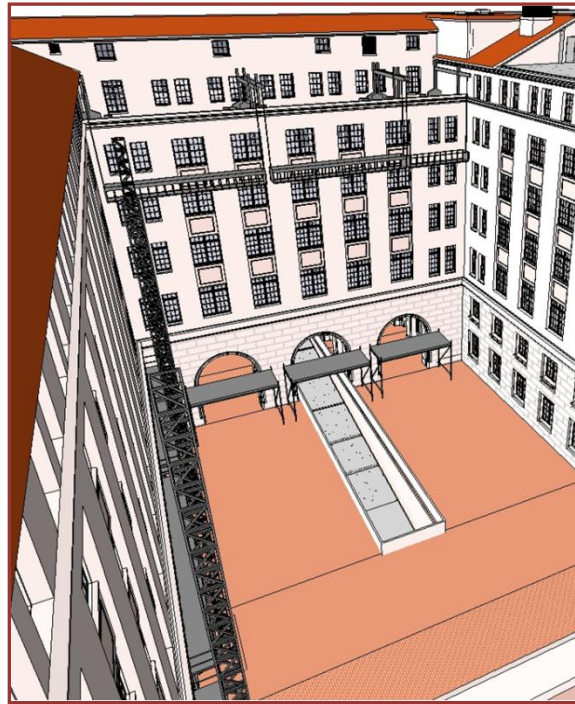
Figure 2: Revit image illustrating the varieties of scaffolding and overhead protection for façade cleaning and window restoration

No new work will be installed by Gilbane-Grunley during phase 2 of the Office Renovation Building but a complete restoration will take place throughout the entirety of the structure's exterior. The limestone façade will be cleaned and restored to its original state; GGJV has already performed several mock-ups to ensure the cleaning it done to the satisfaction of the owner. GSA has recently called in an expert to analyze the staining to provide direction on how to best clean the Indiana limestone. Hydro-mobile and suspended scaffolding will be used for all masonry and window restoration (Figure 2).

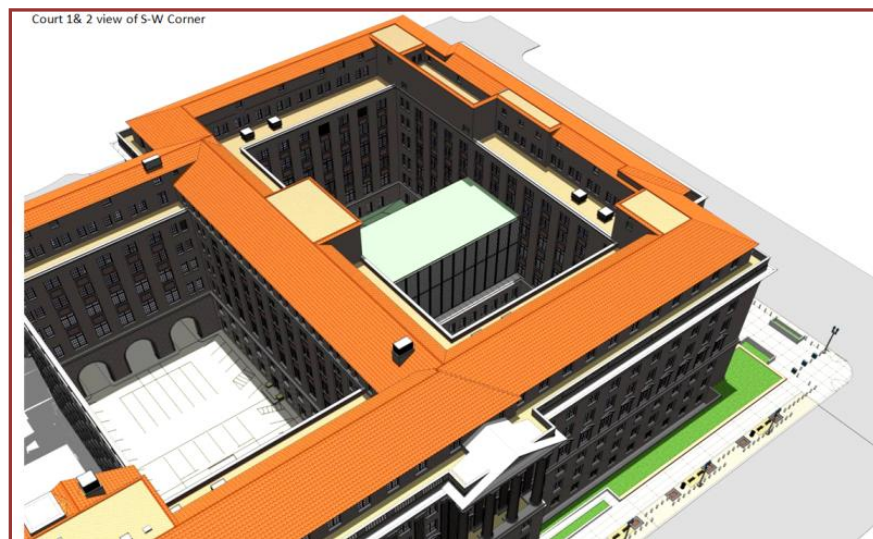
Figure 3: A rendering of the completed Office Renovation Building with the Electrical Equipment Enclosure (EEE) located in the center of courtyard 1. A green roof will be installed throughout the courtyard and on the EEE.

Most of the electrical work is comprised within the construction of the structure's new Electrical Equipment Enclosure. Provided will be five newly installed electrical switchgears, three emergency generators, appropriate transformers, and three fuel cell day tanks to provide temporary power in the event of a crisis. A key element to the project scope strictly defines that there is to be no interruption of the electric services to facilities occupied by the Government or others unless permitted. This is due to the sensitive nature of government work taking place within the building during construction. Gilbane-Grunley has been sure to take every precautionary measure in regards to the project's electrical work and will support the temporary feeding within the existing building electric service. PEPCO Power is the main provider of electrical energy for the Office Renovation Building.

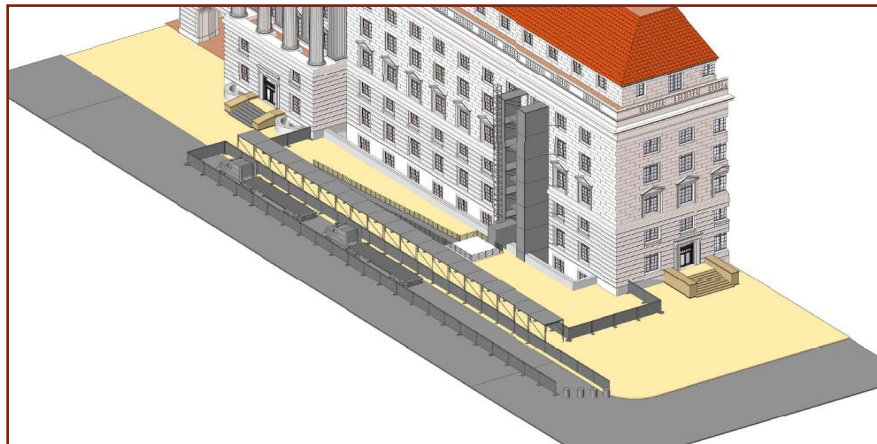
Figure 6:
Revit rendering of the 15th
Street staging area and
material hoist

Due to the high density area of which the Office Renovation Building resides, parking availability for construction vehicles is very limited. Project superintendents have acquired minimal parking within one of the building's courtyards. The majority of any on-site parking is reserved for pre-designated building occupants. However, the lower level loading dock under courtyard 5 may be used to park other small construction vehicles only on a day-to-day basis. As per the contract agreement, there is no parking for subcontractors. Fortunately, many workers utilize the metro rail system located within a city block of the building's location. Delivery trucks and other large construction vehicles may only use the west side of the building's designated loading area adjacent to the material hoist; a detail of the staging area can be seen in **Figure 6**. (please refer to **Figure C-1** in **Appendix C** for further detail).

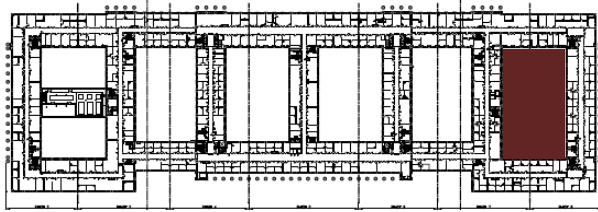
Phase 1: Construction of new temporary office space in courtyard 6 to house relocated occupants

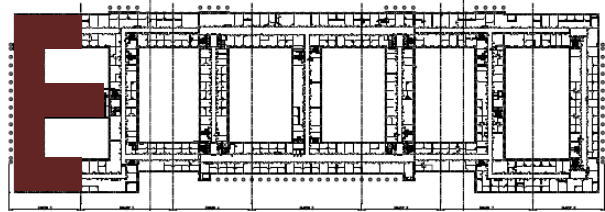
Phase 2: New MEP Infrastructure including chiller plant and new Electrical Equipment Enclosure in courtyard 1. Complete façade restoration and office renovations on 7 floors

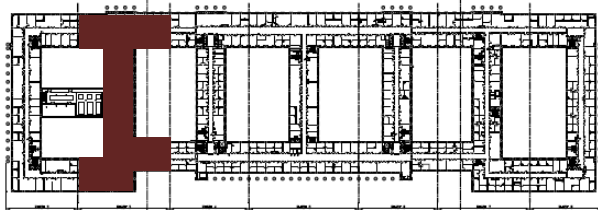
Phase 3: System replacement on all floors and repaving of courtyard 2

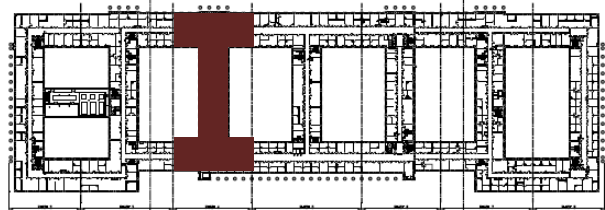
Phase 4: System replacement on all floors

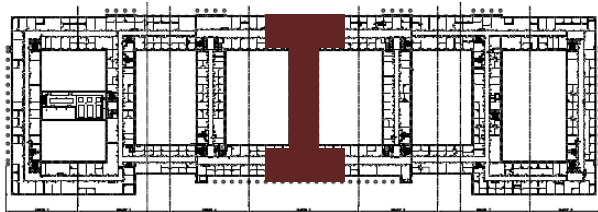
Phase 5: System replacement on all floors including auditorium, main entrance lobby, and mass transit tunnel

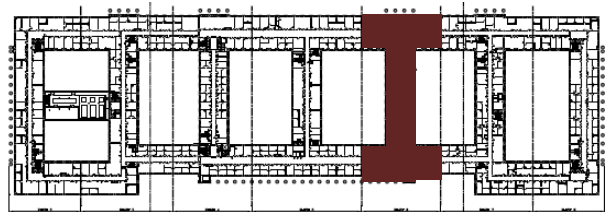
Phase 6: System replacement on all floors and courtyard 5 loading dock part 1

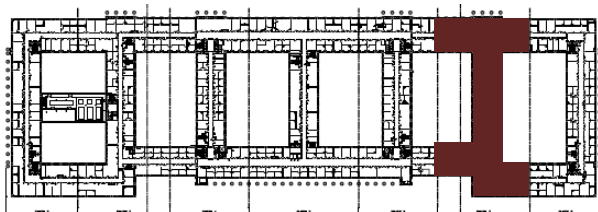
Phase 7: System replacement on all floors and courtyard 5 loading dock part 2

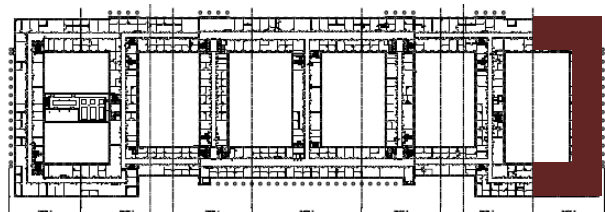
Phase 8: System replacement on all floors and tourist visitor center upgrades
