AE 481W

TECHNICAL ASSIGNMENT 3

[The following report presents a technical summary of the Office Renovation Building project. Within this assignment an in depth discussion of the renovation project will be discussed through constructability challenges, schedule acceleration scenarios, and value engineering topics that have taken place on the project. This assignment also identifies several areas for improvement on the project and applicable technical analyses.]

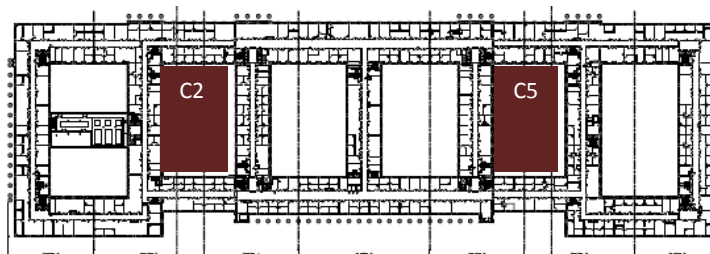
Figure 1: Courtyards 2 and 5 include limited parking spaces for building occupants

Tenant impacts regarding the two parking courtyards within the facility have been the largest challenge for the project team while working in an occupied space. Most of the parking spaces within the courtyards are assigned to high government officials that have been reluctant to relocate their vehicles; GGJV has taken multiple approaches to help satisfy all influenced parties. In an effort to best coordinate activities influencing the parking areas, GGJV has made sure each vehicle owner has significant notice of the dates of these events. With a predetermined schedule of impacts, most vehicle owners will be provided with temporary passes to allow them to park at a garage across the street from the building at no additional cost. This will allow the building occupants to be removed from the area while exterior renovations of the courtyards take place.

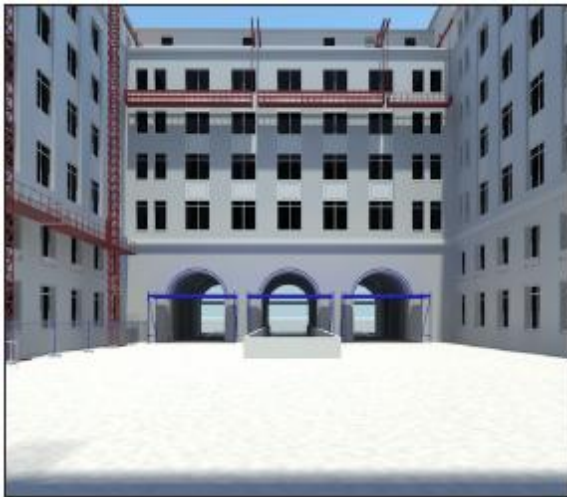
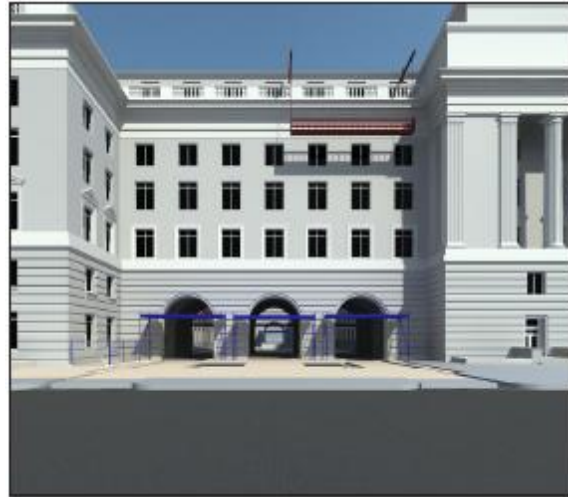
Figure 2: Overhead protection will be erected throughout all entrances corresponding to the parking courtyards. A total of 5 occupant vehicles will be parking in the center of courtyard 2 during exterior restoration work.

However, several building occupants have refused to accept temporary parking passes and will have their vehicles remain within the courtyard during exterior restorations. Though not ideal, the GGJV project team has coordinated exterior activities to ensure this can take place. Several vehicles will be parked within the center of the courtyard as work continues. Significant overhead protection and safety precautions will be implemented to allow such activity to take place. Please refer to figures 1 and 2 for a visualization of the parking courtyards.

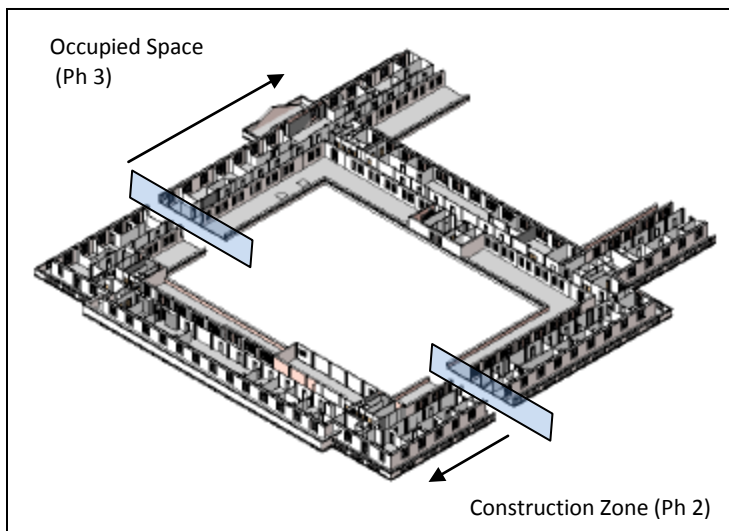
Figure 6: 7th Floor Phase line section (Phases 2 and 3)

The figure on the left is a section illustration of the building's 7th floor phase 2 and phase 3 areas. Phase 2 (on the left) is the current construction area. The spaces adjacent to the construction line (separated by the blue figures) had their respective demising walls constructed over the course of two weekends, one weekend for each side.

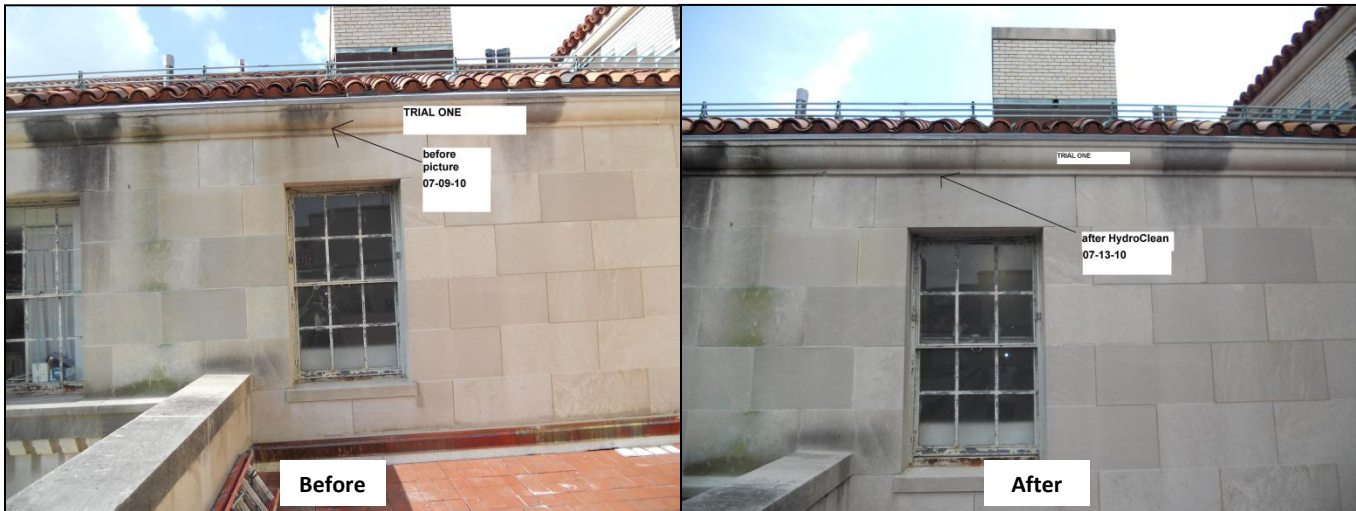
Figure 8: Mock-Up Photos from HydroClean HT Application

Though the project team was able to eventually move forward with the exterior cleaning and restoration, the number of required mock-ups set the project behind schedule. To help compensate for time lost, the cleaning contract must have cleaning crews working late shifts from 7pm-5am and on weekends. The contractor was not able to increase crew size during the day because no cleaning is to take place during regular working hours when the building is occupied.

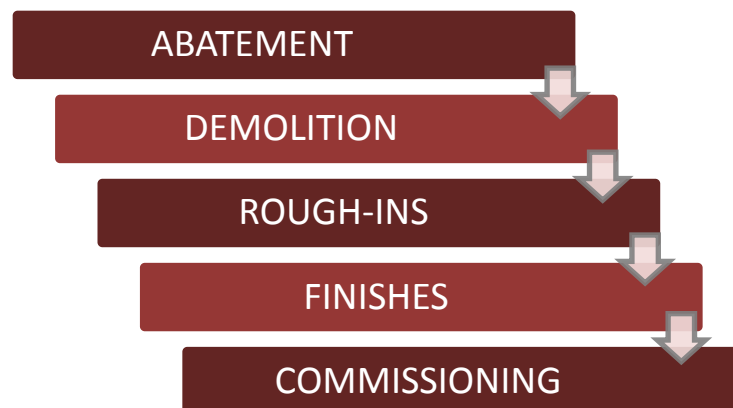
Figure 9: Floor by floor critical path schedule for interior renovation work

A majority of the project's scope includes the demolition and renovation of the building's interior spaces. The project team has followed the critical path schedule shown in figure 9 while utilizing a top-down approach starting with abatement at the building's 8th and 7th floors. As a result of owner directed changes during the abatement and demolition stages of the renovation, the Gilbane-Grunley project team has been forced to implement schedule acceleration techniques to assure that project progression would stay on track.

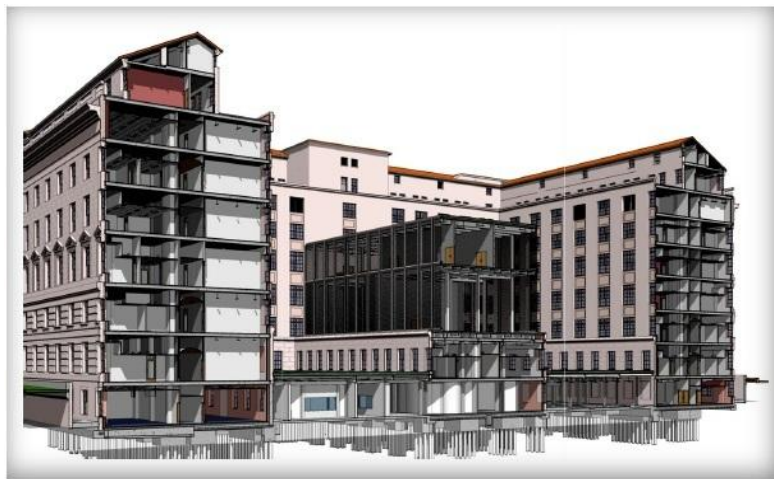
Figure 10: The EEE will extend to the building's 5th floor while offering two stories of space for various electrical equipment

A major task within the project involves the construction of a new electrical equipment enclosure. This 20,000 SF two story facility is to be erected within one of the building's interior courtyards and will be constructed above an existing level of the office building. The electrical equipment enclosure (EEE) will house a variety of transformers, switchgear, and emergency generators to ensure the building remains operable at all times. Figure 10 shows the location of the EEE in the center of courtyard 1 of the structure.

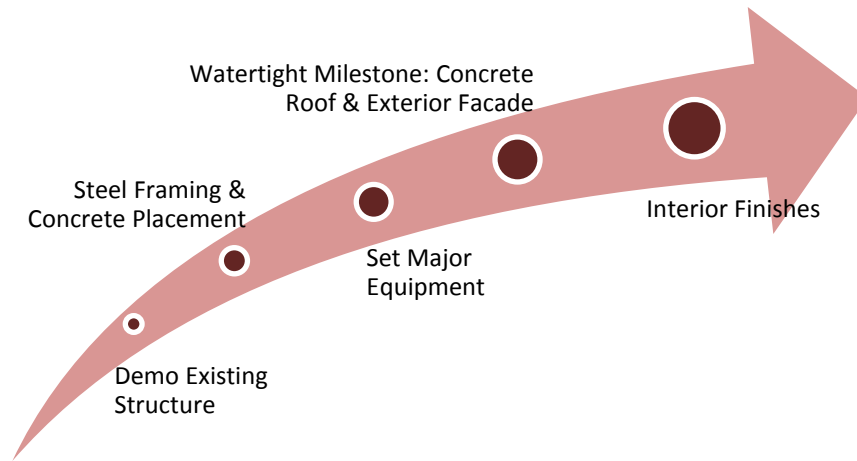
Figure 11: Critical Path Schedule for EEE construction

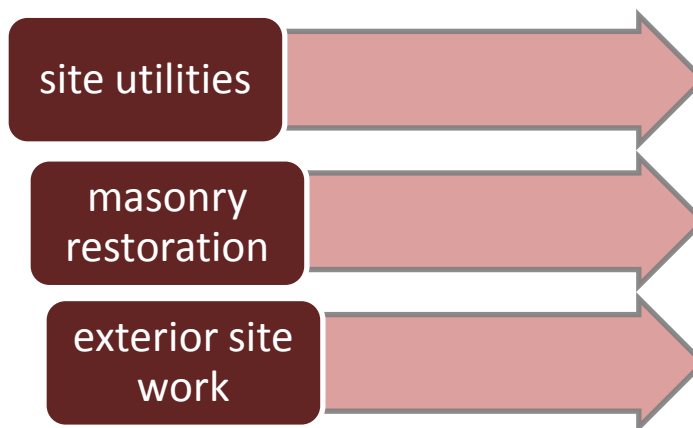
Figure 12: Critical Path activities for exterior work

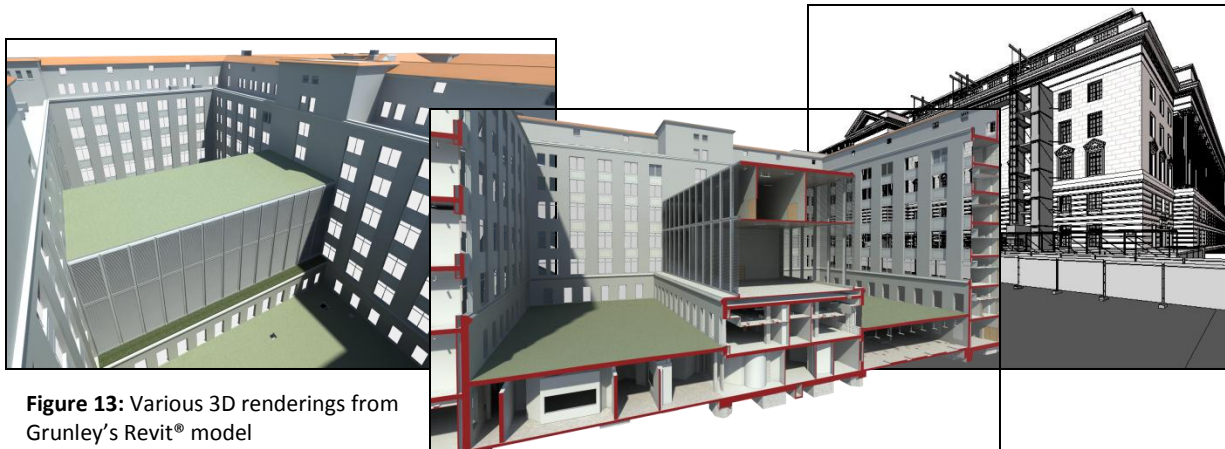
Figure 13: Various 3D renderings from Grunley's Revit® model

The Gilbane-Grunley team proclaims to be utilizing building information modeling to help construct a more efficient project. Unfortunately, GGJV has only been using Autodesk Navisworks® to coordinate MEP drawings for the new system. Also, the project team has created a 3D Revit model of the building, but uses it only to provide the owner with a visualization of the construction process.

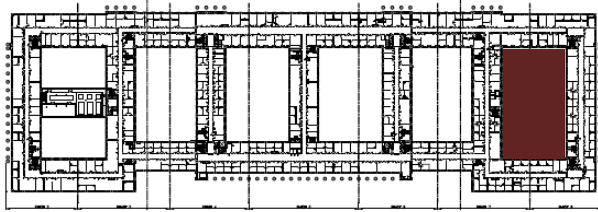
Phase 1: Construction of new temporary office space in courtyard 6 to house relocated occupants

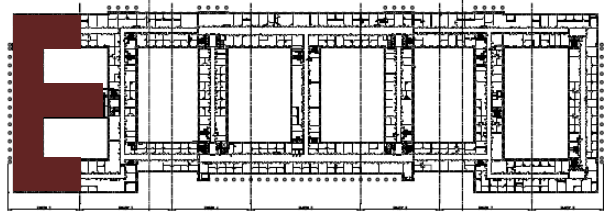
Phase 2: New MEP Infrastructure including chiller plant and new Electrical Equipment Enclosure in courtyard 1. Complete façade restoration and office renovations on 7 floors

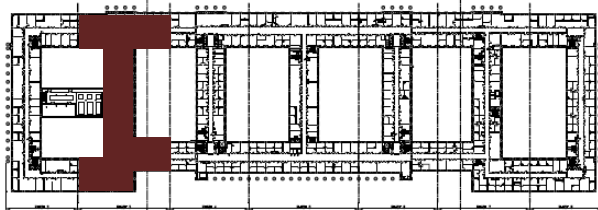
Phase 3: System replacement on all floors and repaving of courtyard 2

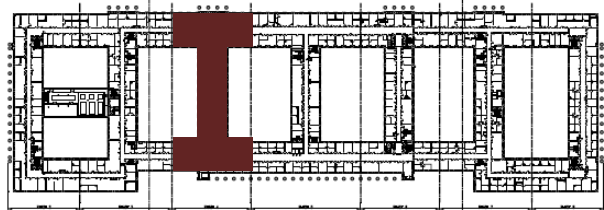
Phase 4: System replacement on all floors

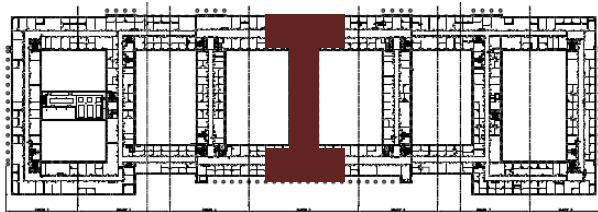
Phase 5: System replacement on all floors including auditorium, main entrance lobby, and mass transit tunnel

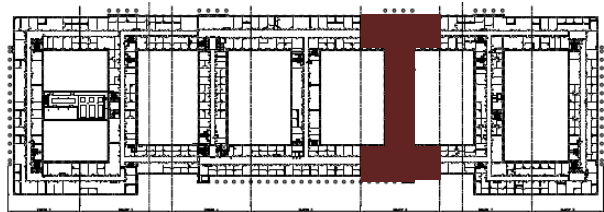
Phase 6: System replacement on all floors and courtyard 5 loading dock part 1

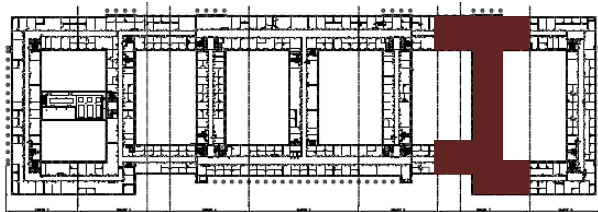
Phase 7: System replacement on all floors and courtyard 5 loading dock part 2

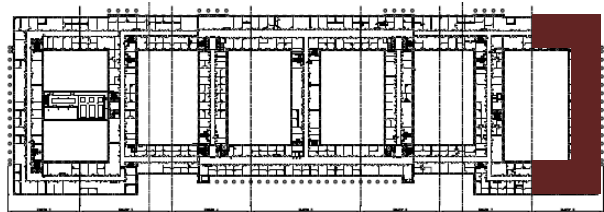
Phase 8: System replacement on all floors and tourist visitor center upgrades
