# STEM Building

*Hagerstown Community College*

## *Technical Assignment 3*

*Craig Owsiany*

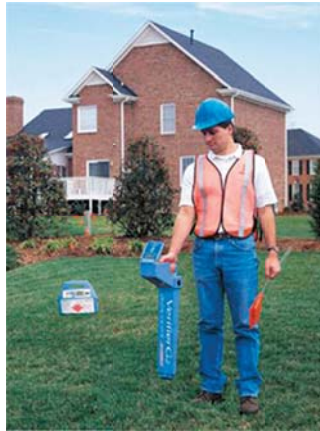
**Figure 1: Utility Line Locator**

On the STEM Building project, excavation will be performed via blasting. This is due to the large masses of limestone rock upon which the footprint of the building resides. Traditional means of excavation would be ineffective and blasting, although more expensive, will allow excavation to be completed in a timely manner. Blasting also brings its challenges regarding the relocation of existing utilities, neighboring buildings and safety; a major concern of the owner. The first obstacle in relocating existing utilities is locating existing utilities. Traditionally subcontractors would have a general idea of where an existing utility line was located and carefully excavate until found. This is not an option on this project because of the limestone. The exact location of utilities lines must be identified. HESS Construction + Engineering Services, the general contractor, hired a specialty subcontractor to perform the task. To locate the water line for example, the subcontractor would hook two clamps to the fire hydrant and send an electric current down the pipe. A special device was used to detect the current and then the utility line was marked with either flags or spray paint. Figure 1 below shows an example of the utility line locator.

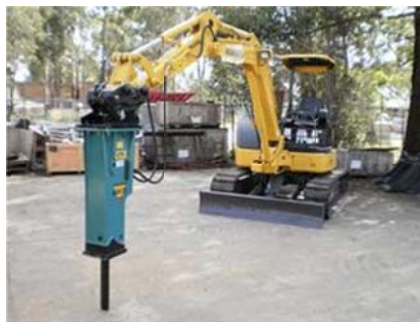
**Figure 2: Rock Breaker**

Once located, a series of small blasts are performed. These blasts must be very precise to come as close as possible to the pipe to minimize the amount of jack hammering and/or rock breaking. Both methods are timely and inefficient. A rock breaker is shown below in Figure 2. In essence, it's a jack hammer hooked up to a backhoe.

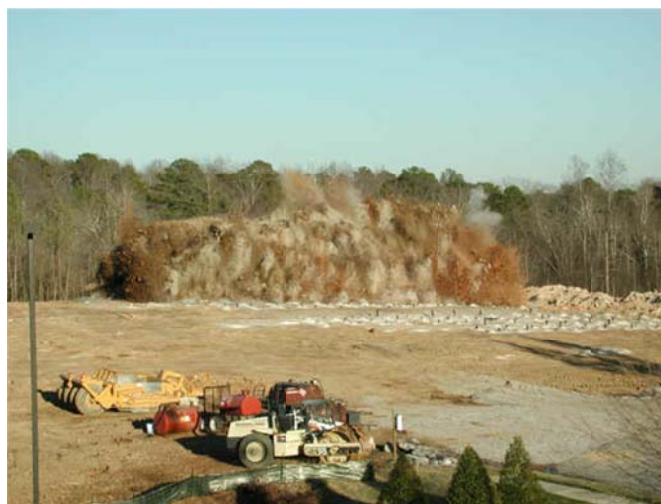
**Figure 4: Mass Blasting**

Once existing utilities have been relocated, mass blasting can begin. Safety becomes a major concern of the owner during this process. Mass blasting uses larger chargers that when detonated, can send rock flying great distances through the air. An example of this is shown below in Figure 4.

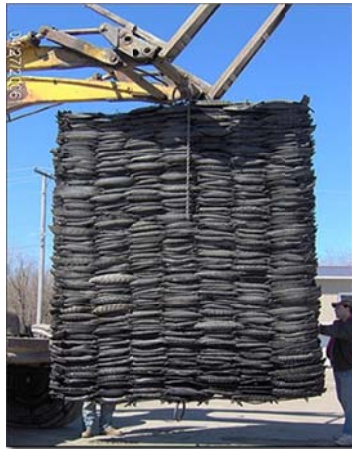
**Figure 5: Blasting Mat**

The safety concern is that such rock has the potential of striking a pedestrian and causing physical harm. To mitigate this risk, C.W. Hetzer will implement blasting mats. Comprised of recycled tires linked together by metal chains, these mats are laid over the area being blasted. The mats absorb the upward force of the blast and hold down the best part of any potential fly rock. The site is also cleared at each blast as another safety precaution. An example of a blasting mat is shown below in Figure 4 for reference.
