New Inpatient Tower

Addition and Renovation

Penn State AE Senior Thesis

Technical Report 3 Table of Contents

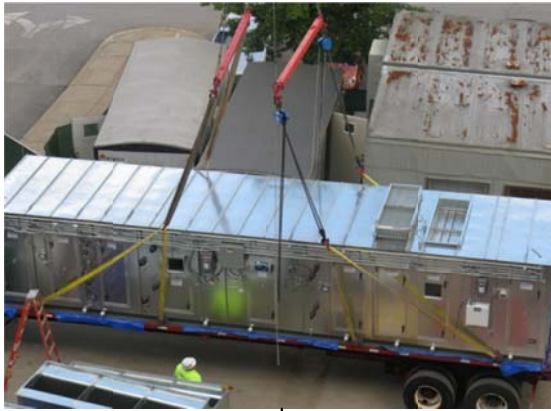
AHU Being Hoisted

This decision was clearly not a conventional method to deliver the units to the appropriate position. The following images represent the sequence of installation of the units:

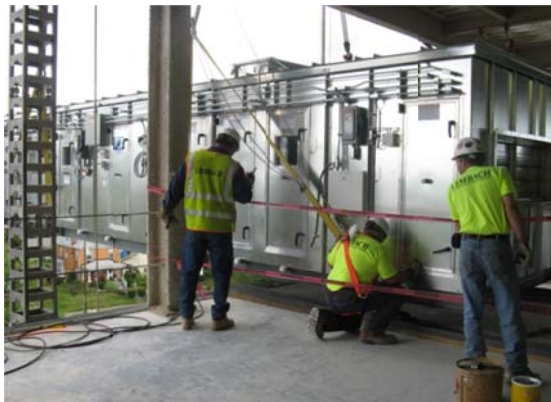
AHU set onto 5th floor

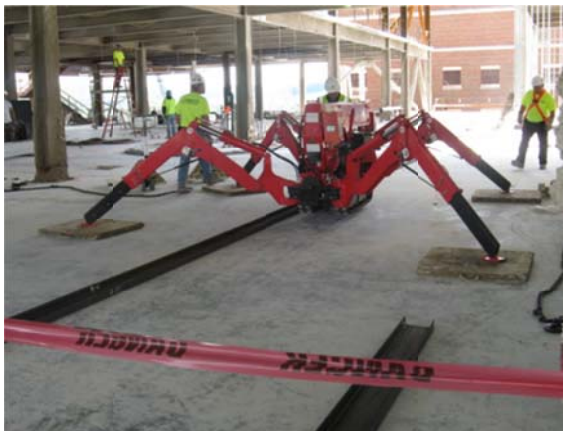
Spider crane set to move Unit

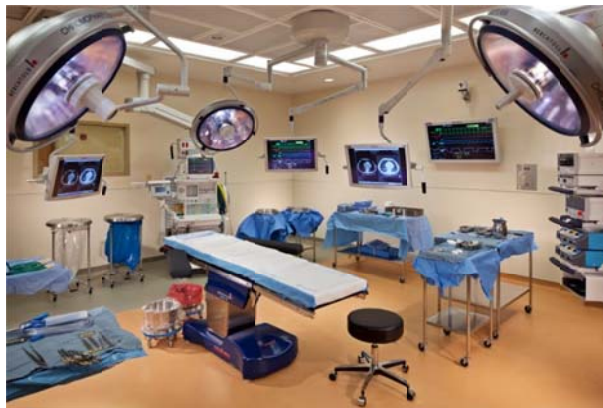
The constructability issue related to owner furnished equipment can be made apparent by looking into the medical booms, which are installed in the operating rooms and several of the patient rooms. The design of the medical booms at Butler Memorial Hospital is now being seen as a state-of-the-art feature. This is due to the fact that these booms are completely mounted from the ceiling. In the operating rooms, this is particularly evident because there is no need for mobile medical equipment. Everything that the doctor would need is easily accessible at all times. The below picture shows the ceiling mounted medical booms in the operating rooms.

Ceiling Mounted Medical Booms

With this high-tech design, it is clear that the vendors must coordinate this equipment with the architect and structural designer. With the large amount of equipment being mounted from the ceiling, a need for more structural steel became evident later in the project than desired. Because

this was not realized at the time of design, the steel design was updated and changed during the construction process.
