# TECHNICAL ASSIGNMENT THREE

PENN STATE SENIOR THESES

## UNIVERSITY SCIENCES BUILDING

NORTHEASTERN U.S.

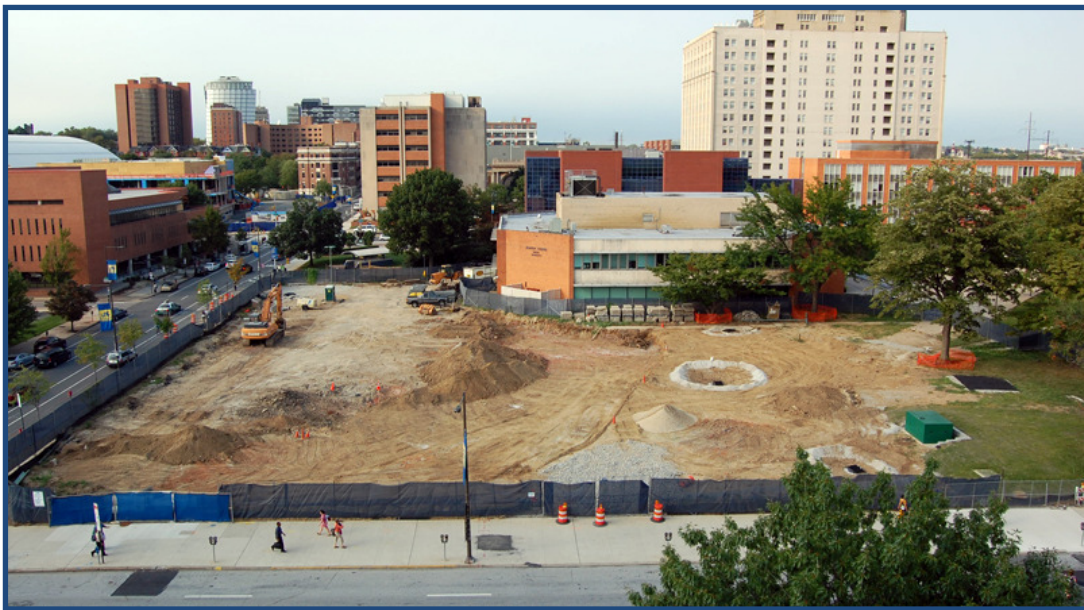
*Figure 1: Overview of the Site*

The site for the University Sciences Building was a challenge from the very start of the project. Turner found the underground site conditions to be contaminated upon their arrival. This contamination was unexpected, and no mention of it could be found in the Geotechnical Report. The specific composition of the contaminated matter is unknown, but this was a major obstacle for the project's initial success. Turner was tasked with removal of all contaminated soils, and replacing them with clean soils from the surrounding area. Contaminated soils are just one of the many items that can fall under the Differing Site Conditions Clause within the contract. Compensation was received for the direct material costs by the owner, but lost labor time and delays in the schedule are something that can not be accounted for in this particular situation. The university requires the facility to be operational by the start of next year's fall semester, and extra time can not be afforded by the owner.

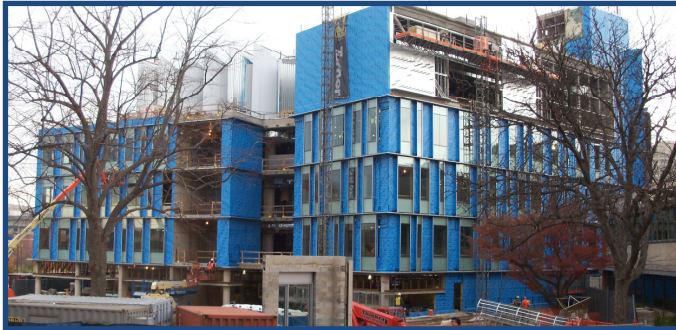
*Figure 8: North-East Corner of the Building*

The biggest risk to the project schedule is the enclosure of the building. Enclosure of the building before the harsh winter months is critical from a temporary heating standpoint. Finishes cannot begin until the temperature and moisture in the building is controlled. Any delays in this activity will delay all of the interior finishes for the facility.

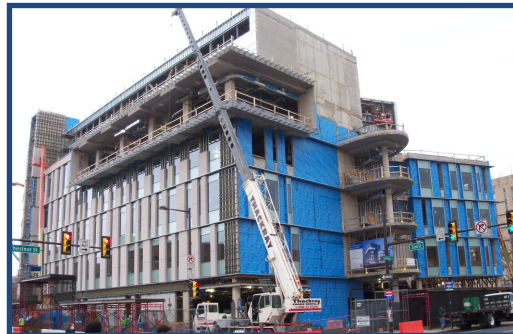
*Figure 10: South-West Corner of the Building*

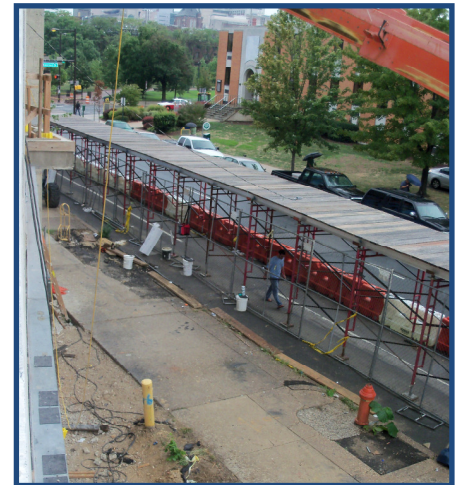
**Figure 11: Overhead Protection**

Overhead protection, lane closures, and blocked off sidewalks with chain linked fencing help establish a working barrier between the site and the city. Tower crane movements and swinging picks over buildings/streets must be coordinated to avoid any sudden drops/failures. An emergency evacuation plan is also critical to the safety of the workers on site and should be known and followed at all times of the job.

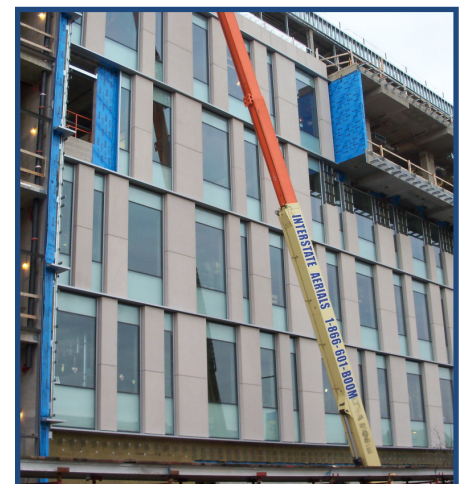
**Figure 12: Completed Portion of Exterior Façade**

As seen in *Figure 12* to the right, the layout of masonry and exterior windows is what gives this building its personality. With creative design follows creative solutions. This scattered arrangement of finished requires an extreme amount of coordination and precision to ensure the proper fit and seal of the building's façade systems. This unusual arrangement makes the layout and construction of these walls a little less efficient than a patterned arrangement because no wall on any floor is completely identical. The owner may like this look, but perhaps there is another way to establish a pattern that gives off the same finished look, but with some repetition to ensure better quality and efficiency from the trades responsible for its construction.

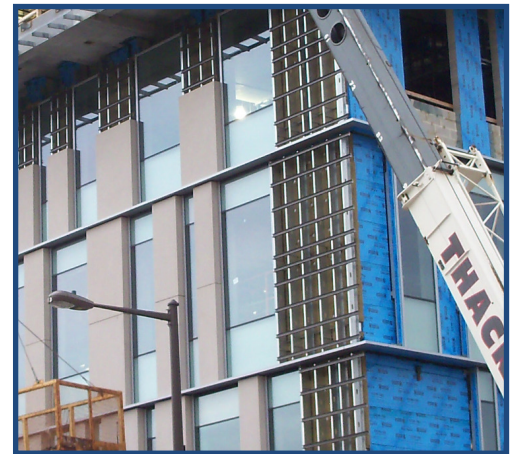
*Figure 13: Progression of Exterior Finish*

This building is also unique in the sense that rainwater is designed to drain behind the exterior aluminum cladding instead of along the outside like most façade systems. This seems like it could provide drainage and warranty issues down the road. If the vapor barrier were to get damaged over time, leaks into the building could prove to be very costly over time. See *Figure 13* to the right for a picture of the installation process from vapor barrier, to metal framing, to hanging of the aluminum panels (right to left).
