WESTINGHOUSE BUILDING 4

TECHNICAL ASSIGNMENT 3

Jonathan Fisher, CM
Robert Leicht
11/29/2010

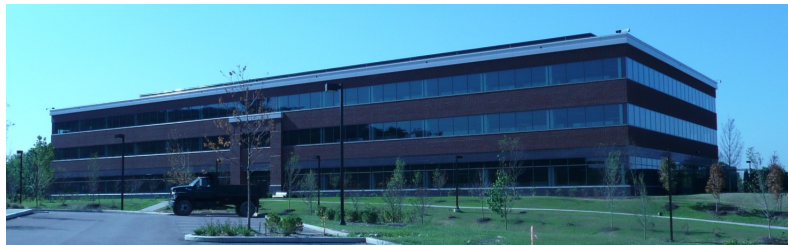
Figure 2: Shows the additional aluminum fascia along the top of the building and a small accent strip in the middle above the entrance.

When Turner and the architect went back to the drawing board another issue came up. Deciding who would pay for this added cost was a huge decision because the material cost of such panels would be around \$120,000. Turner decided they would not try to charge the owner for this design change because they are a good client of theirs. Because Turner would be eating the extra cost, they wanted to minimize the cost of the materials as much as possible. The two entities agreed that non-insulated metal panels would both add flare to the building and not be cost prohibitive. In order to add enough character to the building two separate layers of metal panels had to be added to the building. A metal panel parapet was placed around the top of the building and another layer of panels would be placed between the second and third floor.

These panels would be approximately 3 feet tall and stretch 6 feet across in length. Approximately 10 of these panels would be placed along each of the 60 foot section of the long north and south walls of the building while only the parapet would wrap all the way around all four sides. In their decision of non-insulated panels over insulated ones, Turner managed to save around \$30,000 and got the material cost down to around \$70,000 for the whole system.

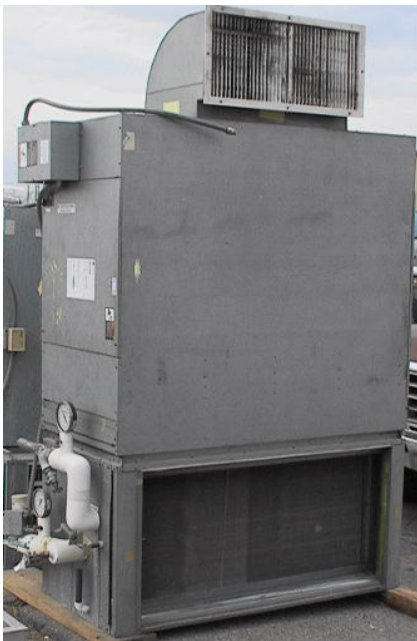
Figure 4: Shows a picture of the Trane Air Handler that was substituted on the project to save cost.

The main value engineering was exemplified in the HVAC systems of the building. The original HVAC systems that were specified were far too large and expensive for the building. Noticing this flaw, the project manager took the building design and load information to Trane and asked for advice on a smaller less expensive unit that would produce the same climate inside the building. Trane packaged their largest system and sold it to the project team. This change in air handlers ended up saving several hundred thousand dollars that the team would have spent uselessly on oversized equipment.
