# **Renovation of an Office Building in Washington D.C.**

**Washington, D.C.**

**Technical Report #2**

Lynn Appel  
Construction Management  
Faculty Consultant: Dr. Riley  
Submitted: October 27, 2010

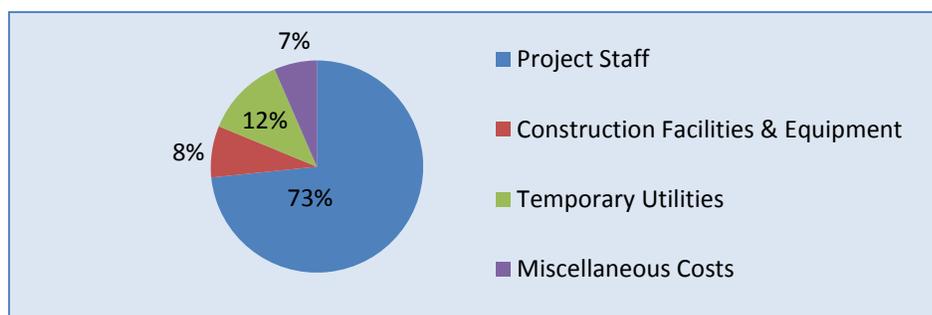
As shown below in Figure 1, the Project Staff costs account for over 70% of the general conditions estimate, which is fairly typical for construction projects. The overall general conditions estimate of \$2.7 million is just over 4% of the total project cost of \$72 million.

**Figure 1 – General Conditions Percent Break-down**

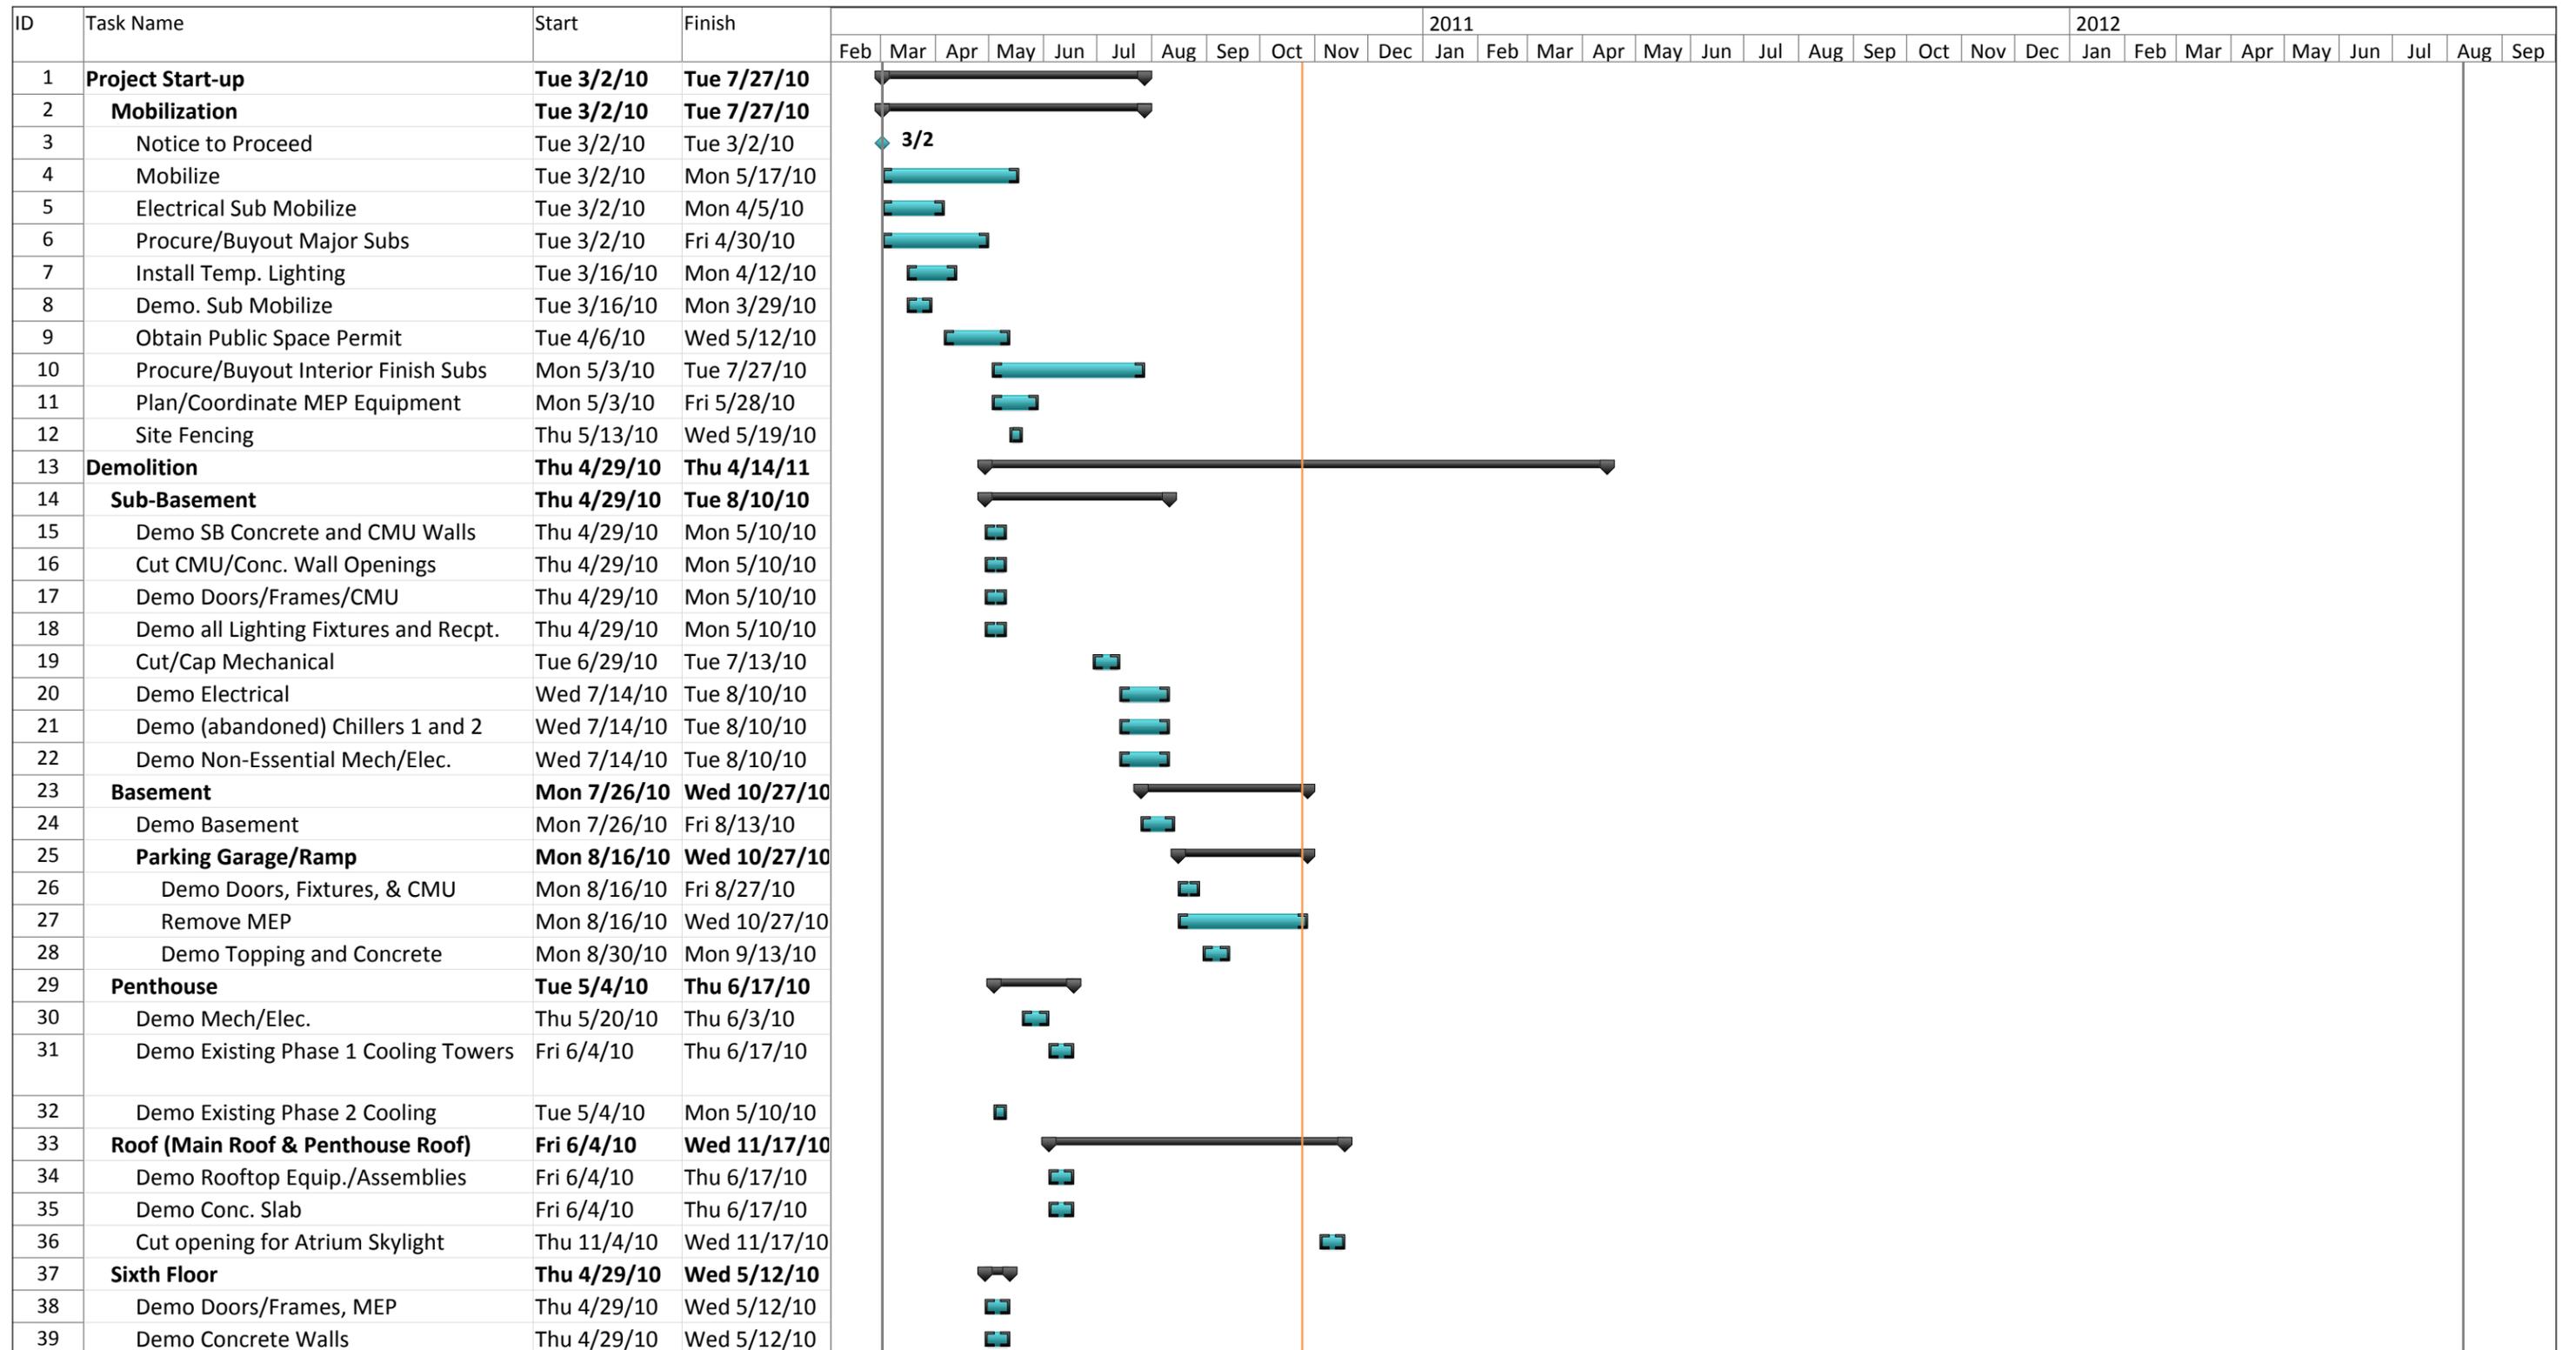
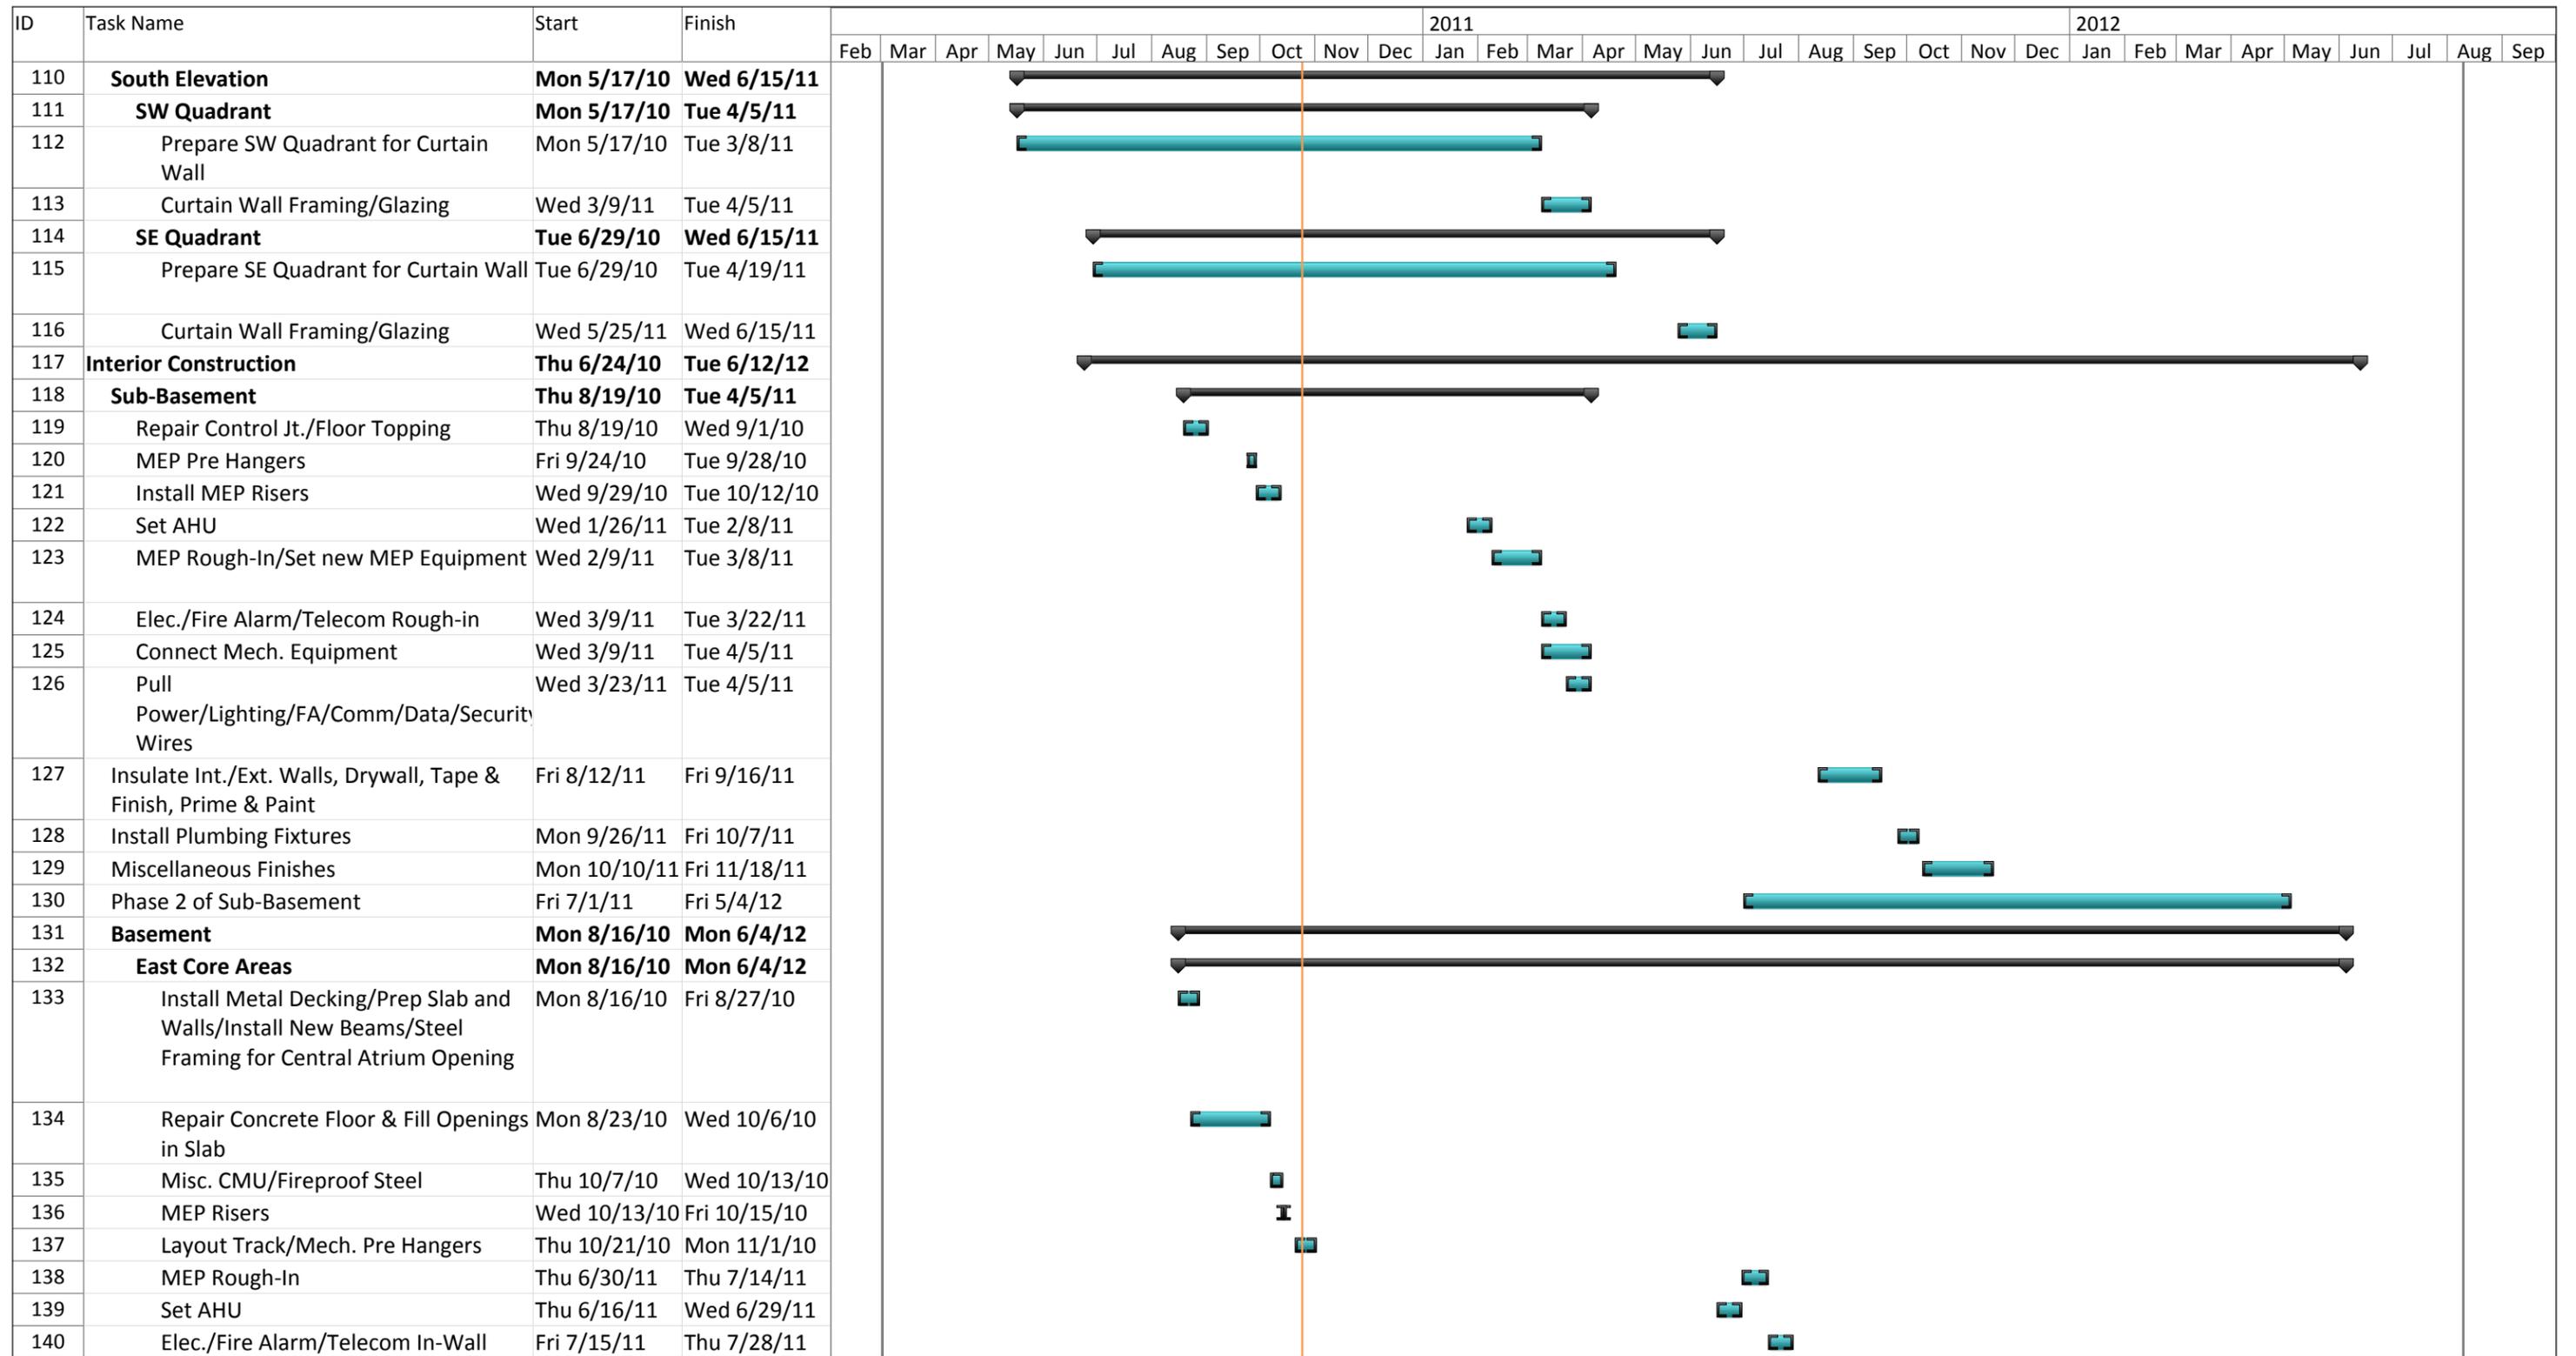
### *Detailed Project Schedule*

Project: Office Building - Detailed Date: Mon 10/25/10	Task		Project Summary		Inactive Milestone		Manual Summary Rollup		Deadline	
	Split		External Tasks		Inactive Summary		Manual Summary		Progress	
	Milestone		External Milestone		Manual Task		Start-only			
	Summary		Inactive Task		Duration-only		Finish-only

The detailed project schedule is based on a Baseline schedule provided by the General Contractor. Notice to Proceed was received on March 2, 2010 and site mobilization began immediately following NTP. Due to the fact that this project is a renovation of an existing building, Demolition was a large portion of the schedule. Interior demolition began in the sub-basement, but then moved up to the penthouse and worked its way down through the building. Demolition of the typical floors included the removal of all doors/frames and MEP and then the removal of the concrete walls. The Exterior Demolition was broken into each elevation and then broken down even further into two quadrants. Overall, demolition will take about a year to complete.

Following Demolition, the schedule was broken into Exterior Construction, Interior Construction, and the construction of the Entry Pavilion/Atrium. Exterior Construction consisted of mainly installing new steel columns and beams followed by the Curtain Wall system. Interior Construction was broken down by floor and then further broken down into East Core Areas and West Core Areas. Construction began in the Penthouse and Roof and worked its way down to the first floor. Other sections of Interior Construction were the elevators and stairwells. The elevators were installed towards the beginning of the project, after demolition was complete, so they could be used during construction. The new stairwells were not constructed until the second half of 2011 because there were existing stairwells in the building that could be used during construction. The Entry Pavilion/Atrium part of the section was broken down into three sections; South Entrance Lobby, Entry Pavilion/Atrium, and Central Atrium.

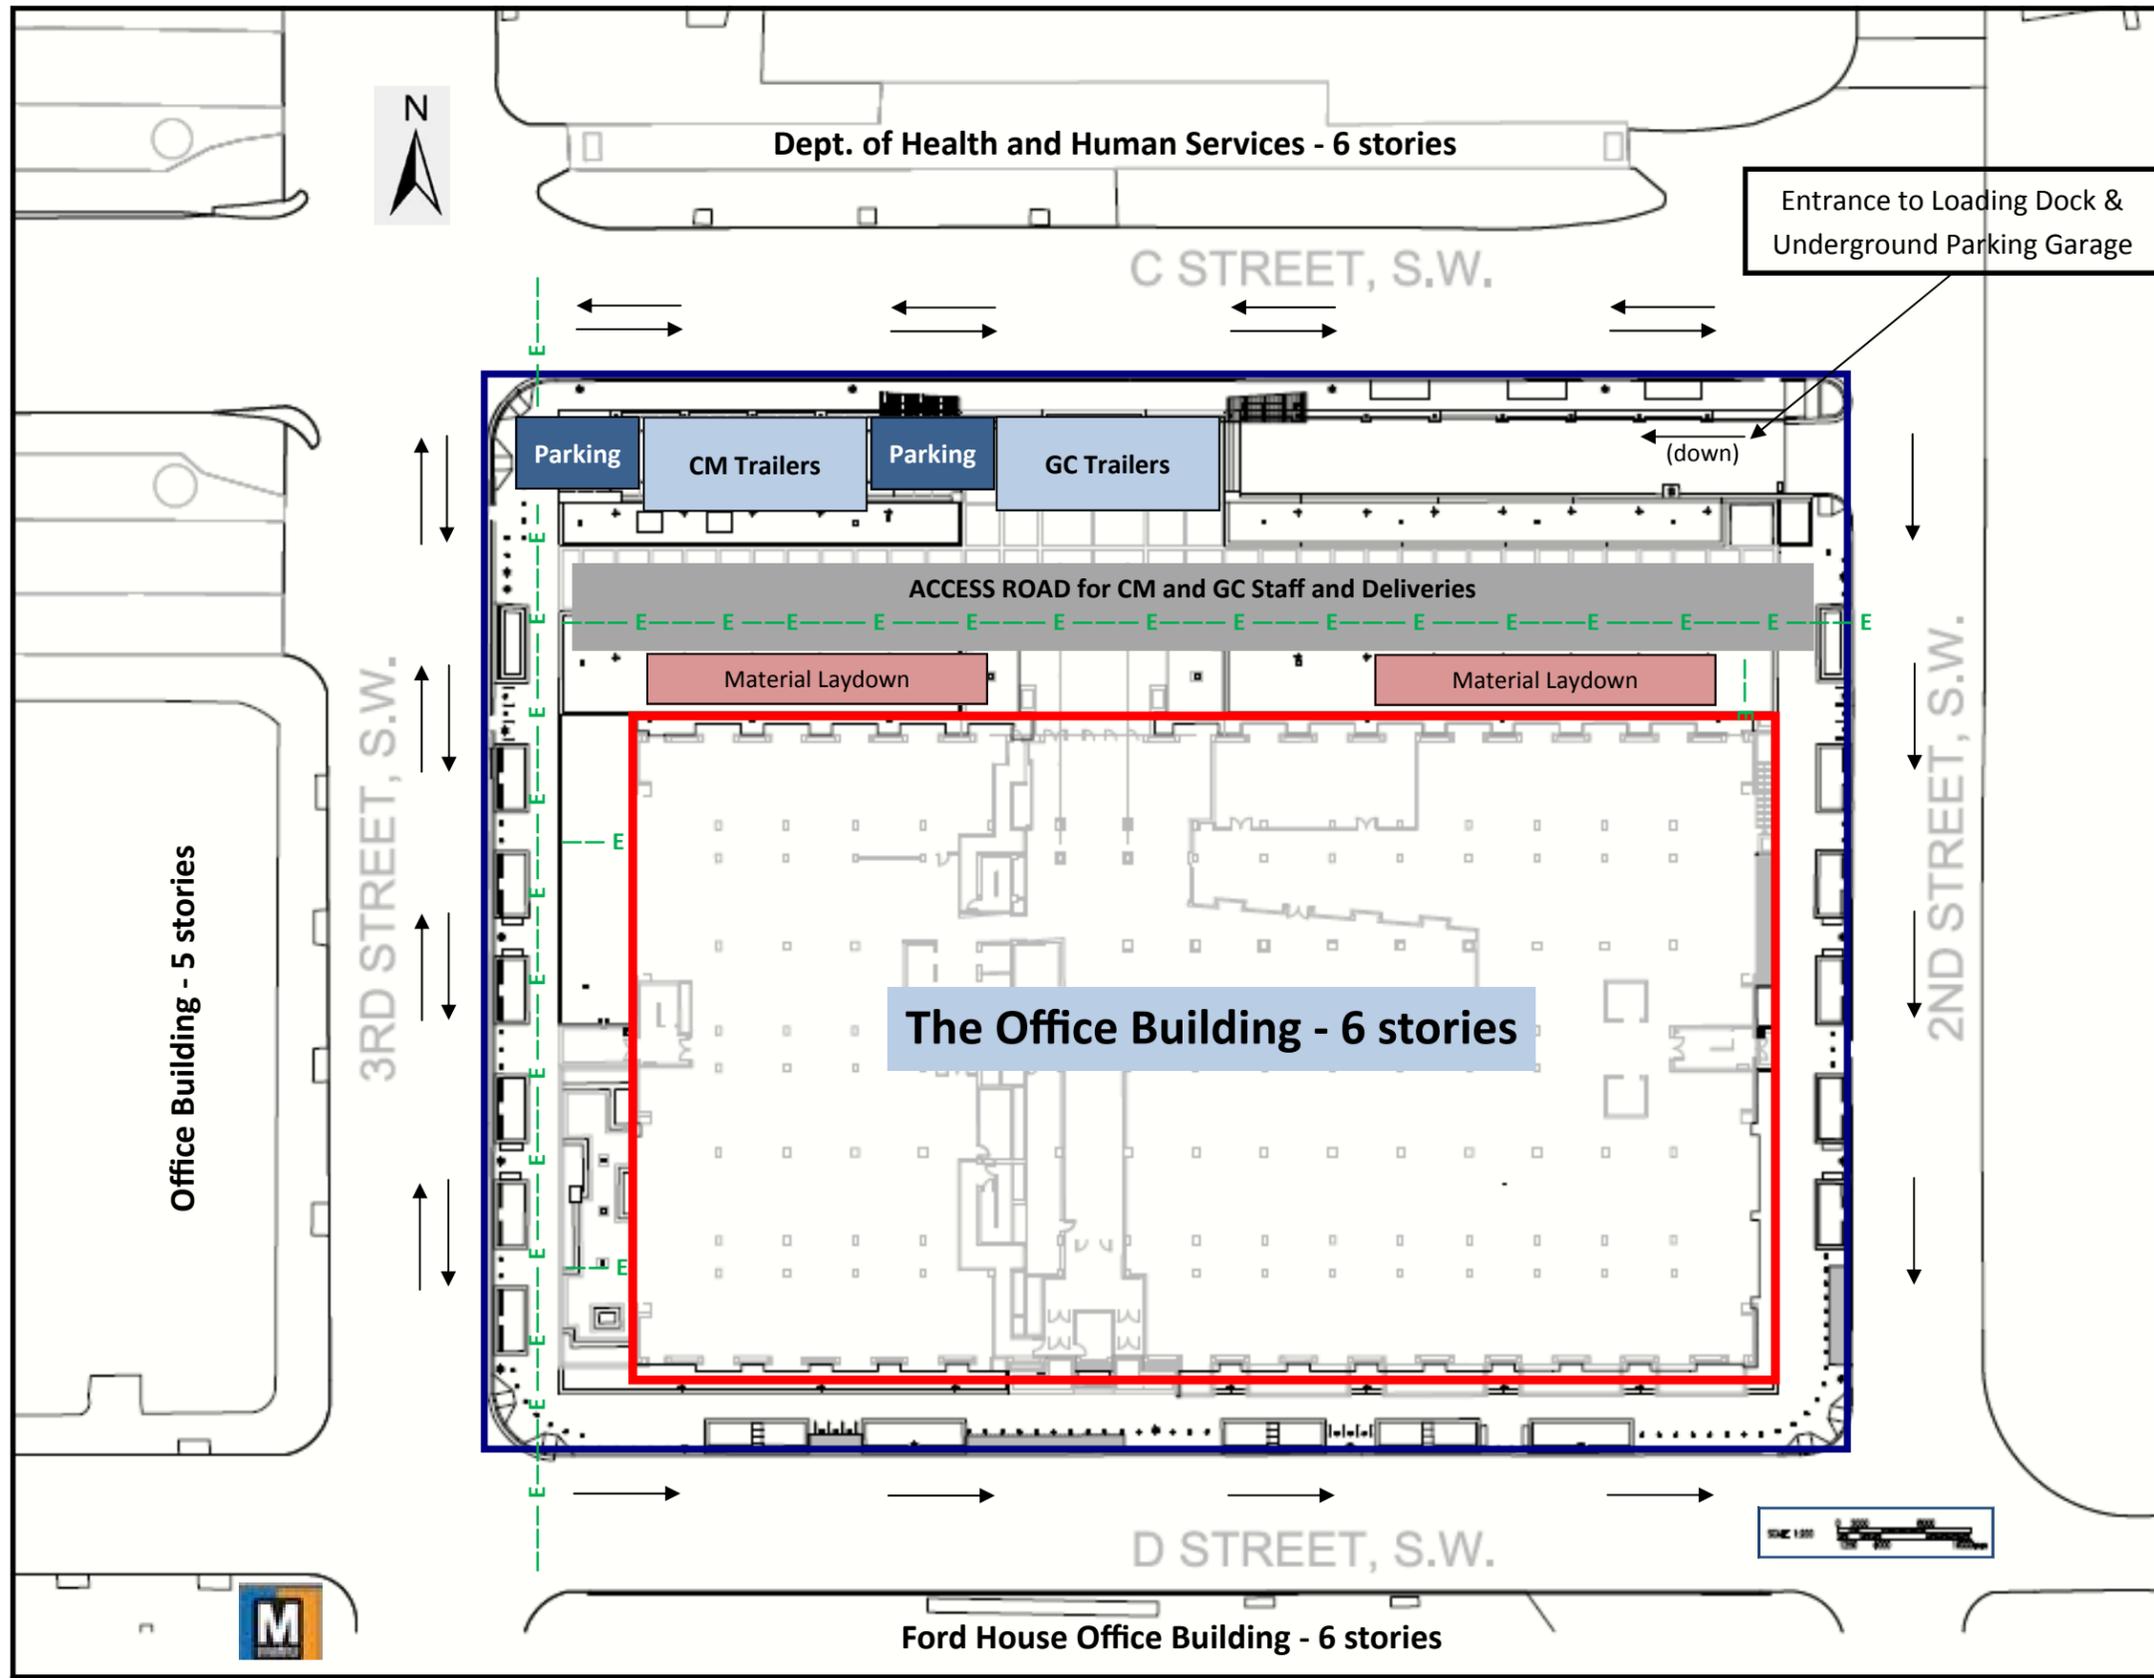
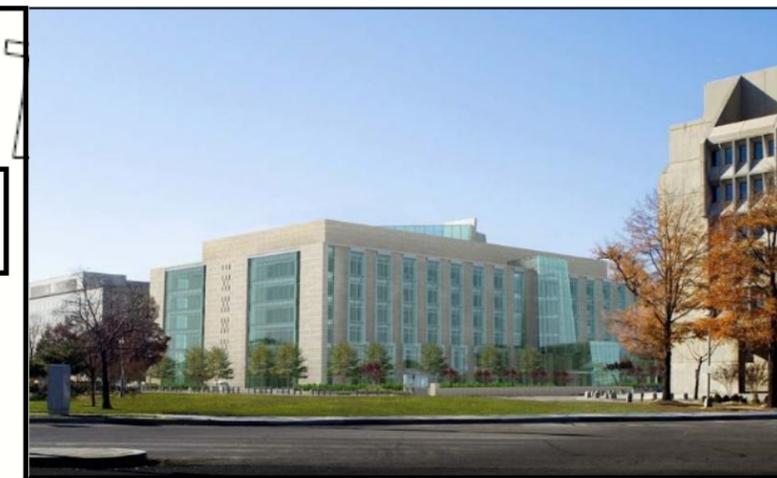
Site Layout Plan

Demolition & Construction  
 Phases

Due to the fact that the Office Building is located in downtown D.C., the site is very restricted and therefore does not change throughout the construction of the building. The Construction Manager and General Contractor trailers are located along C Street, S.W. where a parking lot used to be. Besides the fact that this was the only location on site that the trailers could be placed, it was convenient that the area was already paved and flat. The CM and GC trailers remain in the same location throughout Demolition and Construction of the base building. The trailers sit on the future location of an extensive landscaped plaza. Once the landscaping is ready to begin, the CM and GC trailers will be moved and the staffs will be moved into the building. The subcontractors do not have any trailers and are located in the basement of the building and the underground parking garage.

There are two entrances to the main construction site and then one entrance to the loading dock and underground parking garage. There is one entrance on 2<sup>nd</sup> Street where the GC and subcontractors enter the site and another entrance on 3<sup>rd</sup> Street where the CM enters. There is a service road that connects these two entrances. This service road is used for the CM and GC staff and for deliveries. The entrance to the loading dock and underground parking garage is located on 2<sup>nd</sup> Street.

The electrical subcontractor is providing temporary power. They have provided temporary panels in various locations throughout the building. As far as temporary equipment goes, there will not be a tower crane used onsite. The subcontractors will bring out cranes when needed and they can be located around the perimeter of the building. However, due to weight, no crane can be located on the north side on top of the parking garage. All dumpsters are located in the loading dock in the underground parking garage and will be in that same location for the duration of the project.
