**Moore Building Addition & Renovation**  
**University Park, PA 16802**

# **Technical Assignment Three**

Penn State AE Senior Thesis

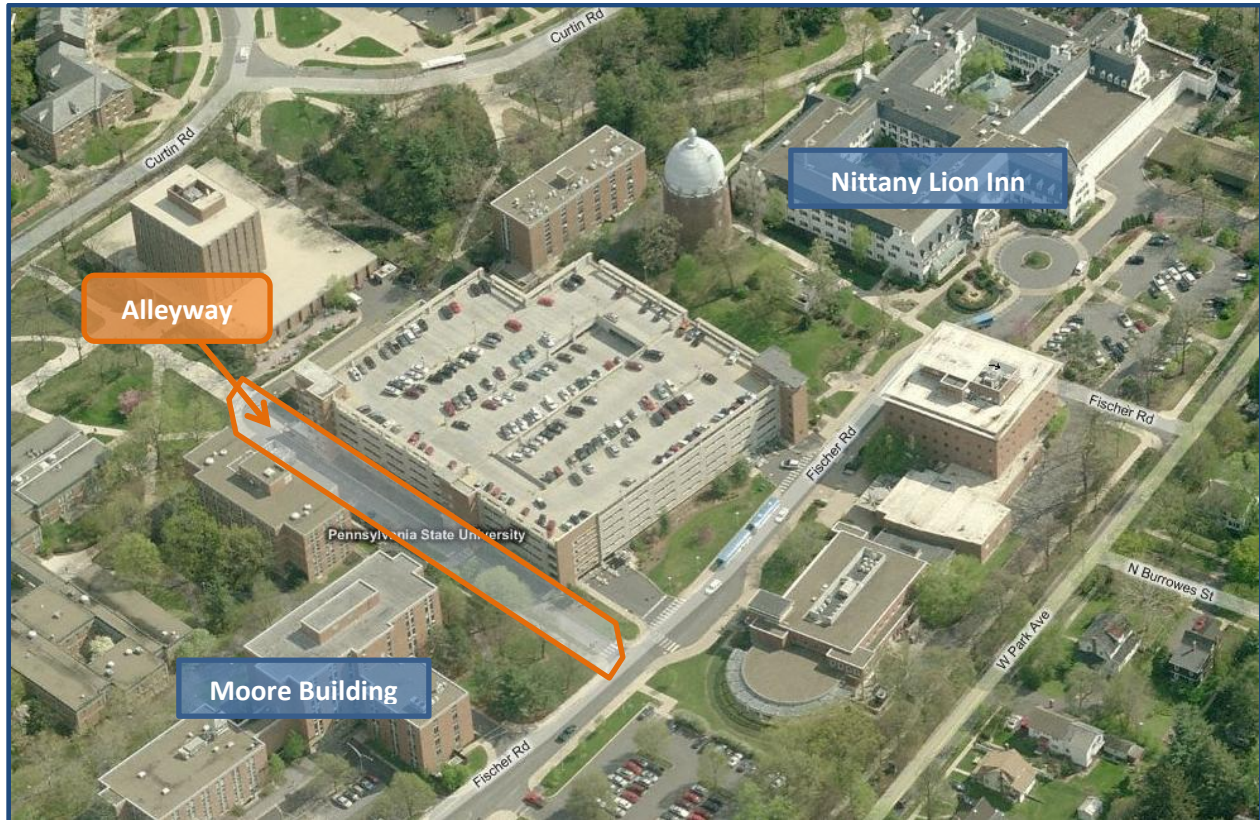
Figure 1: Aerial view of NW area of campus

The alleyway that connects the Moore Building to the buildings behind it (to the South) goes down from the West side of the building (figure 1). This alleyway was an important piece of the project as there were quite a few challenges involved with its closing and upgrading the mechanical utilities located there. These utilities included chilled water piping (both supply and return) and telecommunications lines.

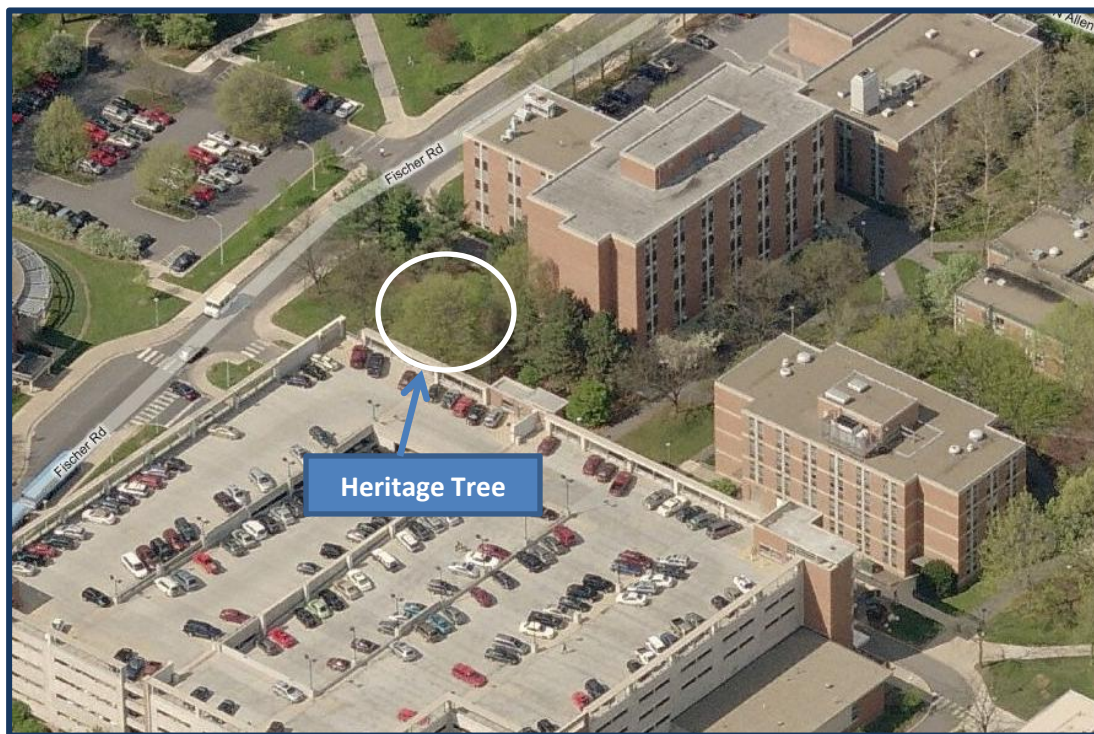
Figure 2: Aerial view of heritage tree

On the southwest corner of the Moore Building Addition site there is a heritage tree that has been maintained for many years and whose importance has grown ever strong. By request of the university, tree was to be kept and maintained during all construction activity, and so, excavation and construction had to, and still must, be coordinated around the tree.

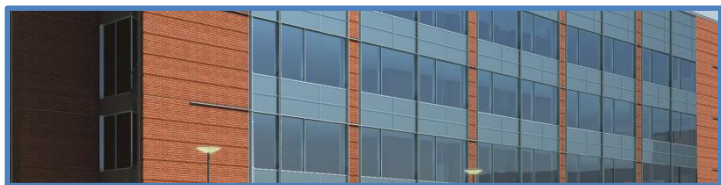
For the façade of the Moore Building Addition all masonry and panel work will be installed on site by masons. Since efforts have been made to speed up the delivery of the building, it would make sense to look for a faster and possibly cheaper way to put up the façade.

One of the most obvious options would be to install the façade pieces as pre-cast members that sit on the structure's steel. This would mean that the façade can be fabricated off-site once the structural steel is up. Then, the pieces could be installed on site at any time.

Figure 5: Façade of Moore Building Addition
