TECHNICAL REPORT THREE

CHEMISTRY BUILDING

Michael Gallagher
Construction Management
Dr. Riley

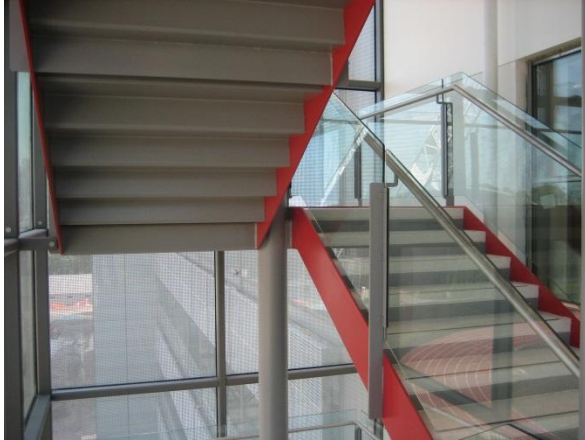
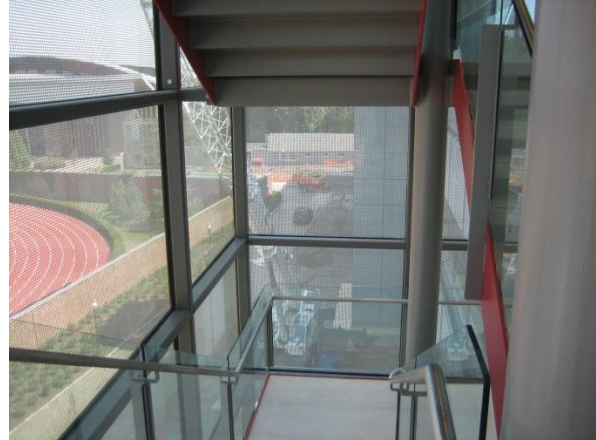
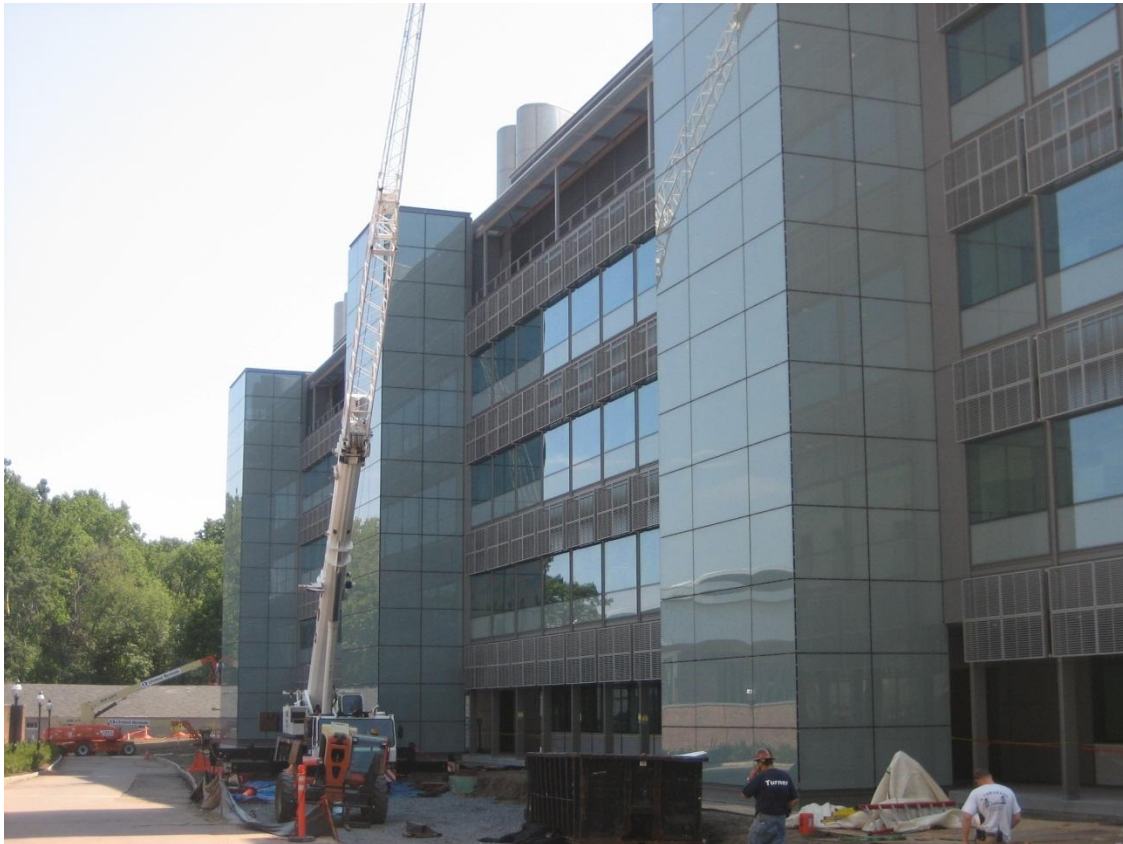
An agreement between the three was to rip out finished site work and pour a pad for a mobile crane to sit on. The pad's location allowed the crane to reach all three towers, work normal hours, and complete the work the best based on time and cost. Below are pictures to better visualize the curtain wall and stair towers.

The curtain wall comprised of a glass façade with aluminum framing. The first challenge associated with this was the lead time. Because of the size of the glass, the only place that was capable of producing it was Italy. Due to the amount of time to produce and ship, the lead time did not allow time to finalize the contract drawings. As a result early design assist with the subcontractor, Permasteelisa, was implemented. This allowed for early production. Lead time also became a problem for replacement glass for pieces that were defective or broken during installation. After ordering a piece of glass it took approximately two months to end up onsite. With the challenges of lead time and getting the curtain wall onsite, Turner Construction had to build temporary walls to enclose the building in order for the mechanical rough in process to continue.

The next challenge pertaining to the curtain wall was the glass on the three exterior stair towers. The original design called for heat strengthened glass on the interior and exterior panes. Permasteelisa's engineers showed with calculations based on the design the inside pane did not have to be heat strengthened. During installation the interior pane of the glass started to crack around the edges. The first action taken was to change the toggles that were torqued down to hold the glass in place. The original toggles would pinch the glass against the framing causing it to crack. After the toggles were changed, the breakage percentage of the glass decreased. However, a percentage of the glass was still breaking. The final solution was to widen the gap between each piece of glass which would give the installer more room to torque down the toggles. In addition to that, all the glass was replaced with the original design of heat strengthened panes on the interior and exterior. Changing out the glass required a lot of logistics planning between Permasteelisa, the owner, and Turner. The stair towers are located along a road that needs to stay open during normal business hours. This was crucial because it affected the type of crane used, the crane location, and the days/hours the crew would work. One option was to bring in a tower crane that could reach all the towers and allow the road to stay open while work was completed during normal working hours. Each stair tower comprised of 115 pieces resulting in a total of 345 pieces to be replaced. With the rate for removal and installation on an estimated average of 7 pieces/day, it would take about 50 days or 400 hours to complete this task. Based on those numbers, if this work was completed only on off hours or weekends, it would take almost half a year to complete. This activity would also take a crane, boom lift, lull, and six workers to complete. Therefore, it was an expensive problem to solve.

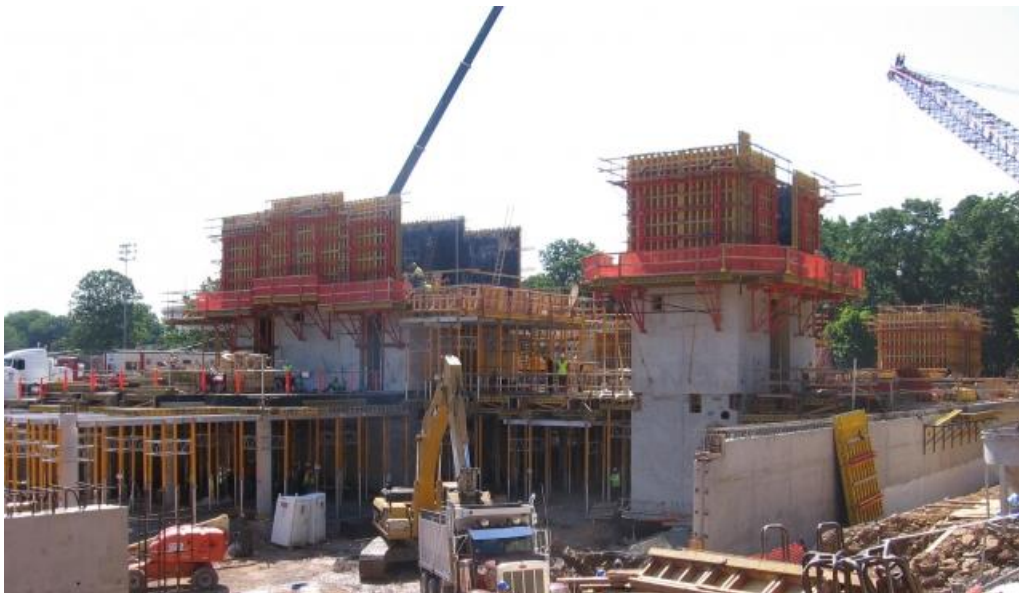
Above is a picture of the construction of the concrete cores.

After the concrete cores were already bid and started, the design of them was changed. Because the concrete cores are a crucial part of the structural system, if held up it would delay the entire schedule. The structural steel ties into these concrete CIP shear walls, and they need to be completed before steel erection can start. Turner Construction's response to this challenge was to pay overtime to redraw and work on the cores.

An additional challenge with the concrete cores was the mechanical drawings were not completed when construction on them started. In order to account for this, Turner Construction and the design team estimated where some of the mechanicals would penetrate the cores. This was done to save time and cost by limiting the number of locations where drilling would take place.

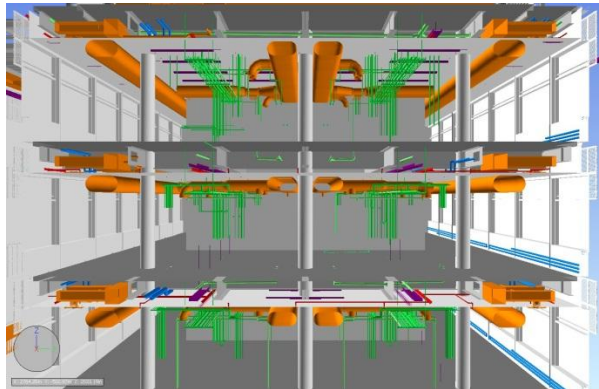
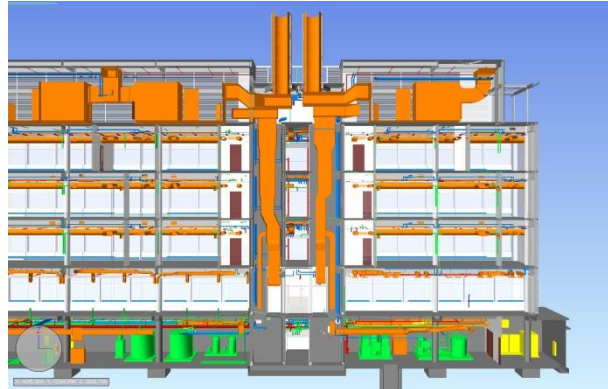
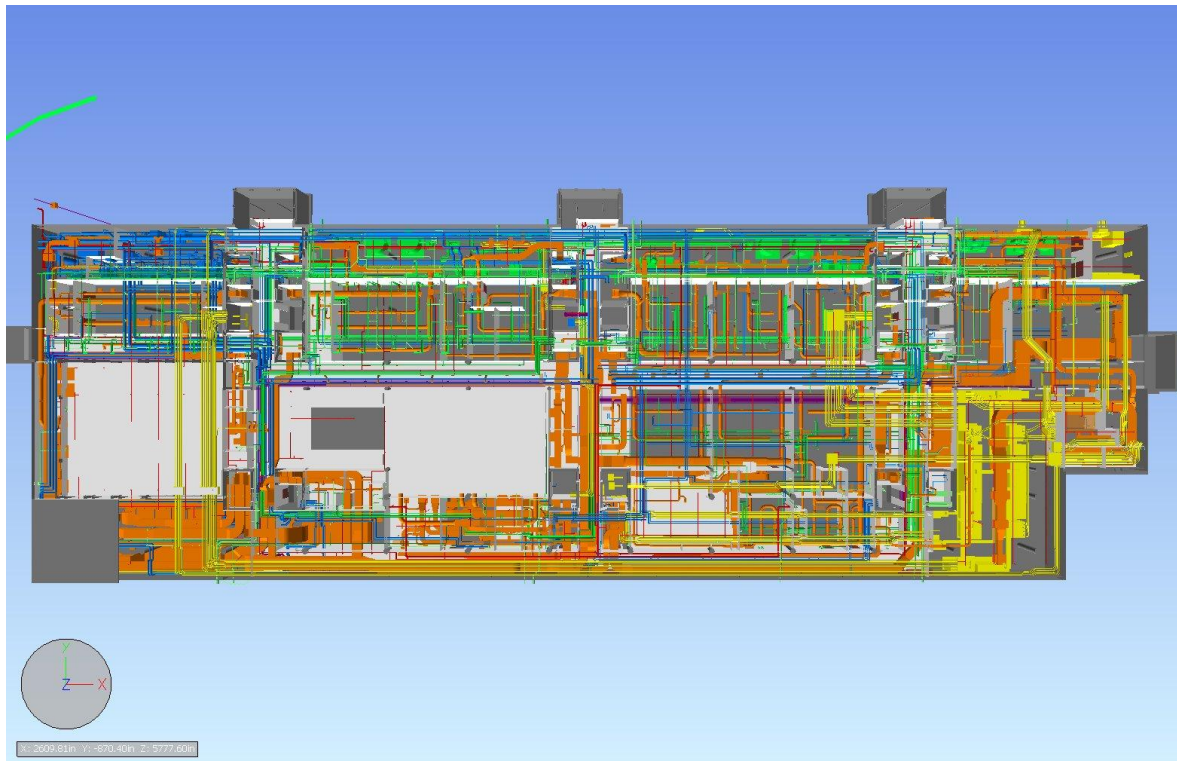
The Chemistry Building is comprised of an office side, 4-story atrium, and lab side. These three differing spaces made the mechanical systems very complex and difficult to design. In order to get the most efficient and highest quality system, changes were constantly taking place. There were so many changes that a period of six months passed and there was no progress. As a result Turner's parent company, Hochtief AG based in Germany, built a 3D mechanical and structural model. In order to make up for the lost time, Turner decided to release the sheet metal orders for the duct work based on the 3D Model.

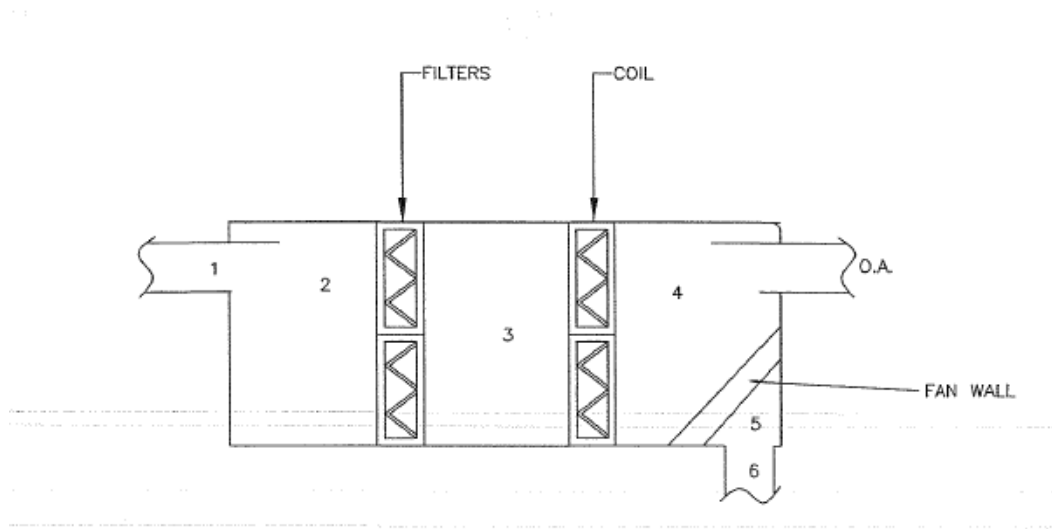
Static Profile

During the commissioning and balancing process of the air handler units in the lab penthouse, it was noted that the energy consumption was too high. The cause of this was a static pressure drop of 2" between the exit of the fans and the exhaust duct (5 to 6 in diagram below). This was a major problem because the fans were using a lot more energy than they should in order to achieve the required exhaust CFM rate.
