UNITED STATES  
DEPARTMENT OF THE INTERIOR  
CAFETERIA  
MODERNIZATION

DEPARTMENT OF THE  
INTERIOR CAFETERIA  
MODERNIZATION

1849 C STREET NW,  
WASHINGTON D.C.

TECHNICAL REPORT II

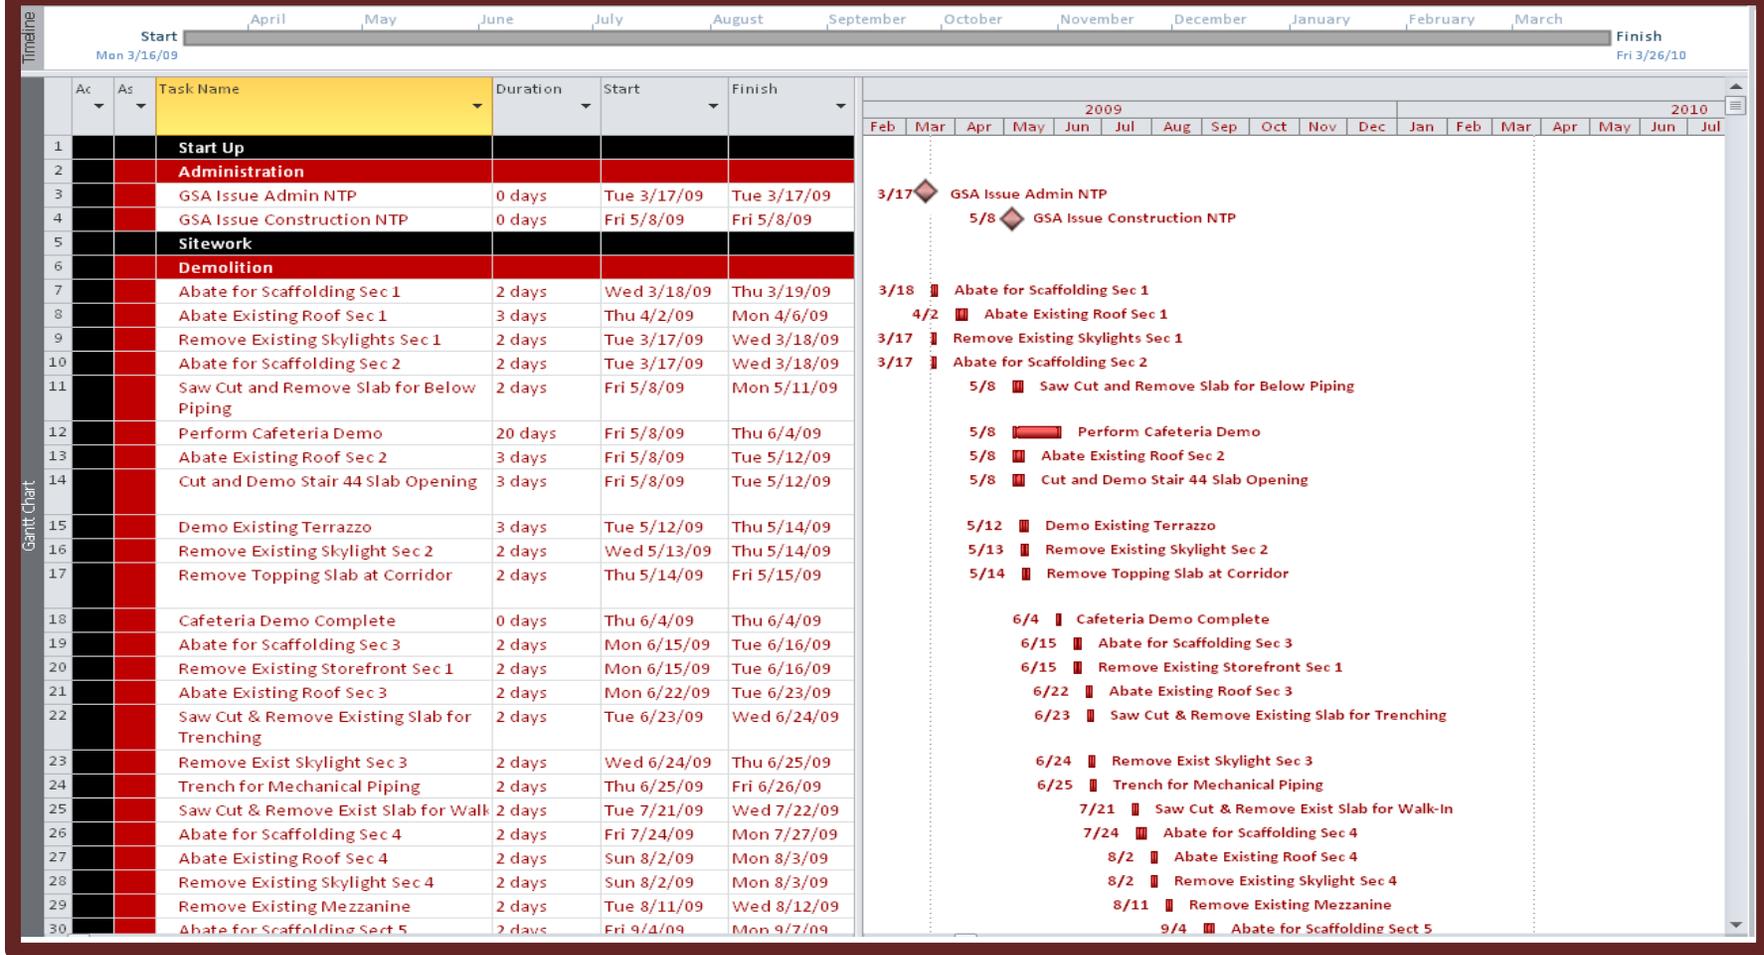
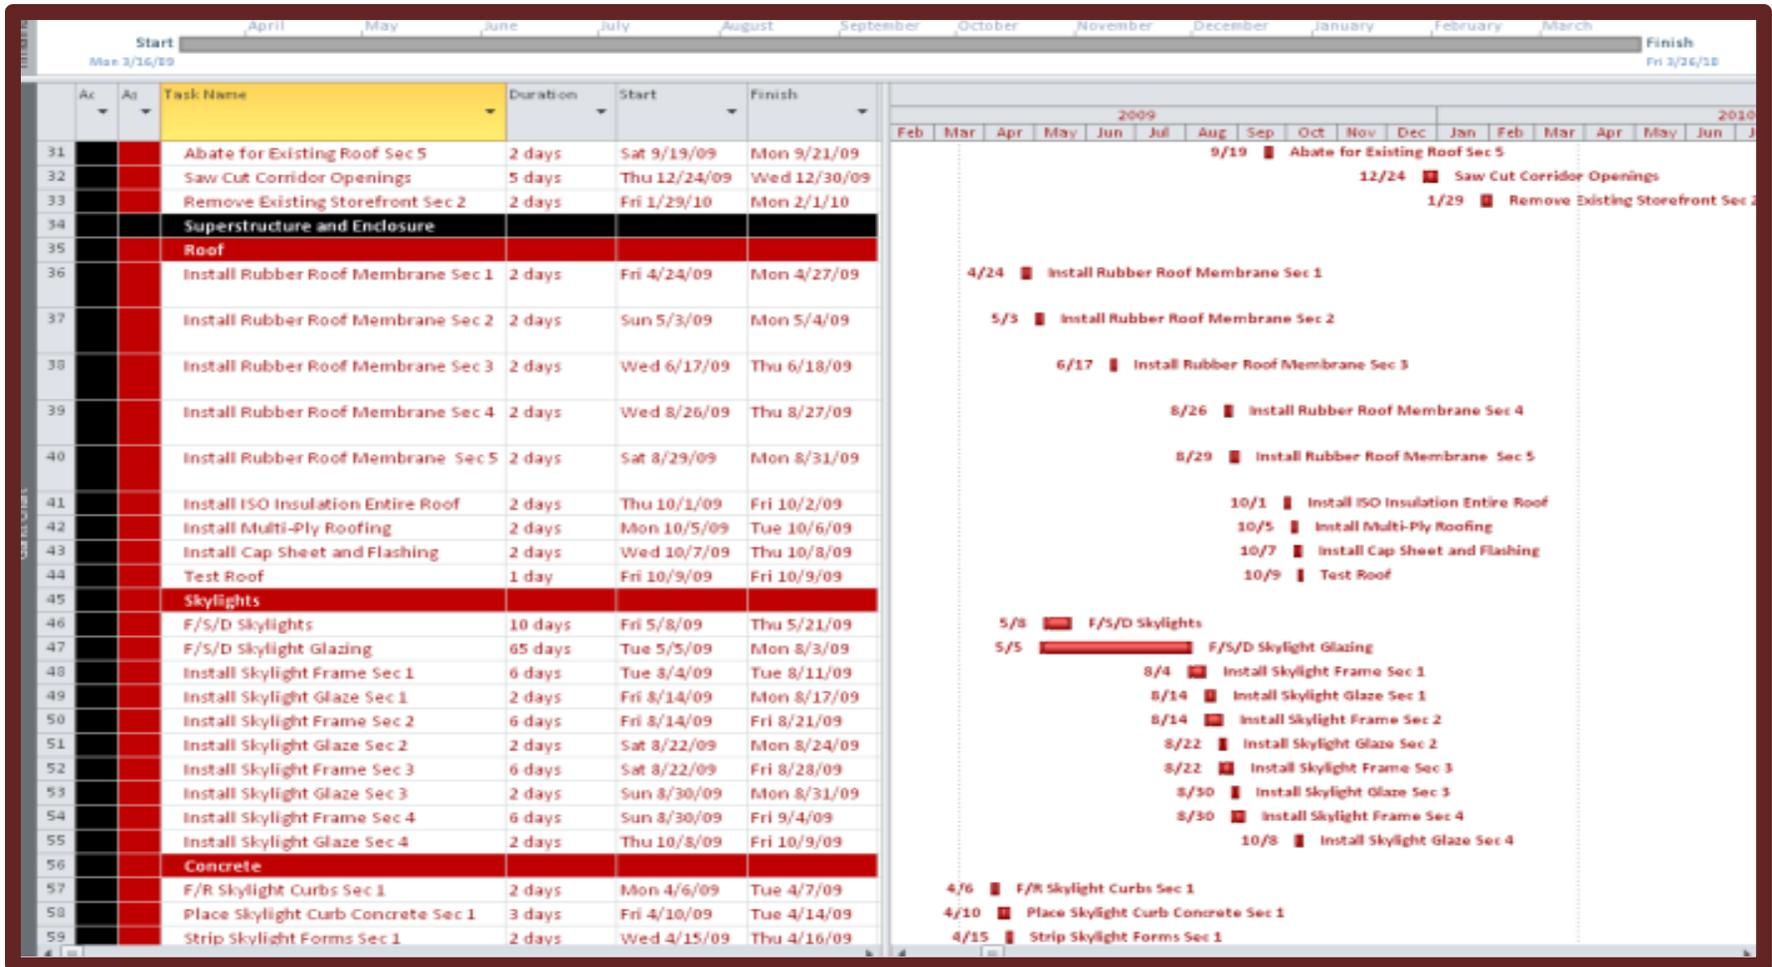
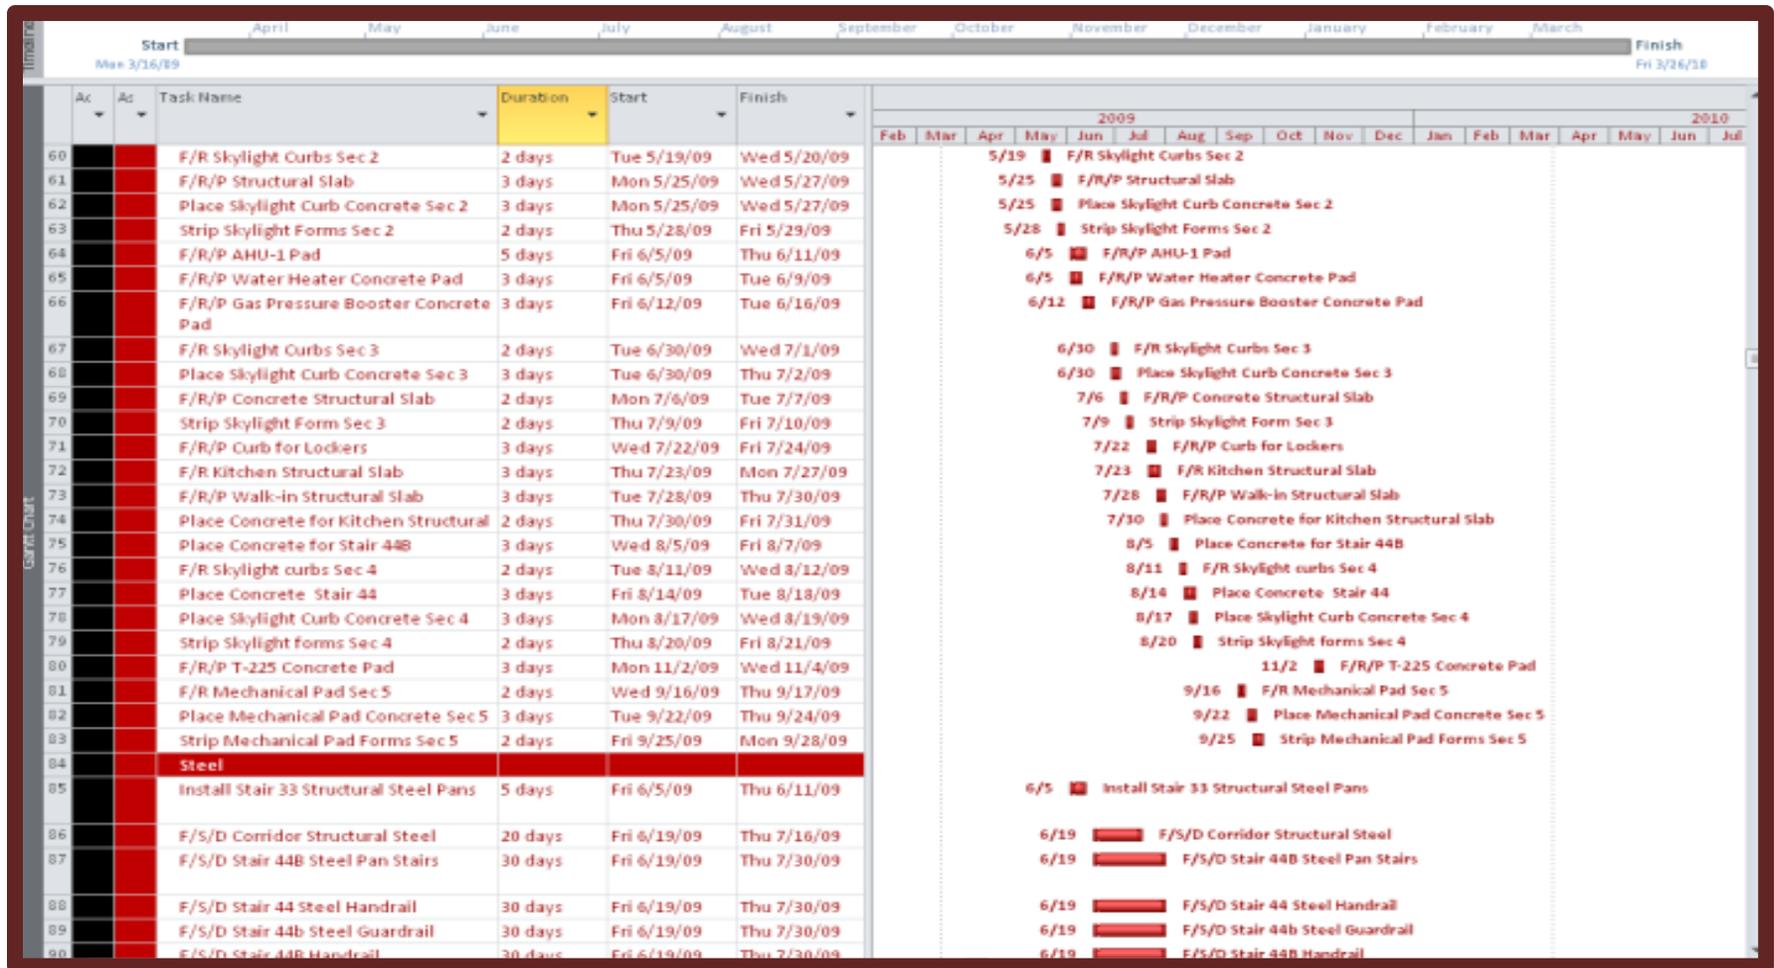
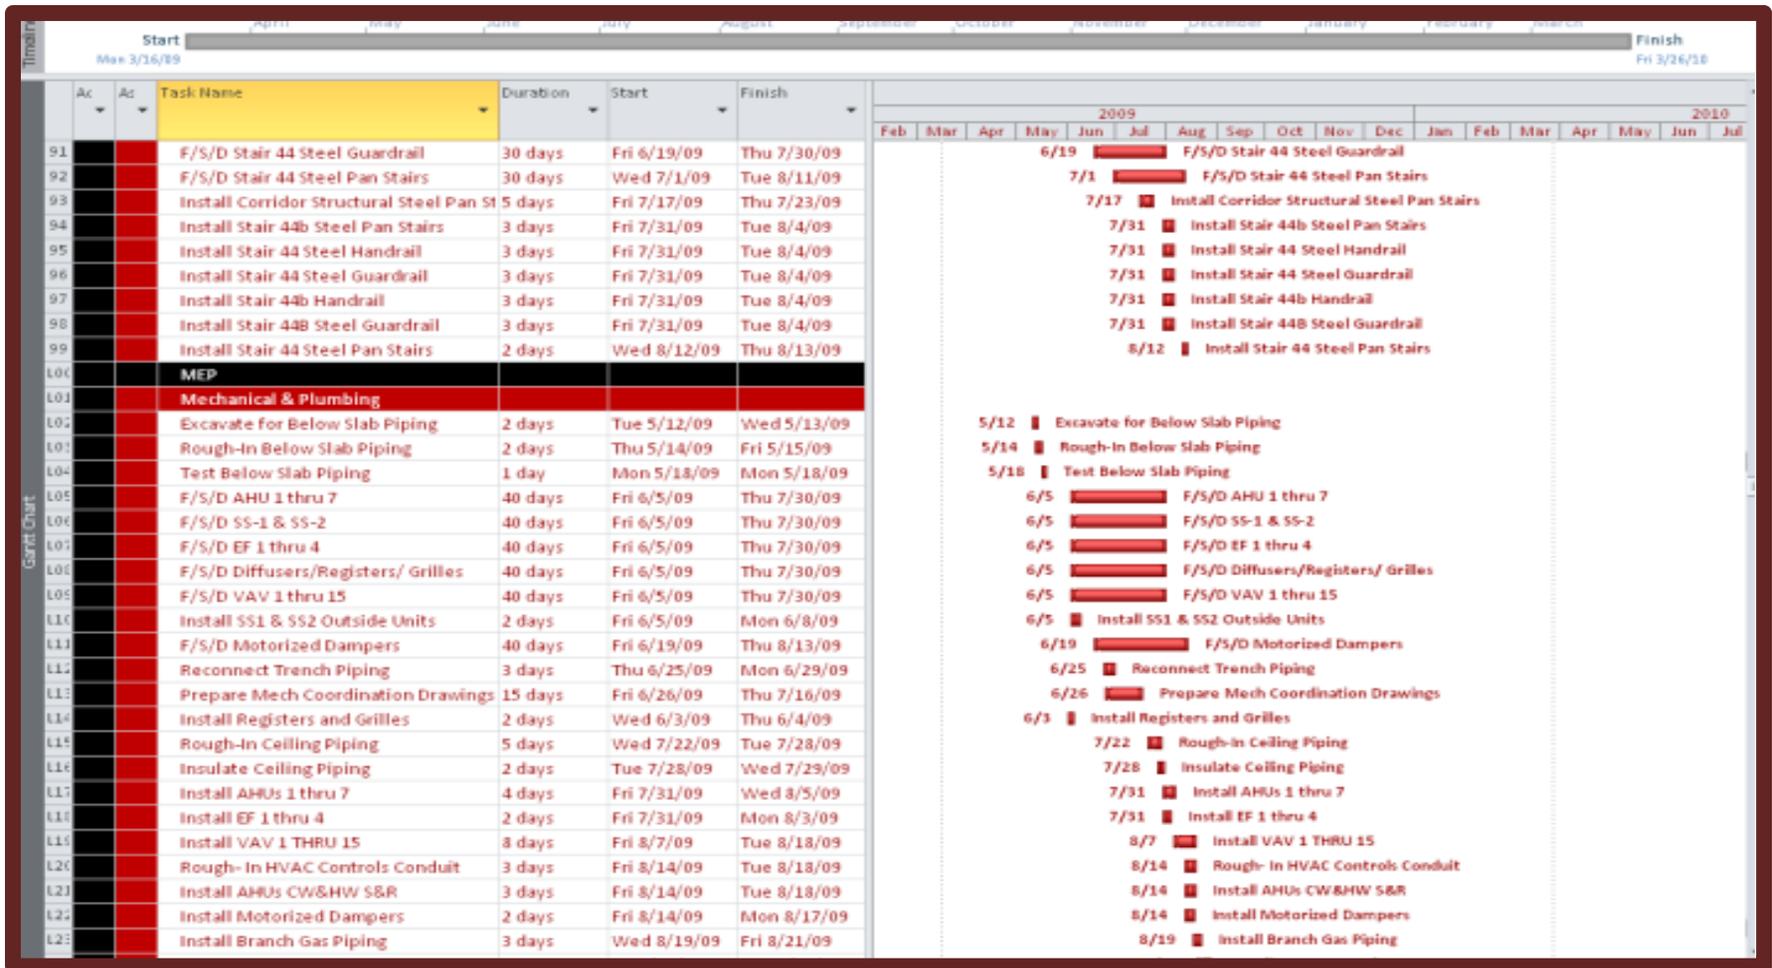
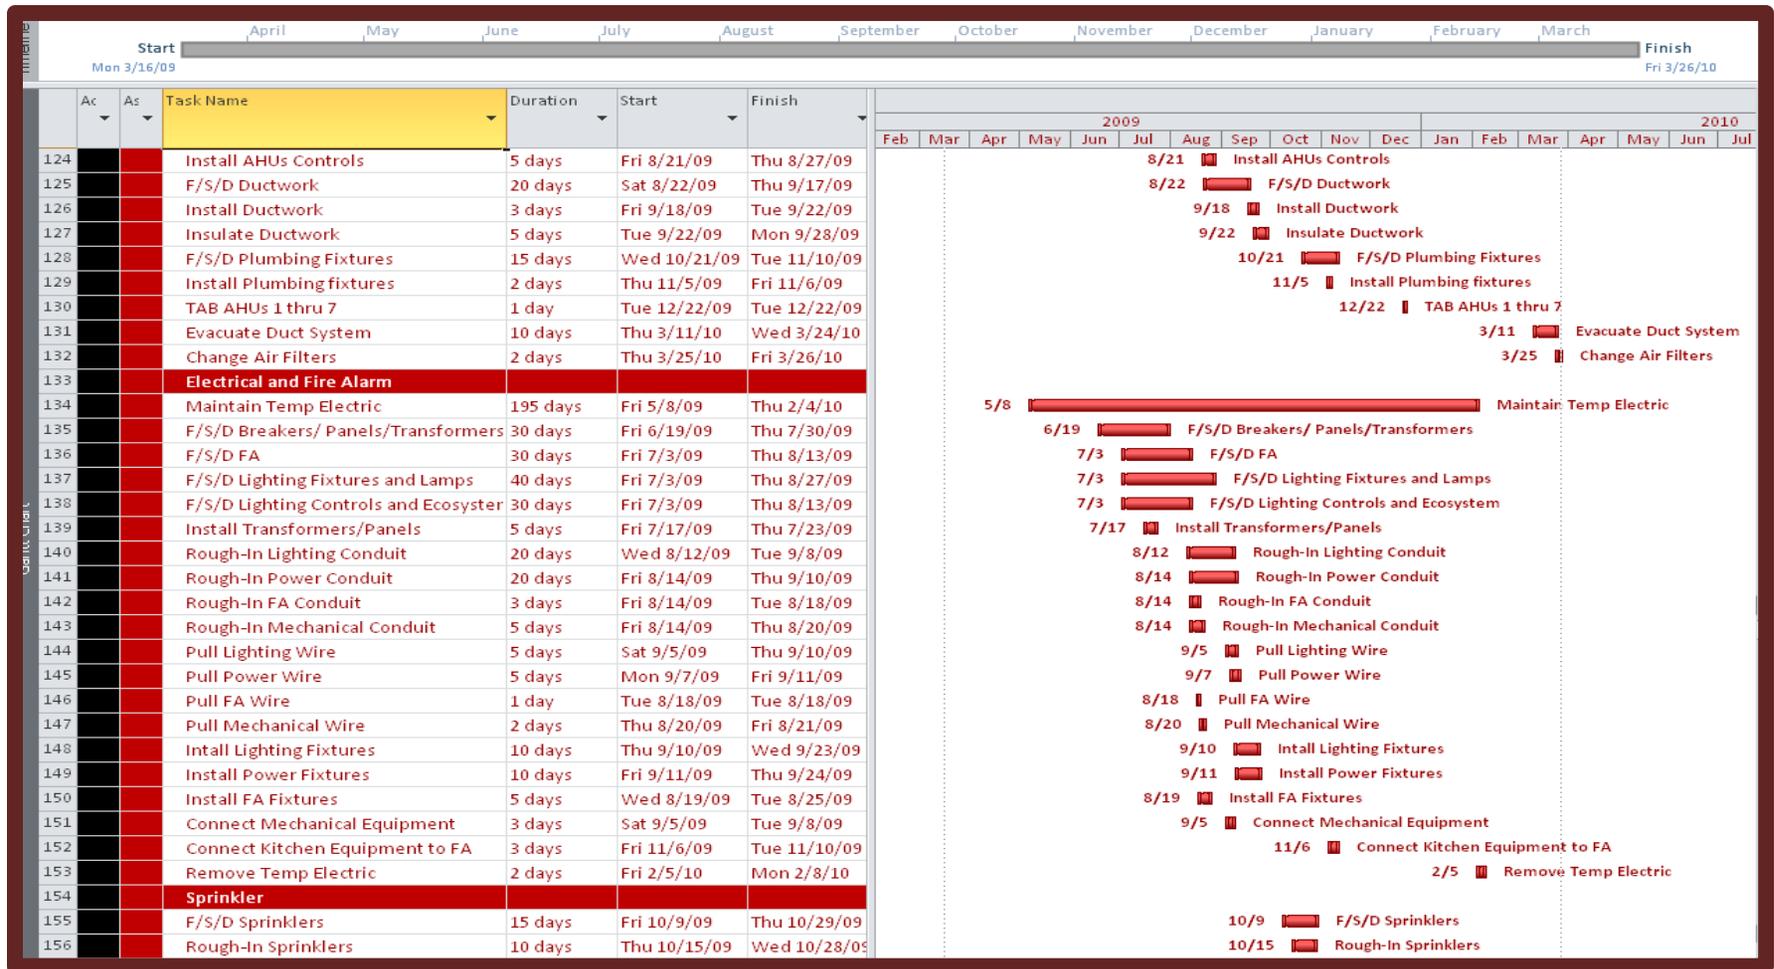
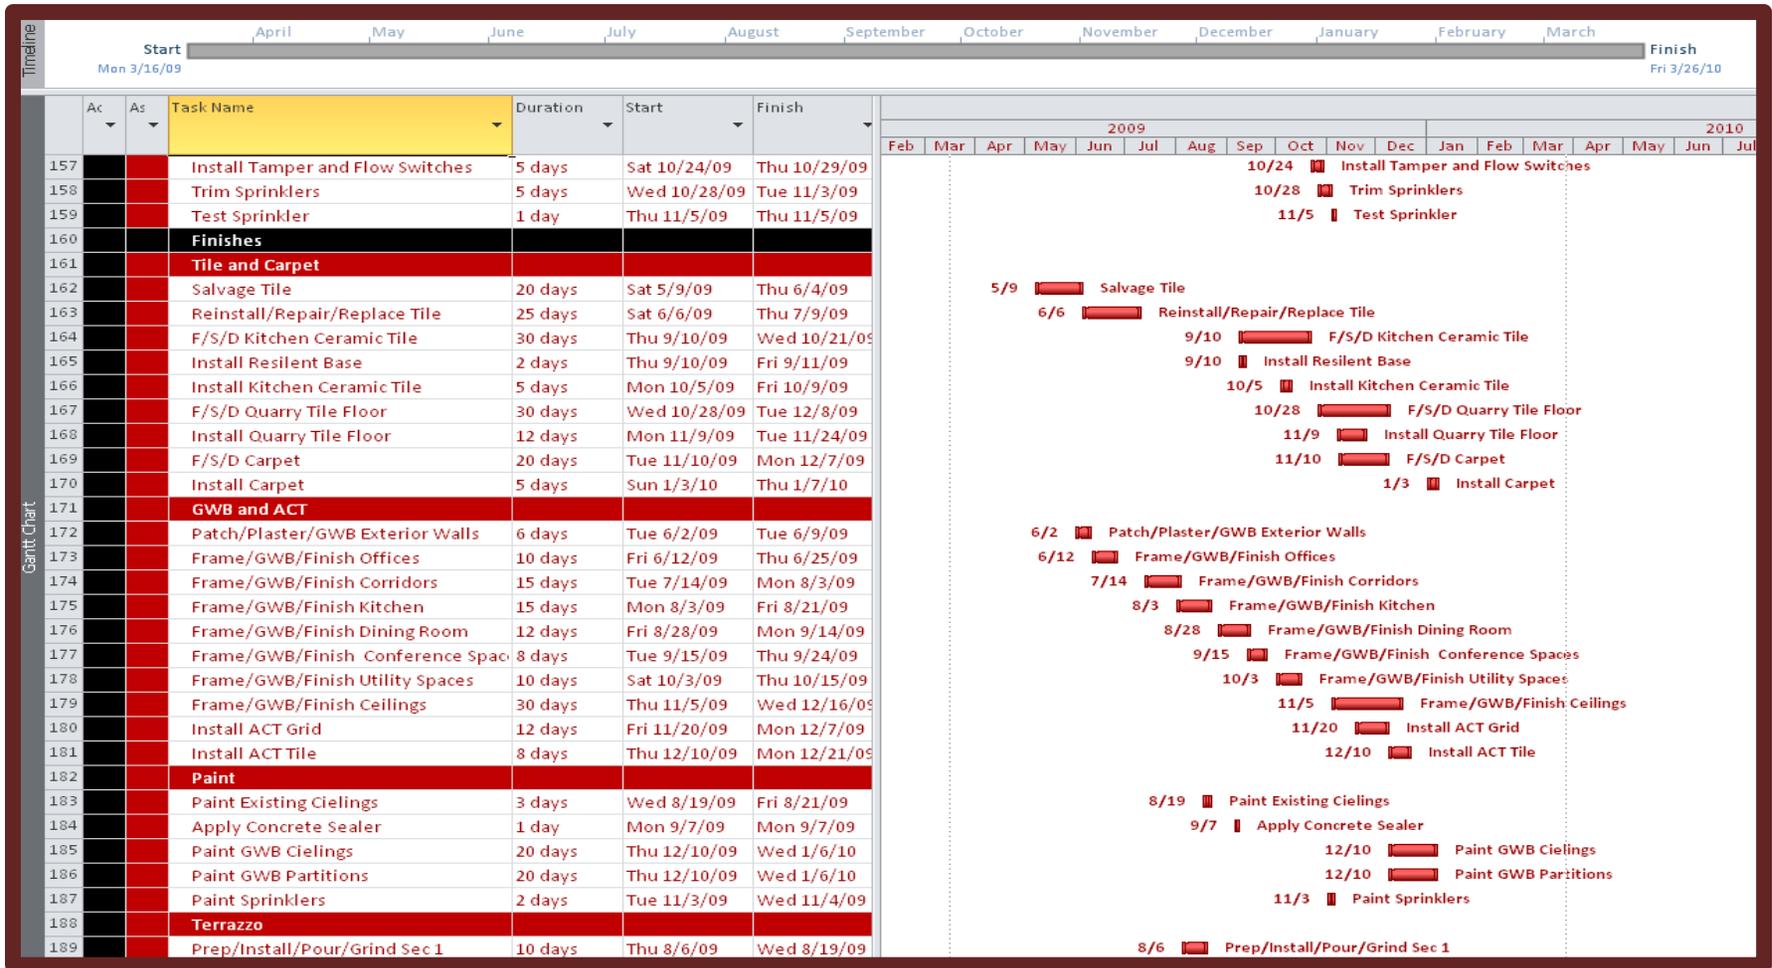
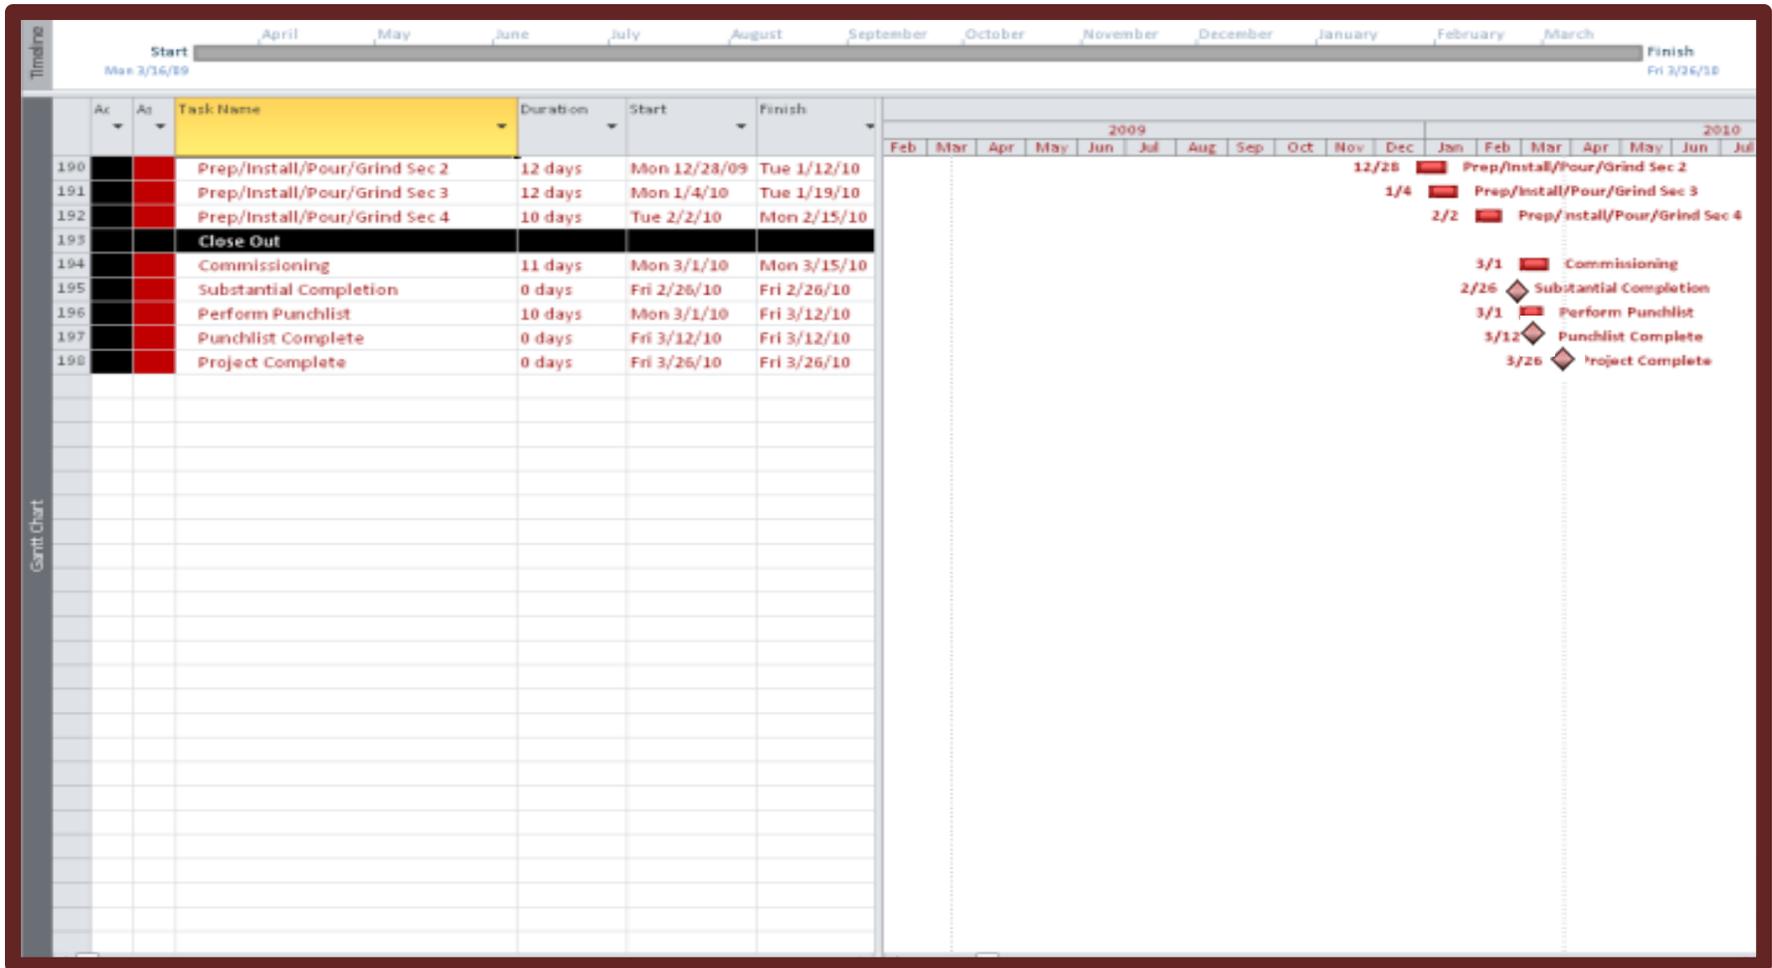
Detailed Project Schedule

The following is a detailed project schedule for the construction of the Department of Interior Cafeteria Modernization Project. This particular schedule is based off of the original general contractor's proposal. This proposal called for project completion on March 26, 2010. The schedule is mostly broken down into construction phases. Each construction phase is then broken down further by trades. The following is the schedule outline:

The original schedule in the General Contractor's proposal broke each construction process into 5 separate activities. The first activity consisted of the submittal process which generally allowed for a month's time. The second activity dealt with the fabrication, delivery, and storage and generally had a two week window. The next step was to install the actual item. At last, the final two activities consisted of commissioning/testing and owner acceptance. For the purpose of this schedule, only the fabrication, delivery, and storage, and the installation activities were shown. This schedule focused on the actual construction instead of the project management components.

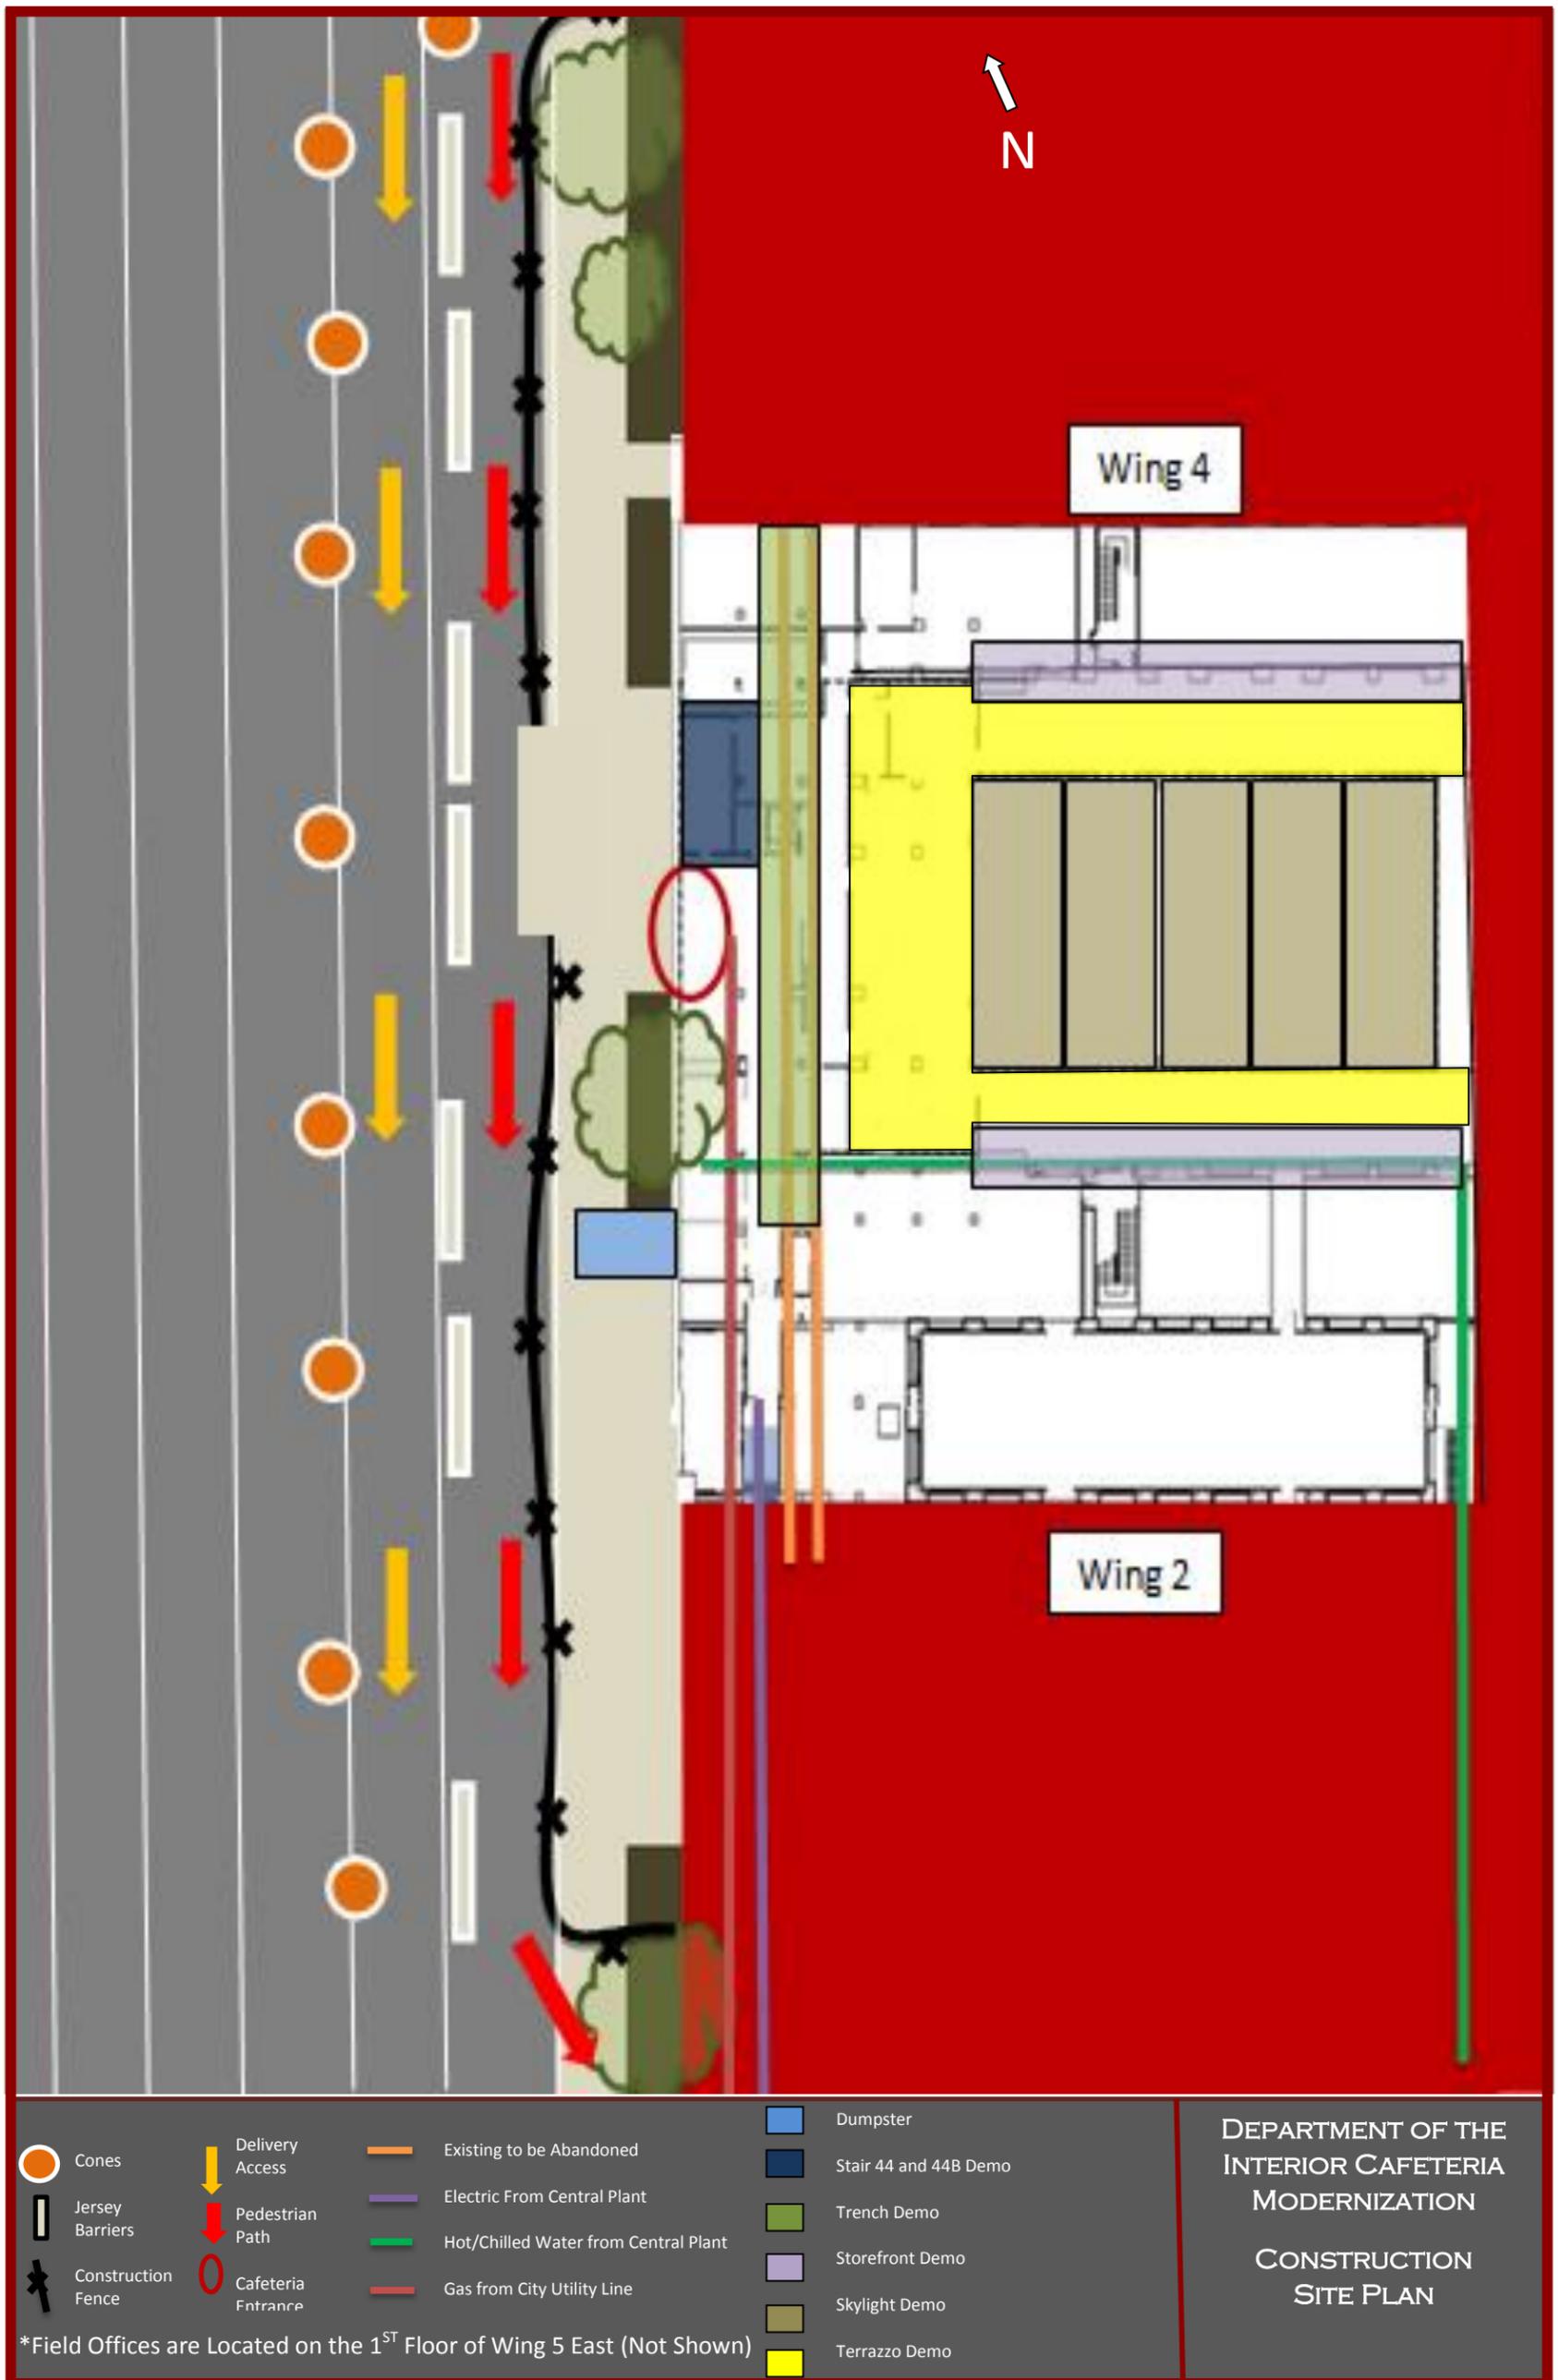
Demolition Site Plan

Demolition is the first major construction activity in the modernization of the cafeteria. Phasing is critical during this part of the schedule. In the cafeteria, almost all demolition processes require abatement. A good example of phasing during demolition can be seen in studying the skylight and roof removal. The roof is broken down into 5 different phases starting from East to West. Each phase consist of 3 demolition task:

- 1) Abate for Scaffolding
- 2) Abate for Existing Roof
- 3) Remove Existing Skylight

Layout and Storage space is scarce on the roof and thus organization is key. Generally, storage and waste were not kept on the roof if at all possible. All materials were taken down through the roof exit to the dumpster outside the building. Demolition time for each phase was a total 7 day. The contractor would not begin the next phase until all the construction activities such as scaffolding assembly, curb pours, skylight installation, and new roofing were completed.

Phase	Abate Scaffolding	Existing Roof Abatement	Remove Existing Skylight
1	3/19/09	4/2/09	4/17/09
2	3/17/09	5/8/09	5/13/09
3	6/15/09	6/22/09	6/24/09
4	7/24/09	8/2/09	8/2/09
5	9/4/09	9/19/09	9/21/09

One possible cost and time saving to this site layout may be to reduce the number of phases. By performing more work at one time, rather than bring labors and equipment back 5 separate times to the roof could be a more effective alternative. The only obvious down side of this proposal, could be the cost of using more scaffolding.
