UNITED STATES
DEPARTMENT OF THE INTERIOR
CAFETERIA
MODERNIZATION

DEPARTMENT OF THE
INTERIOR CAFETERIA
MODERNIZATION

1849 C STREET NW,
WASHINGTON D.C.

FINAL REPORT

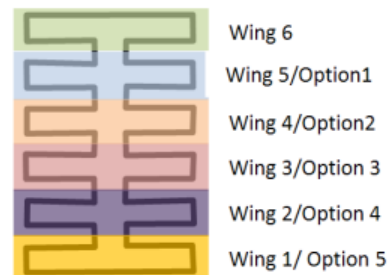
Figure 1: Project Phasing Plan

The Department of Interior Cafeteria Modernization project began construction on February 6, 2009. The cafeteria project included the renovation of multiple spaces, all for the purpose of providing the Department of Interior and its employees with upgrade facilities for their day-to-day lives. The project renovation scope includes a dining area, post office, Interior Department Recreation Association Office, credit union, two conference rooms, a barber shop, kitchen area, server area, locker room, three walk in coolers, mechanical room, electrical room and elevator. Renovations to the building’s structure (steel frame encased in concrete) would include a new skylight system for the dining area, and slab replacement in the kitchen. The original schedule had called for completion in March of 2010, but did not actually occur until July 29th.

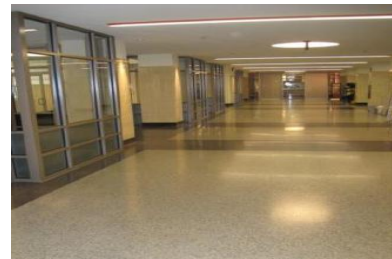
Figure 3: Dining Room Corridor

Terrazzo is a popular flooring material used in government office buildings. The popularity of terrazzo in the DC area made finding competent contractors and quality materials an easy task.

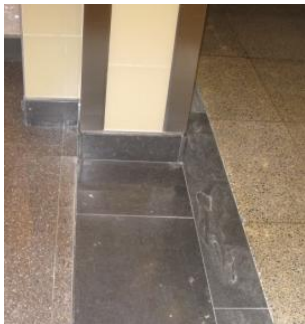
Figure 4: Stone Transition

Popular throughout the Department of the Interior Building, black quarry stone is used from flooring transitions, to baseboards, to door trim. This historic stone was pulled from a quarry in DC in the early 1920's that is no longer in use. Somehow, a piece of historic stone that had been taken out for preservation was lost and needed to be replaced. Unfortunately no such local stone could match the historic one. In the end a close match was shipped in from a Tennessee quarry.

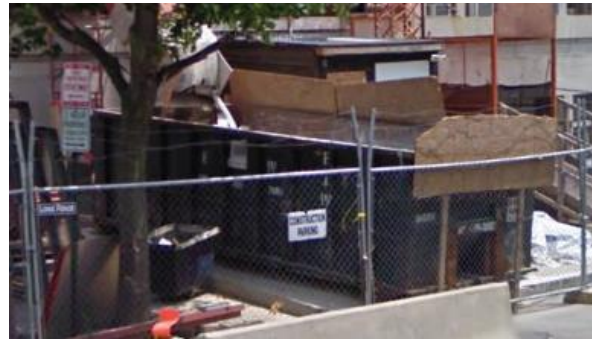
Figure 6: Cafeteria Dumpster

One dumpster is available onsite for garbage. It is sorted for recyclables off site. The typical tipping fee is \$500.

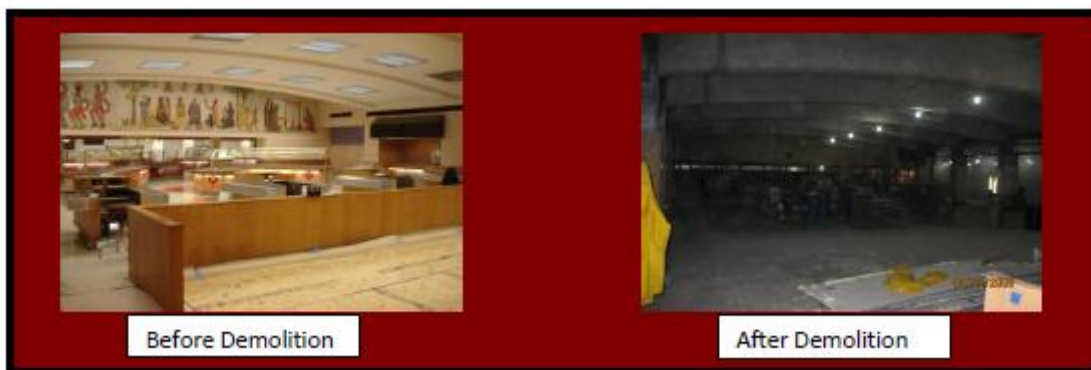
Figure 7: Dining Room Demolition Comparison

Demolition was the first phase of construction in the modernization of the cafeteria. The original cafeteria was laden with dilapidated carpet, flooring, equipment etc.. Fortunately, the cafeteria also had some historic pieces that were to be incorporated with the new design in order to pay homage to its history. Removing original ceramic tiles, stone flooring transitions, and stone bases requires a significant amount of time and care. In addition to removing and refinishing those materials, there were various murals painted in the cafeteria that needed proper protection. In one instance a contractor working on the opposite side of a wall mural accidentally punctured through to the opposite side of the wall disturbing the mural. Fortunately this was the only incident throughout the construction. Before any of the above could take place, the site must first be declared free from hazardous materials.

Abatement of hazardous materials was a concern throughout modernization of the entire Department of the Interior Building. The cafeteria was no exception. Asbestos was found all over the site from the glue on flooring tiles, to the insulation of piping. In addition to asbestos, lead paint needed to be removed from all surfaces as well. This abatement period was scheduled to occur during night time shifts. All abatement work was done by the contractor Aceco, and daily air quality monitoring performed by Mactec.

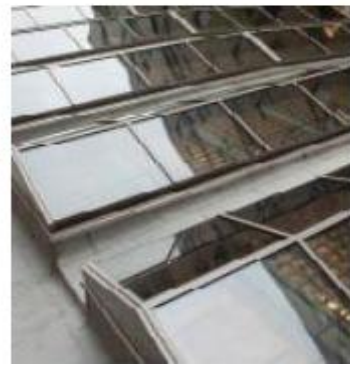
Figure 9: Skylight System

The largest structural feature on this project lies in the new skylight system for the dining room roof. The dining room roof, lies between Wing 4 and Wing 3, and is one story above grade. The roof is supported by eight main girders that span the entire dining area from north to south. In the original skylight system the roof was completely flat. The new proposed skylights consist of eight pyramid-like skylights that rest on a one foot high cast-in-place concrete curb. The new skylight system adds a significant amount of load to the original roof. After a structural review by Thornton Tomasetti, it was decided that the original steel encased in concrete roof structure could support the load.

A major scheduling obstacle, laid in the completion of the new skylight system. Due to lack of as-builts, the contractors were unable to approximate the correct scheduling time for the removal of original roofing membrane. This would not be the last major delay to the schedule. Perhaps the largest delay came after the completion of demolition in the kitchen area. The utility trenches under the kitchen were in far worse condition than previously planned for. Replacing dilapidated utility lines, filling the trench with aggregate, and placing a 4" concrete slab over the trenches held up the original schedule by more than a month.

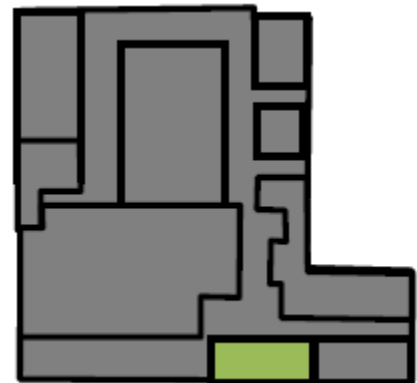
Figure 10: Cafeteria Plan

The system’s cooling is provided by chilled water cooling coils in each of the new air handlers. This chilled water comes from the existing base–building cooling plant. The system’s heating is provided from multiple sources. Each air handler receives hot–water from the base–building plant. Reheat coils are furnished in each VAV box with exterior exposure. In addition, electric baseboard heaters are located under every tall window. The dining room, kitchen, IDRA, post office, and two conference rooms each have their own air handling unit that is controlled by individual wall mounted thermostats. The kitchen’s air handling unit is a Variable Air Volume unit so as to handle the multiple zones in the kitchen. The entire cafeteria is covered with a dry standpipe sprinkler system.

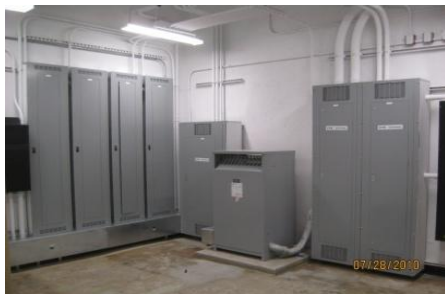
Figure 10: Electric Room

The cafeteria project contains a complex electrical system. Between the lighting controls in the dining room, the electric heating, and the multitude of kitchen equipment the electrical system has many different loads to account for. The system brings in power at both 480Y/277 and 208Y/120 due to the different demands for voltage. All existing panel boards and wiring were removed during demolition and replaced by new ones. The power is supplied from the base building’s power system and is also backed up by the main building’s generator. The IDRA, post office, credit union, and barbershop all have their own panel.

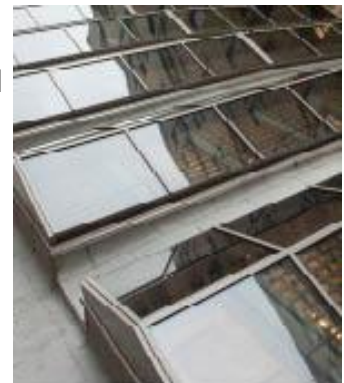
Figure 12: New Skylights

One of the largest design features on this project lies in the new skylight system for the dining room roof. The cafeteria's original design had flat ceiling skylights that allowed natural light to flood the dining room. During the World Wars it became a government mandate to cover all glass ceiling exposures to protect incase of espionage or bombing. These orginial skylights were abandoned in place and cloved up with layers of roofing material. The new design calls for the return of natural light to the dining room by replacing the previous drop ceiling with a new skylight system that will restore natural light to the space.

The proposed skylight system will require demolition of the present drop ceiling, the original skylights, and the current roofing system. There will also need to be concrete curbs built around the roof openings to support the new skylights. The replacement roofing and removal of present roofing will not be considered in this decision because they were deemed necessary regardless of whether new skylights were installed or not.

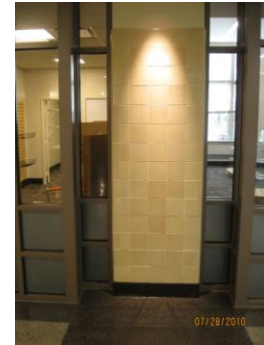
Figure 13: Historic Ceramic Wall Tile

During site investigation, a section of drywall had been removed from a dining room column exposing the original ceramic tile. It was deemed to be in relatively good condition, and the idea to uncover all of the dining rooms original ceramic tile and to restore it to its original condition was born. The original ceramic tile was created in the 1930’s and would thus be impossible to replicate exactly. Any significantly damaged tile would have to be replaced by relocating tiles from other locations. A standard for deeming which cracked or broken tiles were acceptable and which were not was drafted into the construction documents to facilitate these decisions. In all, the restoration of the ceramic tile would require the demolition of the surfaces covering them, the removal and reinstallation of broken tiles, and finally the refinishing of the ceramic tile and grout.

- Demolition of Drywall that is covering up the original ceramic tile, 1100 S.F. @ \$0.41/ S.F. of wall
- Demolition of the original ceramic tile in certain areas so that it may be repurposed in locations where the the original tile has been broken or chipped, 200 S.F. @ \$1.34/ S.F. of wall
- Plywood Protection for all ceramic tile surfaces to prevent from damage during other demolition or construction 210 L.F. @ \$10.10/L.F.
- Replacing and regrouting broken ceramic tile with tile removed from other areas, material and labor cost is \$0.475/ S.F. @ 200 S.F. of replaced tile
- Refinishing the ceramic tile with a ceramic coating @ 1.46/ S.F. of tile

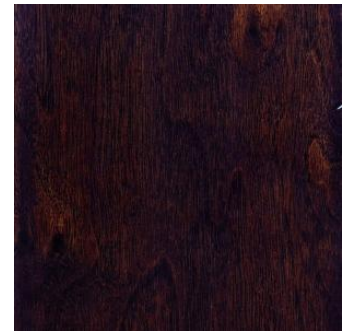
Figure 16: Home Legend Hand Scratched Veneer

The location of each of the murals is the focal point of the space. When sitting anywhere in the dining room, the occupants’ eyes are automatically drawn to the front of the room. For this reason, the mural walls must contain a bold design feature. Below the murals, are large planters containing various natural vegetation. A common theme throughout the Department of the Interior Building’s design is the attention to nature. Since the department itself, is responsible for all of the nation’s national parks, it is important to involve nature in the dining room’s redesign as well. For those reason, the mural wall redesign consist of a dark hand scraped walnut veneer paneling. The dark color will provide contrast to the light colors throughout the space. The natural wood textures will accent the various plants and trees in the space.

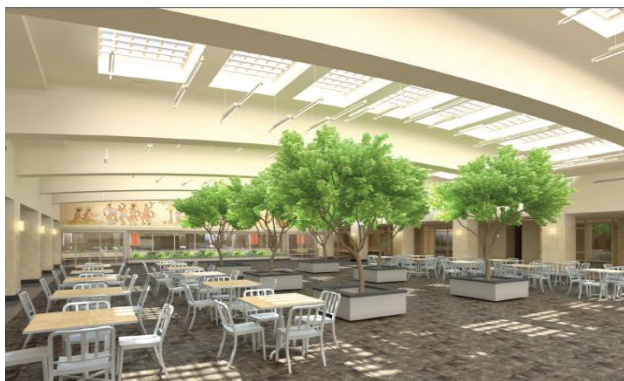
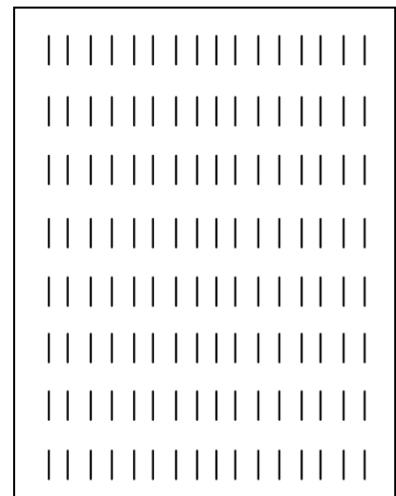
Figure 16: Lighting Array

The layout of the lighting system also provided an interesting architectural feature to the dining room. Each luminaire was suspended by string from the ceiling. Each of the 8 bays consisted of 16 suspended luminaires. Each luminaire was suspended at a different height to provide an oscillating wave appearance. This design feature is also important to the overall space and will also be kept in the redesign.

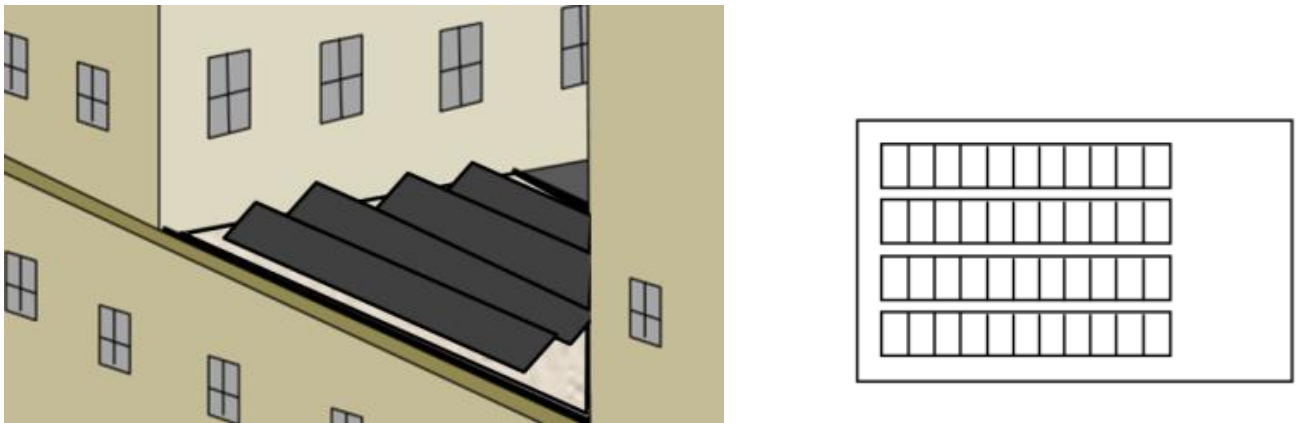
Figure 20: Proposed PV Array

The second story roof location that was selected in the solar study is a 50' x 30' foot area. Each Sharp® panel is 3'x5'. By keeping the panels in rows of 11 the array allows room for maintenance. By keep the array to the north most side of the building, some early morning shadowing can be avoided. The panels will be fixed at an angle of 38% based on the buildings latitude.

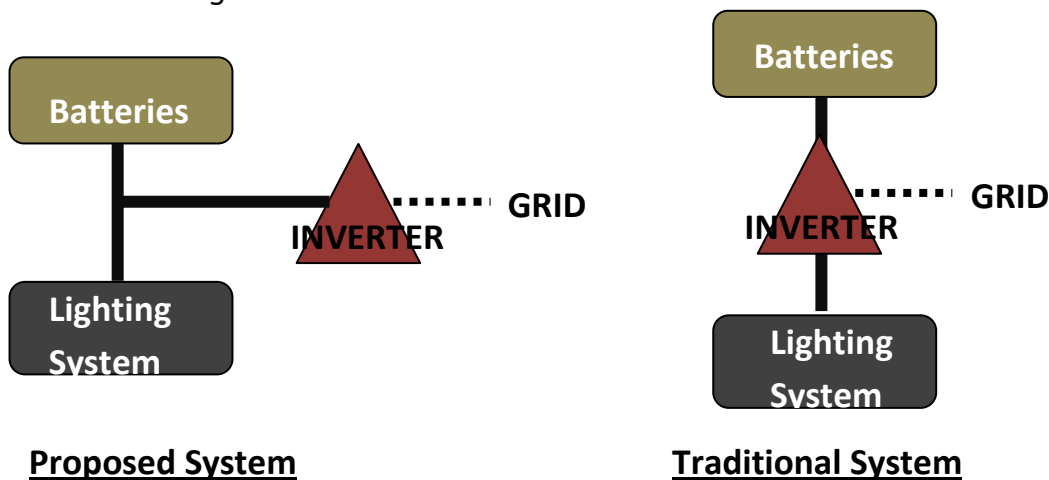
Figure 21: Inverter Set Up

Since a tie to the grid is also necessary to serve as a backup during instances of low solar contribution, and also a means of selling back excess power, it is necessary to still have an inverter in the system. The difference in this design will be that the only time power will be converted is when not enough or too much solar energy is available. Reference the diagram below:

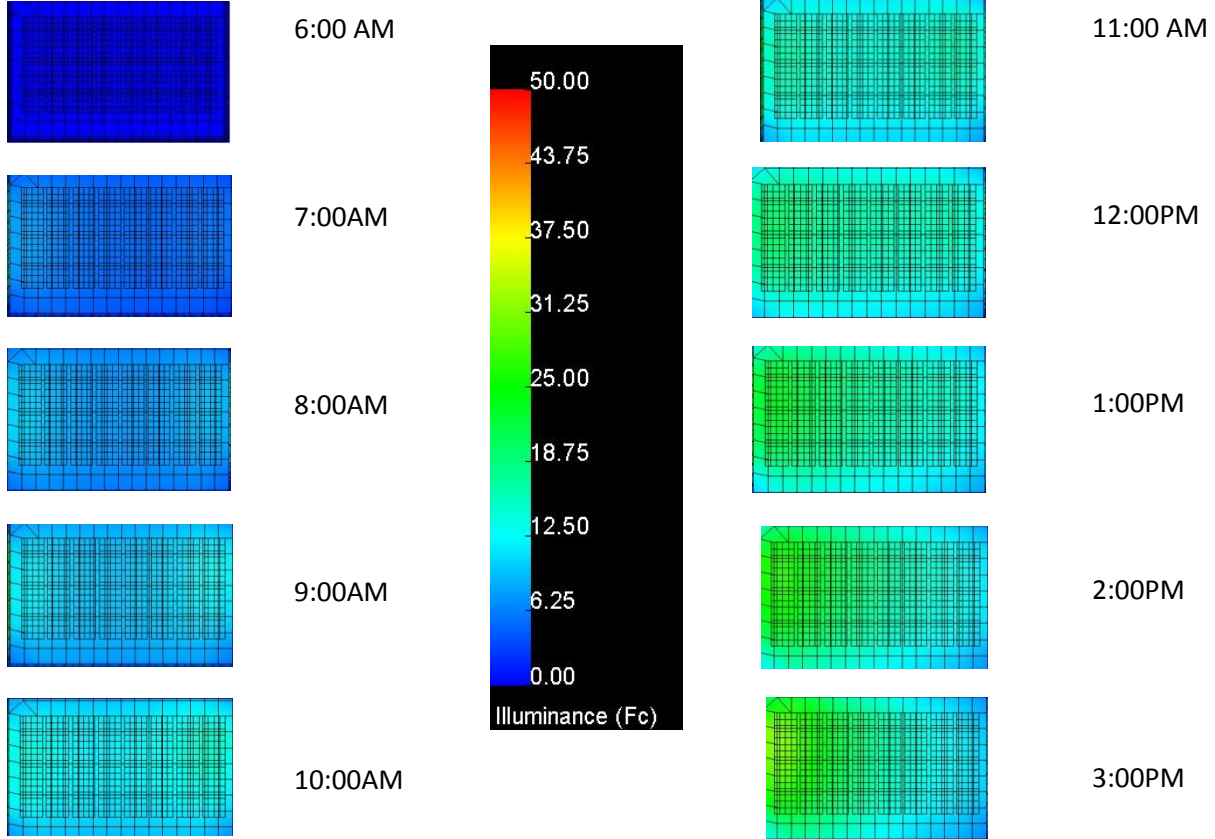
Lighting Demand Study

Spring Equinox

March 21

Determining the lighting load to size the photovoltaic system is extremely difficult. The first step was to measure the amount of natural light the space experiences throughout the course of the time that the dining room is in use (6am-3pm). Using AGI a daylight study was performed on the spring and fall equinox, as well as the summer and winter solstice. See Appendix B for sample images of the spring equinox study. From this study it should be noted that a significant amount of light ranging from 0-30 foot-candles can be measure at the floor level just from the natural light contribution throughout the day.
