UNITED STATES
DEPARTMENT OF THE INTERIOR
CAFETERIA
MODERNIZATION

DEPARTMENT OF THE
INTERIOR CAFETERIA
MODERNIZATION

1849 C STREET NW,
WASHINGTON D.C.

TECHNICAL REPORT

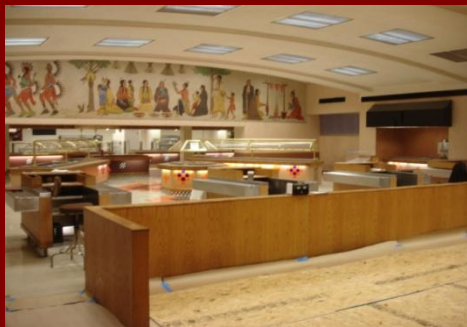
Before Demolition

Demolition was the first phase of construction in the modernization of the cafeteria. The original cafeteria was laden with dilapidated carpet, flooring, equipment etc.. Fortunately, the cafeteria also had some historic pieces that were to be incorporated with the new design in order to pay homage to its history. Removing original ceramic tiles, stone flooring transitions, and stone bases requires a significant amount of time and care. In addition to removing and refinishing those materials, there were various murals painted in the cafeteria that needed proper protection. At one a contractor working on the opposite side of a wall mural punctured the wall and disturbed the mural. Fortunately this was the only incident throughout the construction. Before any of the above can take place, the site must first be declared free from hazardous materials.

Abatement of hazardous materials was a concern throughout modernization of the entire Department of the Interior Building. The cafeteria was no exception. Asbestos could be found all over the site from the glue on flooring tiles, to the insulation of piping. In addition to asbestos, lead paint needed to be removed from all surfaces as well. This abatement period was scheduled to occur during night time shifts. All abatement work was done by the contractor Aceco, and daily air quality monitoring performed by Mactec.

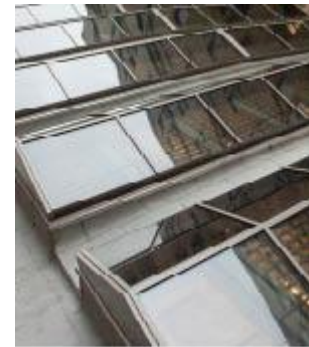
New Skylights

The largest structural feature on this project lies in the new skylight system for the dining room roof. The Dining room roof, lies between Wing 4 and Wing 3, and is one story above grade. The roof is held up by eight main girders that span the entire dining area from north to south. In the original skylight system the roof was completely flat. The new proposed skylights consist of seven pyramid-like skylights that rest on a one foot high cast-in-place curb. The new skylight system adds a significant amount of load to the original roof. After a structural review by Thornton Tomassetti, it was decided that the original steel encased in concrete roof structure could support the load.

A major scheduling obstacle, laid in the completion of the new skylight system. Due to lack of as-builts, the contractors were unable to approximate the correct scheduling time for the removal of original roofing membrane. This would not be the last major delay to the schedule. Perhaps the largest delay came after the completion of demolition in the kitchen area. The utility trenches under the kitchen were in far worse condition then previously planned for. Replacing dilapidated utility lines, filling the trench with aggregate, and placing a 4" concrete slab over the trenches held up the original schedule by more than a month.

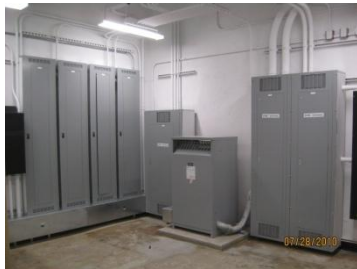
Electrical Room

The cafeteria project contains a complex electrical system. Between the lighting controls in the dining room, the electric heating, and the multitude of kitchen equipment the electrical system has many different loads to account for. The system brings in power at both 480Y/277 and 208Y/120 due to the different demands for voltage. All existing panel boards and wiring were removed during demolition and replaced by new ones. The power is supplied from the base building's power system and is also backed up by the main building's generator. The IDRA, post office, credit union, and barber shop all have their own panel.

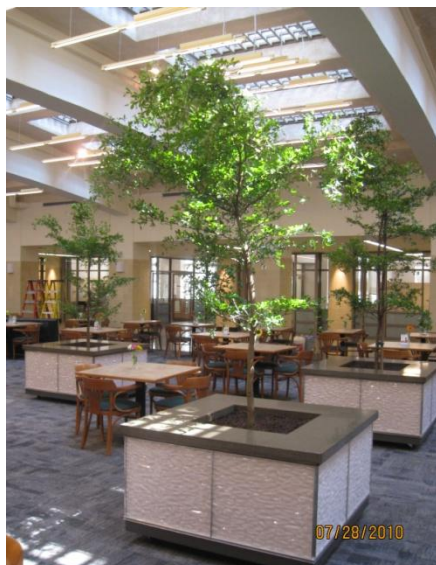
Dining Room
Planter

The cafeteria modernization project is working towards achieving a Silver Certification for LEED for Commercial Construction v2.0. The initial design analysis called out 30 “probable” and 17 “possible” points. The construction management process would prove to be vital in this certification due to a significant focus in points through waste recycling, restoration of original materials, material selection from local manufacturers, as well as indoor air quality during construction. A LEED consultant was hired on this project during the design phase and retained throughout the construction period.

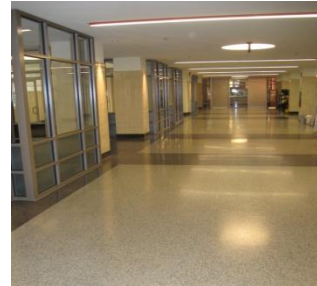
Stone

Popular throughout the Department of the Interior Building, black quarry stone is used from flooring transitions, to baseboards, to door trim. This historic stone was pulled from a quarry in DC in the early 1920's that is no longer in use. Somehow, a piece of historic stone that had been taken out for preservation was lost and needed to be replaced. Unfortunately no such local stone could match the historic one. In the end a close match was shipped in from a Tennessee quarry.

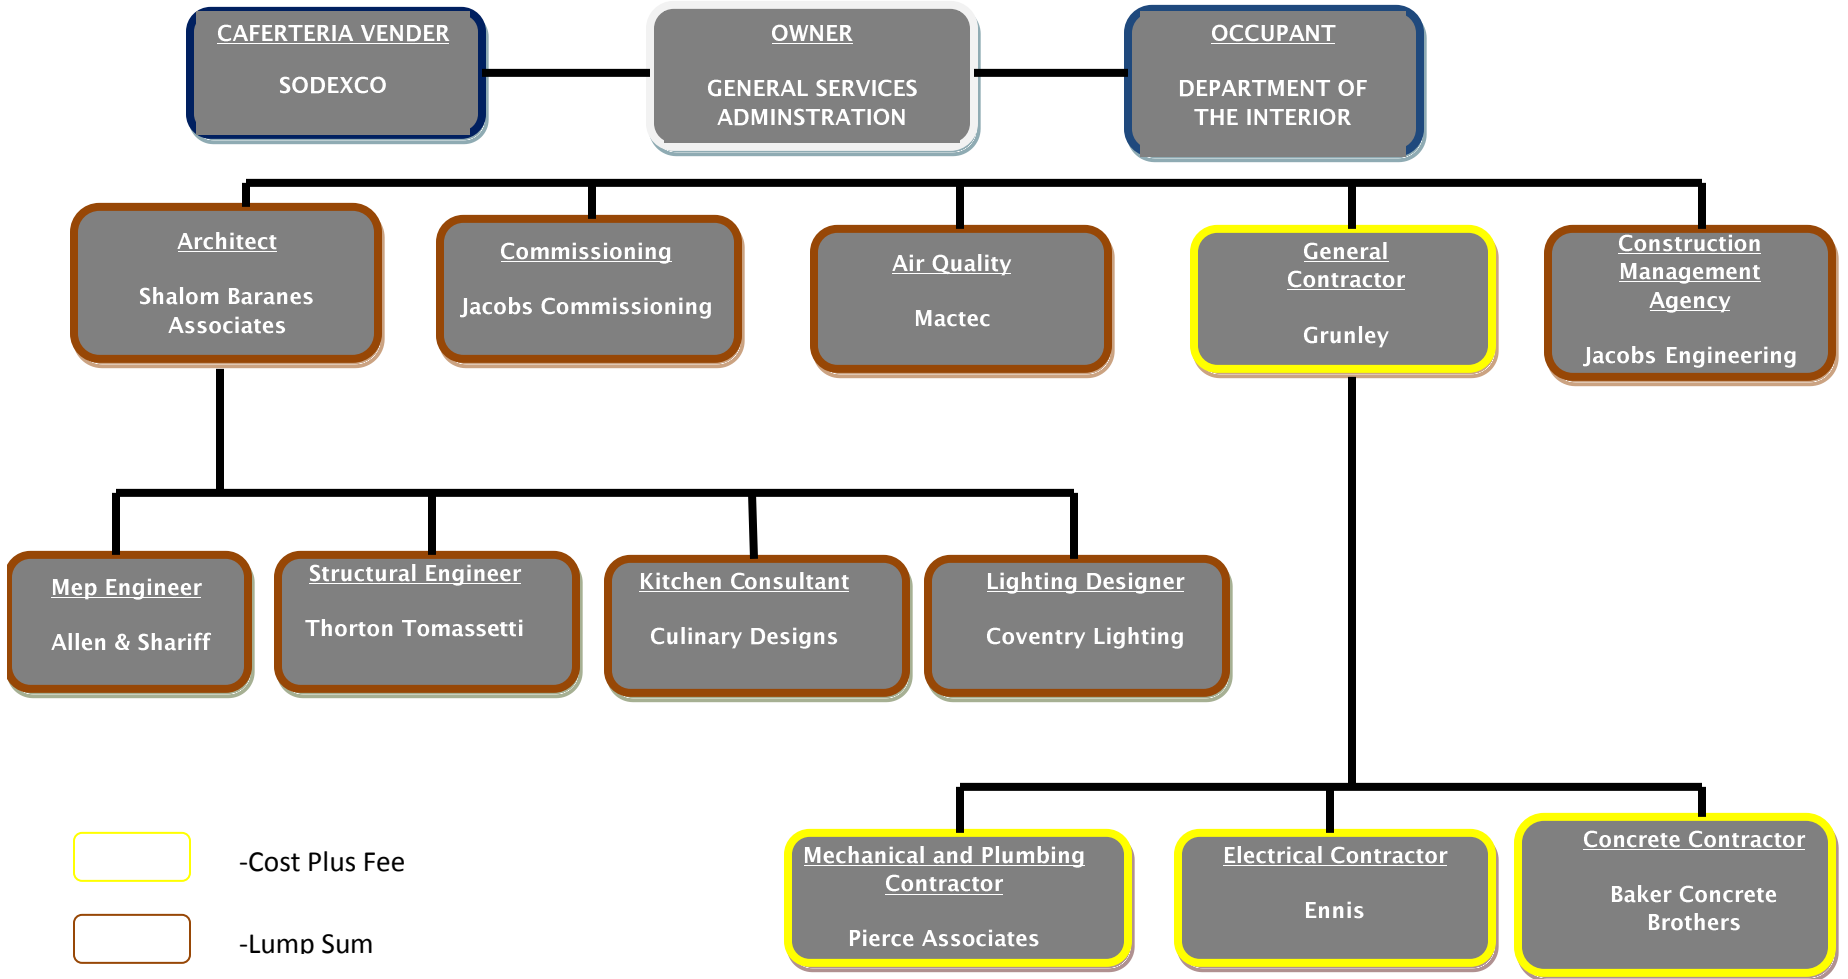
All design communication runs through Shalom Baranes Associates. Any RFI or submittal will come through them, and then passed down to the appropriate engineer or designer. All construction communication runs through Grunley. Grunley must follow government regulations for contractor selection (minority owned contractors, bidding process, bidding invitations, etc.). Any communication between the construction team, the design team, and the owner runs through Jacobs Engineering. Jacobs acts solely for the Owner's Interest and thus only holds a contract with the owner despite lines of communication with every party.

- Cost Plus Fee
- Lump Sum
- Tenant
