GOVERNMENT OFFICE CENTER
MID-ATLANTIC U.S.

TECHNICAL ASSIGNMENT 1

23 September 2011

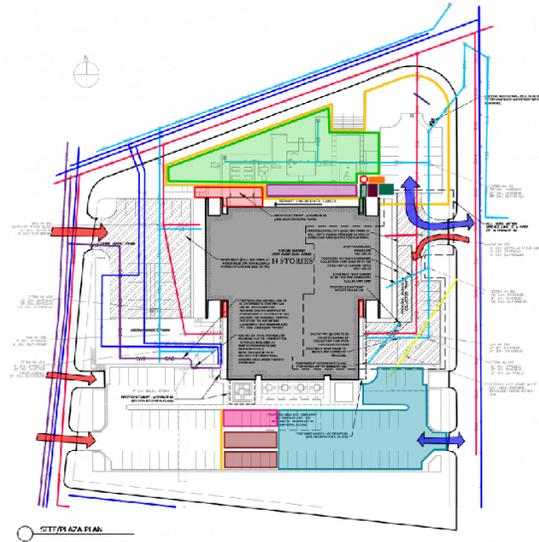
Given that this project is a major systems renovation of an existing structure, it is critical to note that the important aspects of the existing conditions of this project differ substantially from those of the construction of a new building. For example, the building is to remain fully operational during the demolition and construction phases of the project. As a result, a certain level of available parking is required on site, limiting available space for the construction management team to work with. Furthermore, there are existing roads that surround the project site, under which the majority of the existing utilities are located. Any connections to these utilities as part of the scope of work will require consideration of how to handle resulting traffic issues.

Also, it is important to note that the site plans do not distinguish between existing and proposed gas lines, but these lines can be distinguished due to the fact that the building currently has no natural gas connection. Therefore, the gas line connecting the building to the utilities under the road should be taken as the proposed gas line.

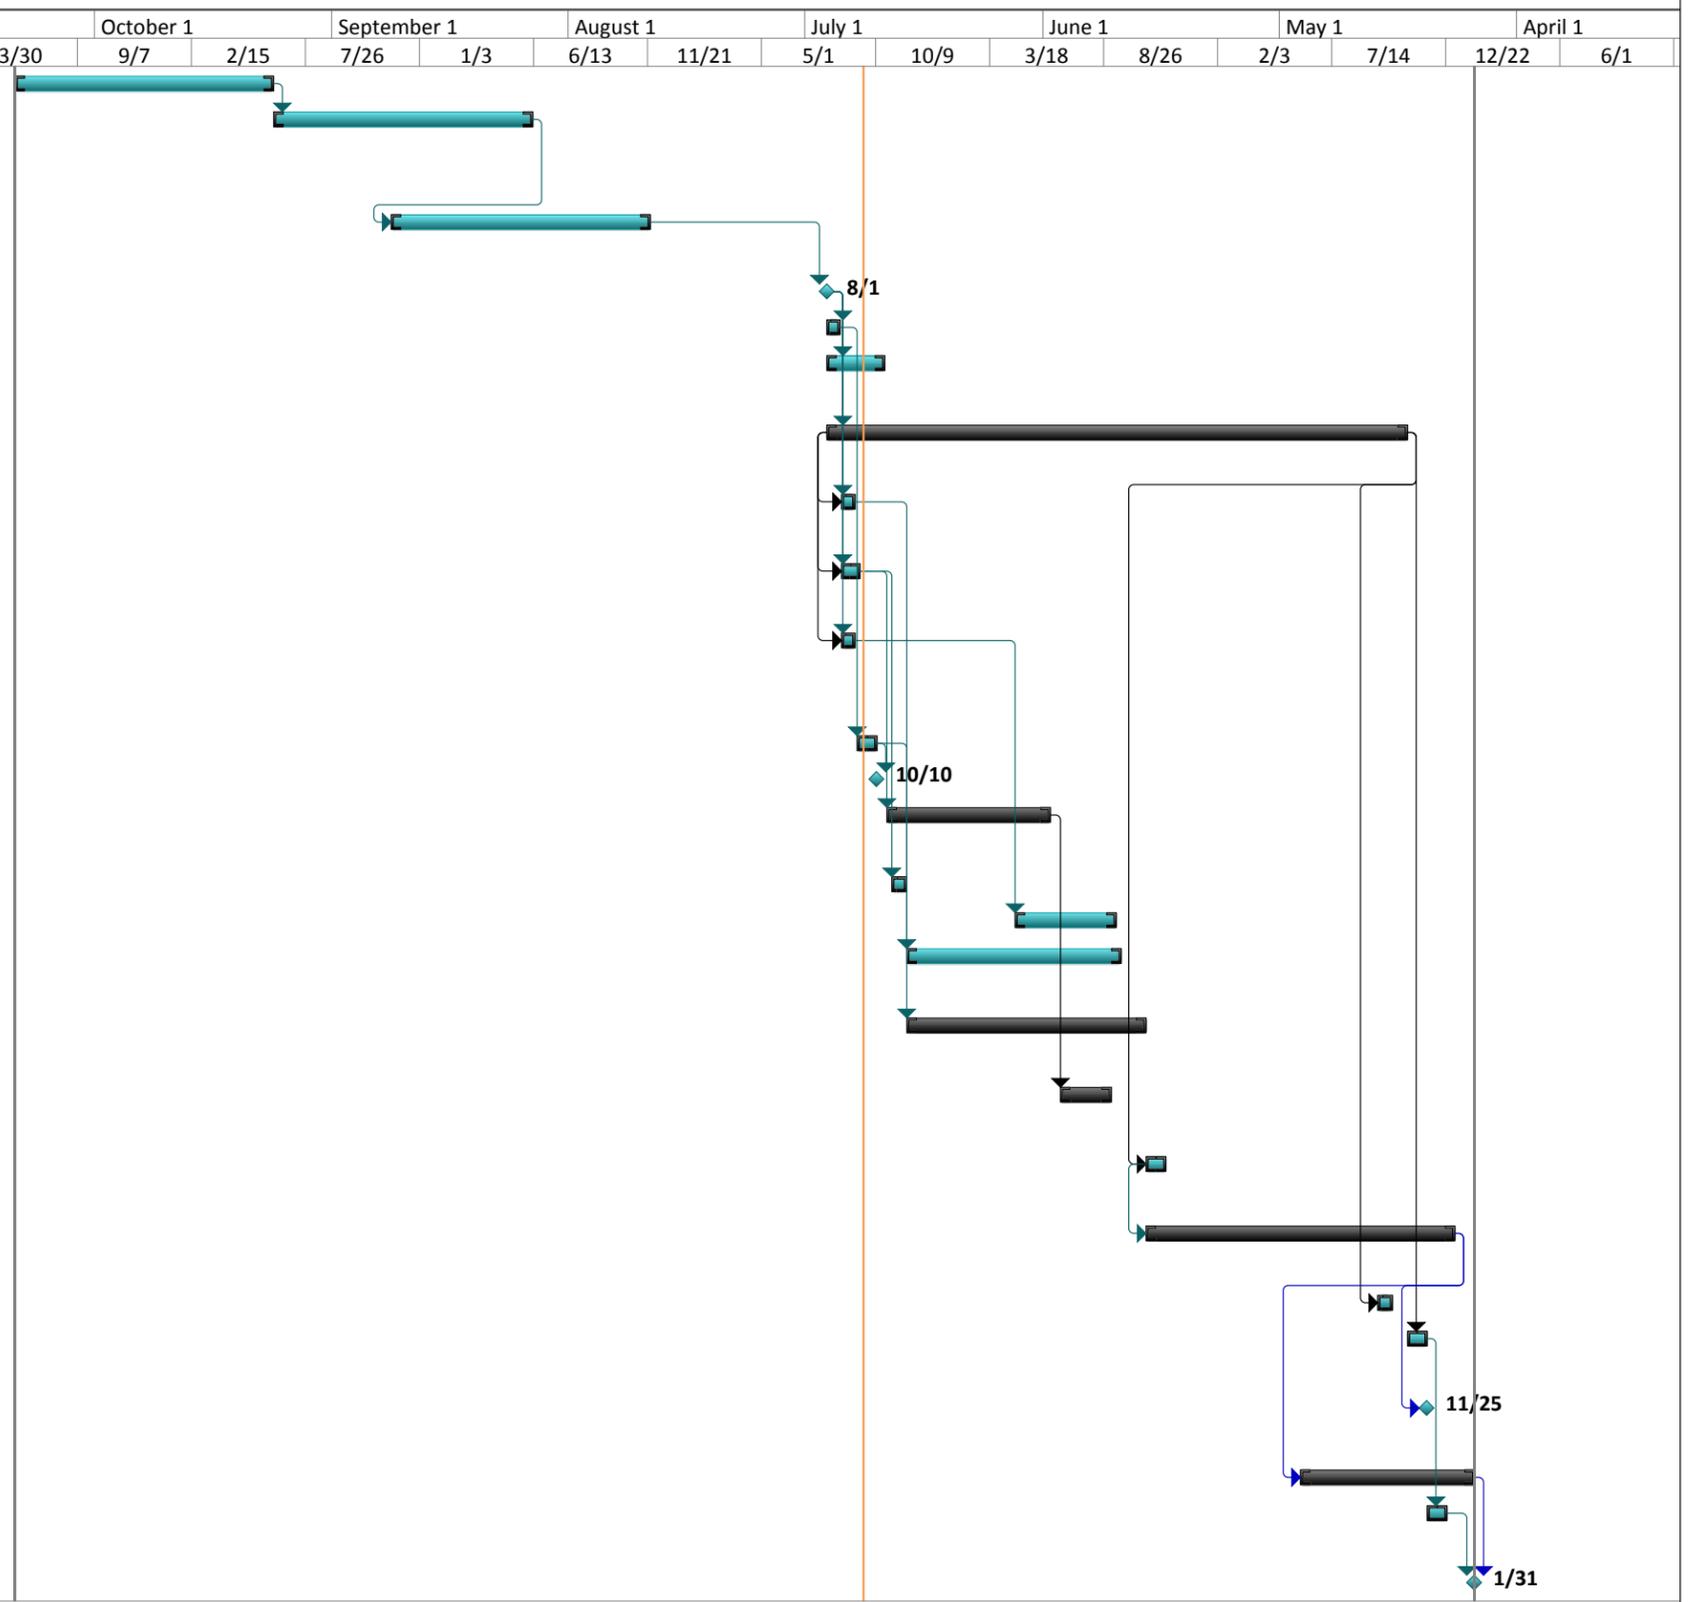
Project: Tech 1 Project Schedule S
Date: Thu 9/22/11

The project schedule is divided into six phases of work, which often overlap over the course of the renovation. The critical aspects of the renovation of the Government Office Center include the demolition of existing curtain wall and mechanical systems, followed by installation of new, more energy efficient systems to replace them. Construction activities begin with demolition of a section of curtain wall on the South building elevation to allow for installation of a temporary material hoist. Truss reinforcement on levels 9-13 will take place in October 2011. In late November 2011, renovation of mechanical rooms in levels 1 and 14 will begin. Demolition and replacement of the curtain wall on the North façade of the Government Office Center will take place between November 2011 and April 2012, while corresponding work on the South façade will take place between December 2012 and May 2013. Finishes in the North and South building areas will be installed during the five months following completion of their respective curtain wall renovations. The final major phase of construction work for the Government Office Center involves roofing renovation in August of 2013, reinforcement of the CMU walls in level 2 during October 2013, and installation of a photovoltaic panel array in September and October 2013.

Since this project is a fairly complex renovation of a government building, design and preconstruction services were critical in determining the feasibility of this project before commitment of substantial federal spending was made. Preconstruction services were awarded to the construction manager in late November 2009 and limited to a period of one year. Notice to proceed was given on August 1, 2011. The renovation and modernization of the Government Office Center is scheduled for completion on January 31, 2014.

A key scheduling concern for this project is the need to maintain occupancy during the entire construction period. Significant coordination must be in place in order to ensure that building occupants, files, and furniture are appropriately relocated to allow demolition and construction activities to take place while minimizing the impact on ongoing functions within the building.

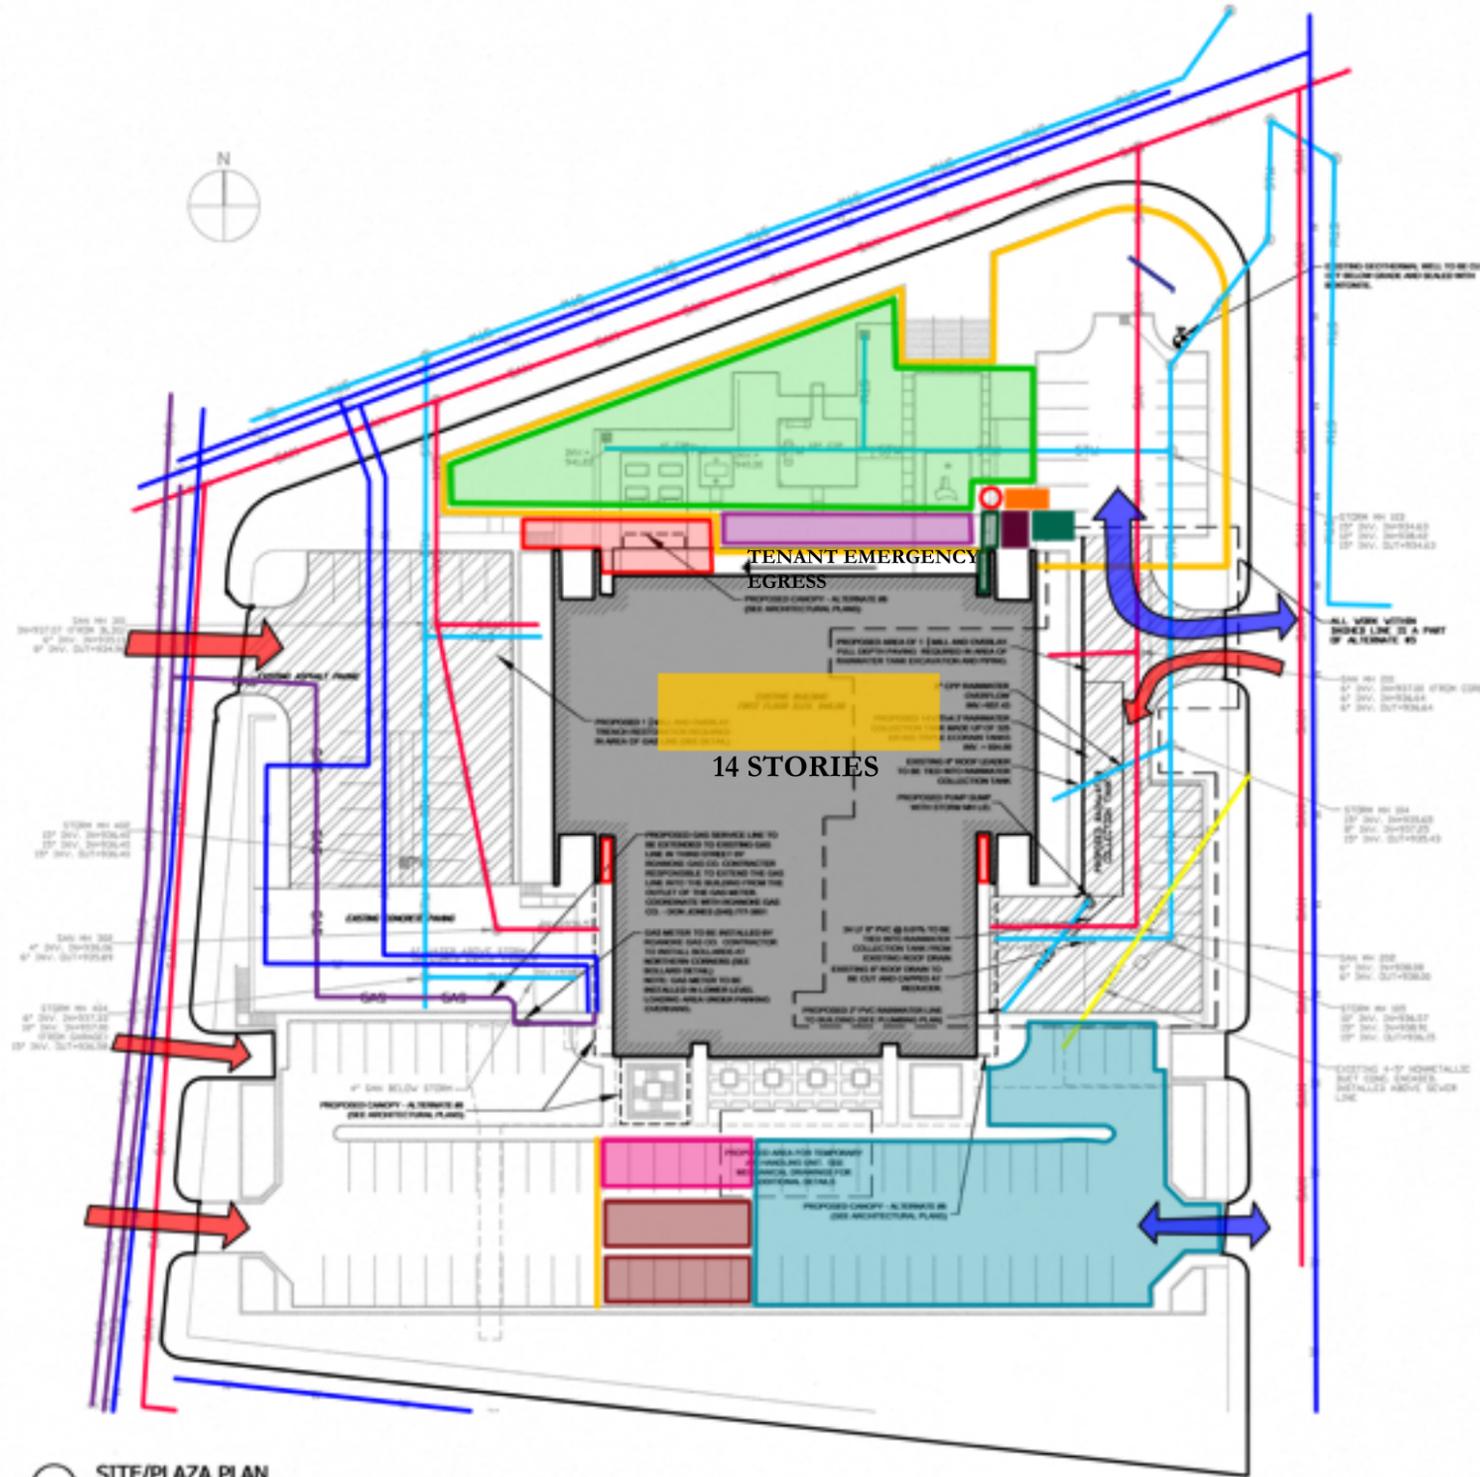
SITE/PLAZA PLAN

Note that the work involved in each phase presented is highlighted in orange to indicate demolition and replacement of existing building features, such as mechanical rooms (Phase 0), curtain walls (Phase 1A), and roofing (Phase 3).

This renovation project is being performed on a fairly constrained site. Using parts of the existing parking areas on site, the construction management team will place trailers, temporary air handlers, and material laydown and storage areas according to the needs of the project. The space is limited to the extent that there is no on-site parking available to the construction management team or the subcontractors.
