Susquehanna Sports Center | Harford Community College | Bel Air, MD

Senior Thesis Final Report

HAITHAM ALRASBI

ARCHITECTURAL ENGINEERING - CONSTRUCTION MANAGEMENT

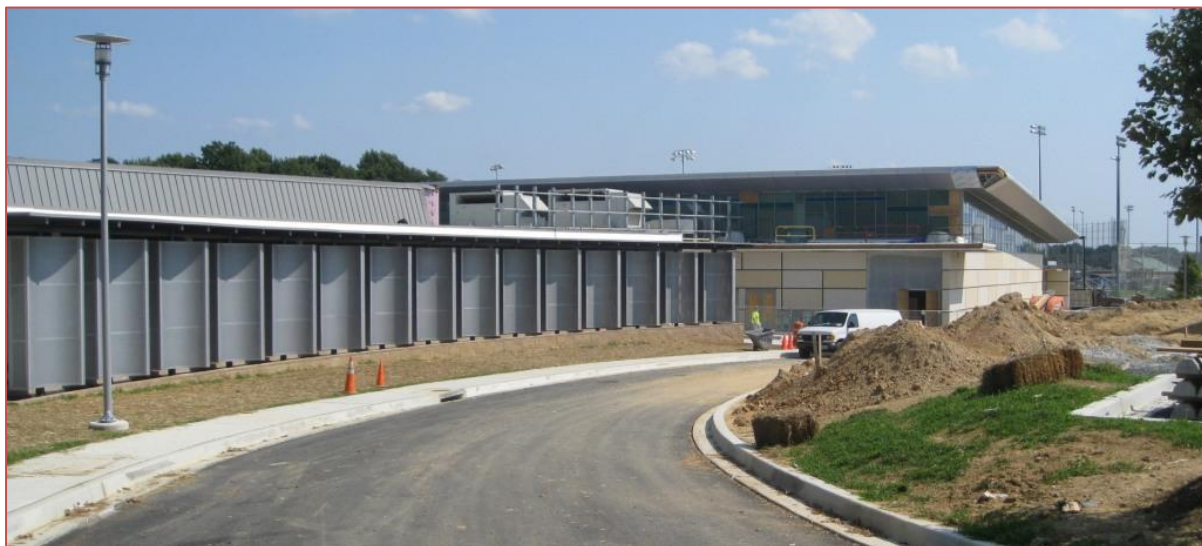
Figure 1 shows a view of both the renovation and addition parts of the project. The canopy of the façade is shown at the left and it extends till it reaches the basketball arena addition at the right, which has a greater height. The photo was taken during construction in early September.

The new addition has 153' steel trusses that span through the new basketball arena addition. Figure 1 shows that it has a beautifully designed curtain wall at the top portion of the walls, which increases the usage of natural light. The owner, Harford Community College, had a goal to make the campus more environmentally friendly and this is one of the projects that they had in their master plan. They were originally planning on getting Silver LEED certification for this project. However, the owner decided not to strive for it right before construction started, but still the environment is one of the main components to care about in this project.

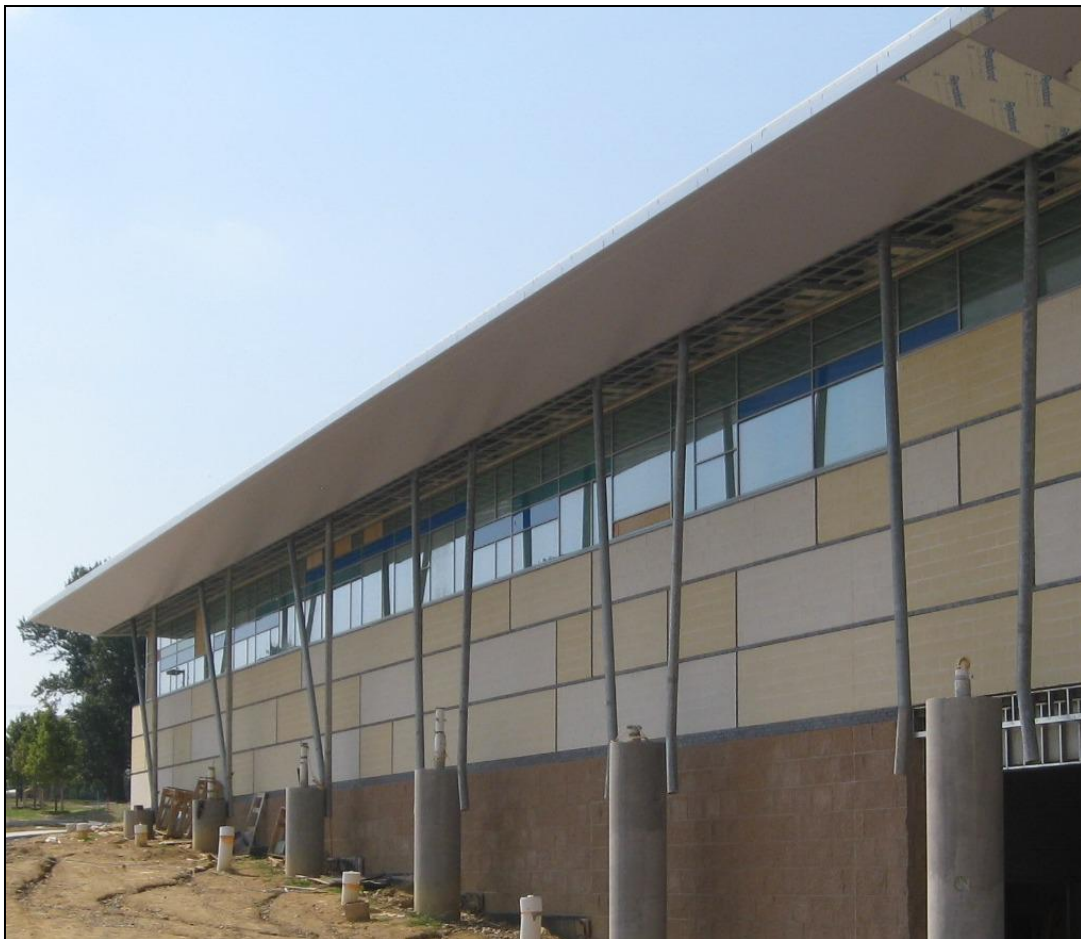
Figure 2: Drainage pipes along the south side of the basketball arena. The pipes create an architectural feature and functions as a roof rainwater collector.

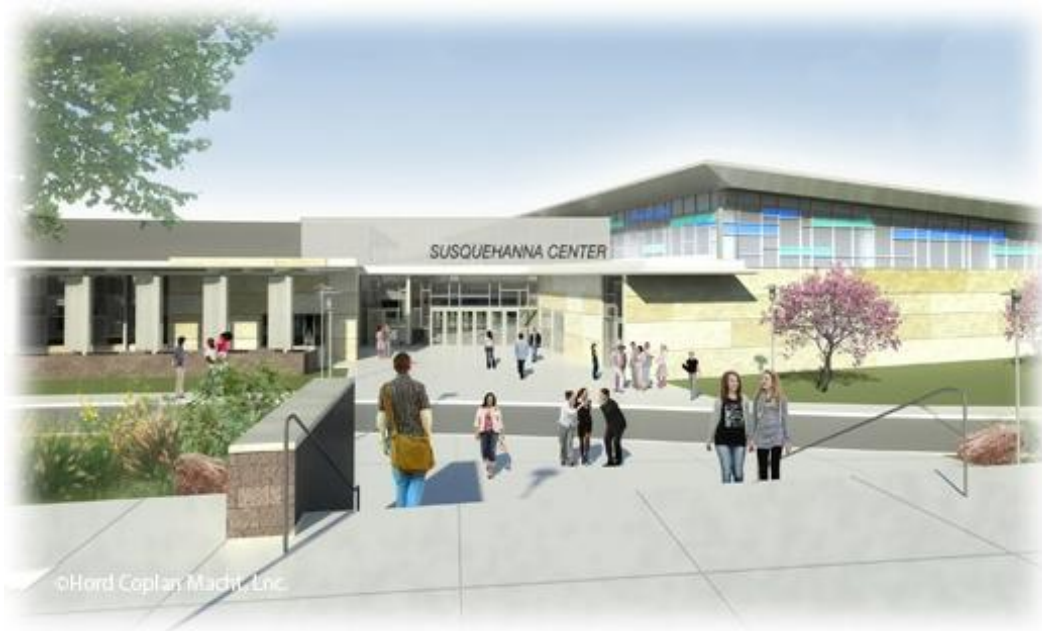
Figure 6: A rendering of the Susquehanna Center's facade

The renovation of the existing Susquehanna Center includes an updated and expanded fitness center with a new façade that provides filtered, natural, indirect light into the space. The administrative offices for the athletics department and physical education faculty and staff will also be upgraded. The existing gymnasium will be updated and retained as an all-purpose auxiliary gym with studios for martial arts, yoga, Pilates, and other fitness classes. The existing 25-yard swimming pool will be refurbished and fitted with new equipment and the athletic training facility, locker and team rooms will be renovated. The new construction includes a 2,500 seat arena with wood athletic floor, concessions, ticket windows, and public toilet rooms. The facility is designed to accommodate locally televised basketball games as well as large public concerts and events.

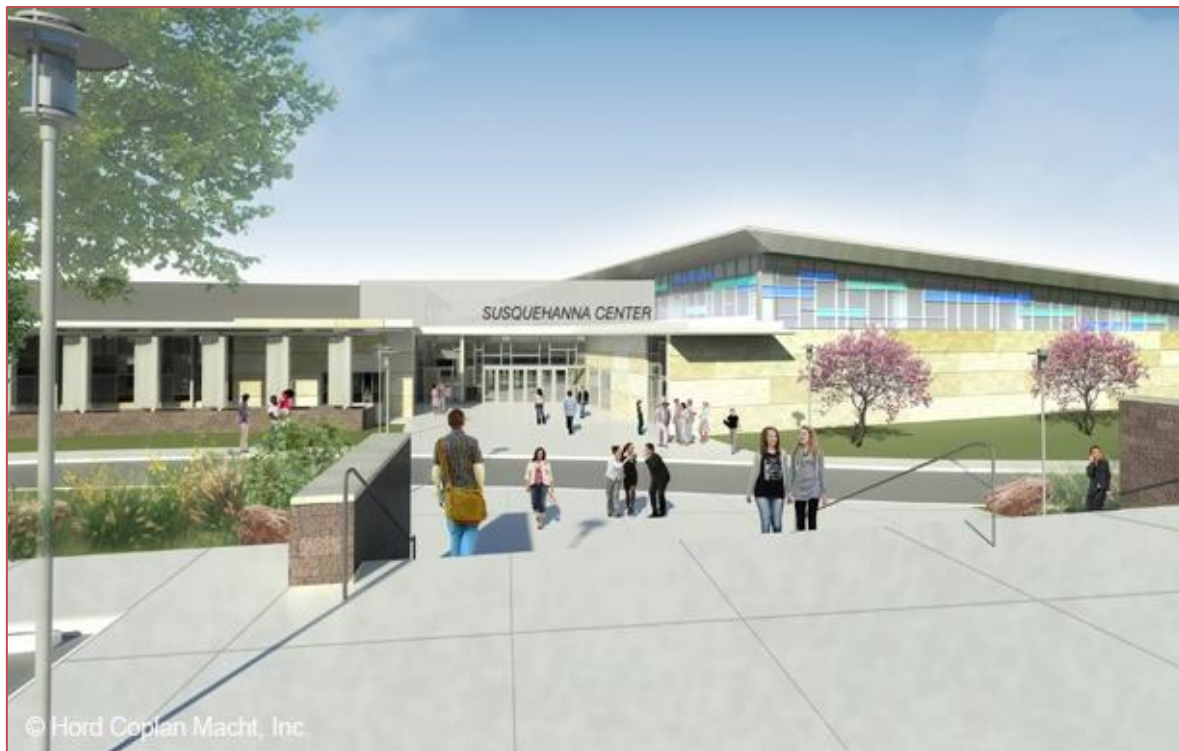
Figure 9. Rendering of the Susquehanna Center Project

Hord, Coplan, & Macht were the main architects for this project, therefore they designed the curtain wall. The Curtain wall is located above the arena masonry wall. A mix of blue, green, and clear insulated glass has been used along with 7" x 2 ½" aluminum curtain wall frames which creates this aesthetically pleasing look to the arena. It drops down to the entrance of the arena. The glass there is tampered to allow for doors to be installed.

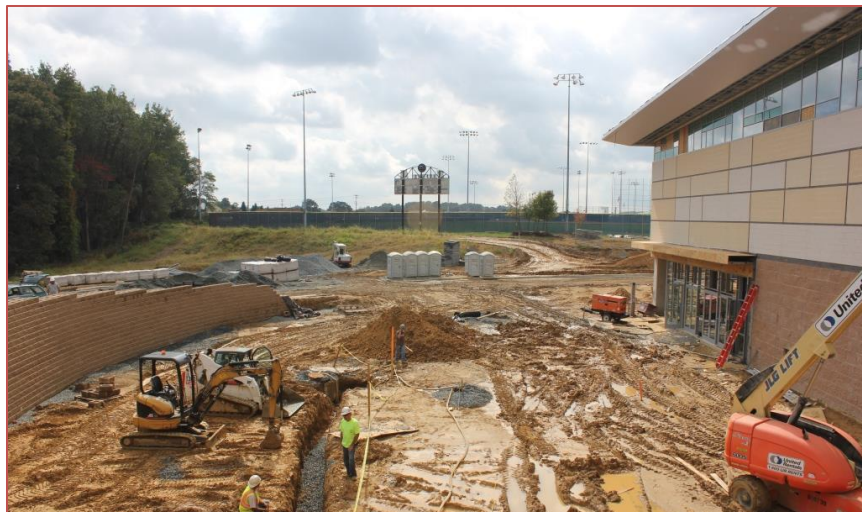
Figure 10: A picture of the back of the Basketball Arena where some landscape work is taking place. It shows that rain made the site muddy, which could contribute to discomforting the workers when maneuvering around. (Photo taken: September 28th, 2012)

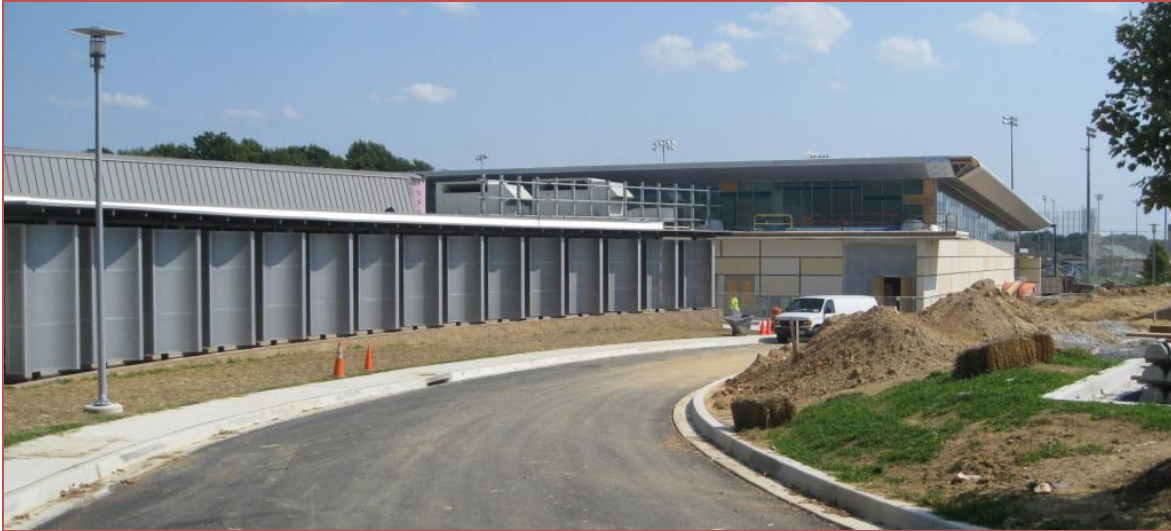
Figure 20: The current facade is shown in this picture at the left while the basketball arena is located right next to it in the far center.

The current façade avoids the entrance of direct sunlight to the fitness center because of the canopy that acts like an overhang. At the same time though, the fitness center benefits from indirect sunlight which is important there.

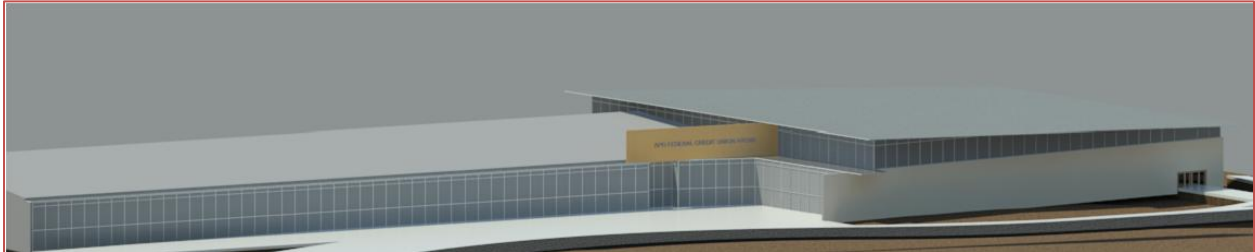
Figure 21: Design #1 Rendering

Figure 22: Design #1 Façade Outline

This is a view of the first design step where the canopy is removed and a straight curtain wall has been placed in place where the old brick wall used to be. This will save costs in both canopy construction and demolition for the addition part in front of the Susquehanna Center. This, though, eliminates a big part of the gymnasium area.

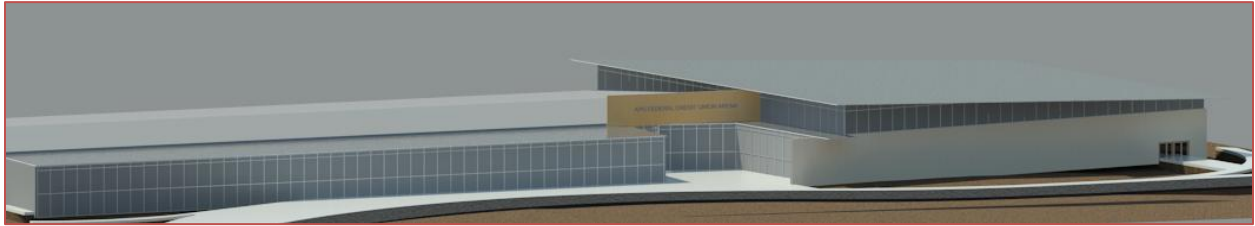
Figure 23: Design #2 Rendering

Figure 24: Design #2 Façade Outline

Design #2 fixes the problem that the first design had by adding into the gymnasium area. However, this makes like the gymnasium is kind of isolated and has a blocky look. It is not very aesthetically pleasing.

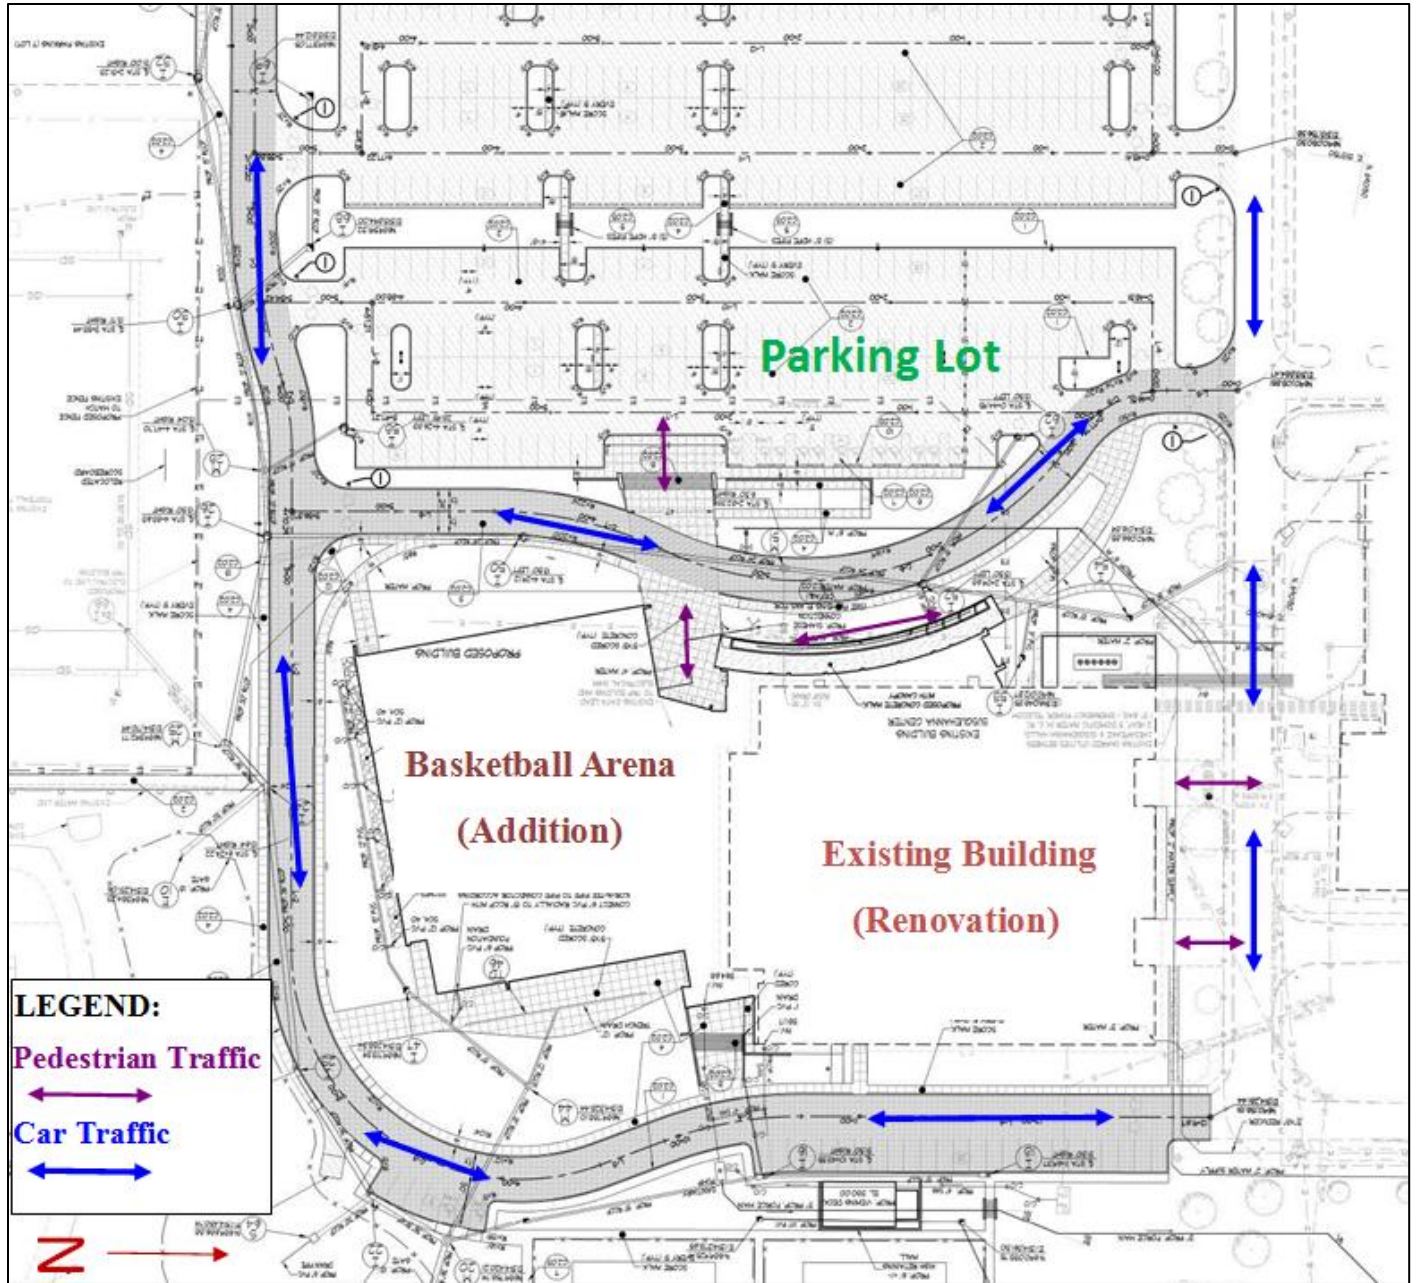
Pedestrian and Car traffic Site Plan

Pedestrian and Car traffic site analysis
