Technical Report II

The Office Building

Brett Miller

Executive Summary

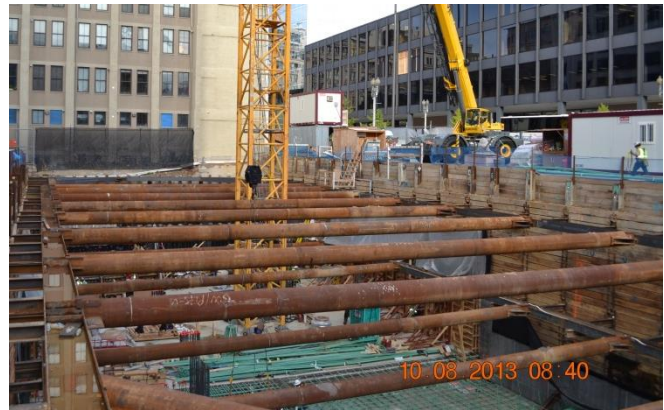
Figure 1. Installation of Mat Slab

Once the existing build was demolished, the crew could get to work excavating the soon to be parking garage. The use of cross braces (as seen in figure 1) posed some delays in the excavation. For this reason, the excavation stage lasted 95 days, starting on April 3, 2013 and ending on August 15, 2013.

With the wrap up of excavation in August, the structural phase was able to begin with the construction of the mat slab (as seen in figure 1). Between the substructure and the superstructure, the entire phase will last a total of 213 days. To shorten the schedule length, the next phase will start at the same time as the structure on level 7 on February 18, 2014.
