# Technical Report No. 2

**Silverado Senior Living**  
Brookfield, WI

The Pennsylvania State University  
Department of Architectural Engineering  
Construction Management

AE 481 – Fall 2013

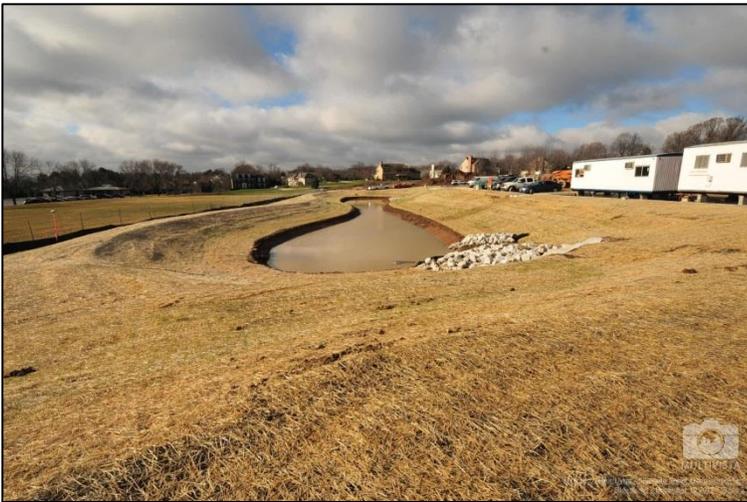
Figure 4 – Detention Pond

For this phase, the most critical task was the development of the construction sediment basin, located on the south of the lot, and the temporary diversion swales. The temporary sediment basin would ultimately become the detention pond. The property has to accommodate the storm water run-off from the adjacent lots to the north and north-east, so it was paramount to have completed. Also it was important to be aware of the close proximity of the water and sewer mains on the east side of the property even though excavation did not interfere with either utility main. Another major portion of this phase was stockpiling the topsoil so it could be reused. No hauling of topsoil or fill dirt occurred on this project, so any extra ground material

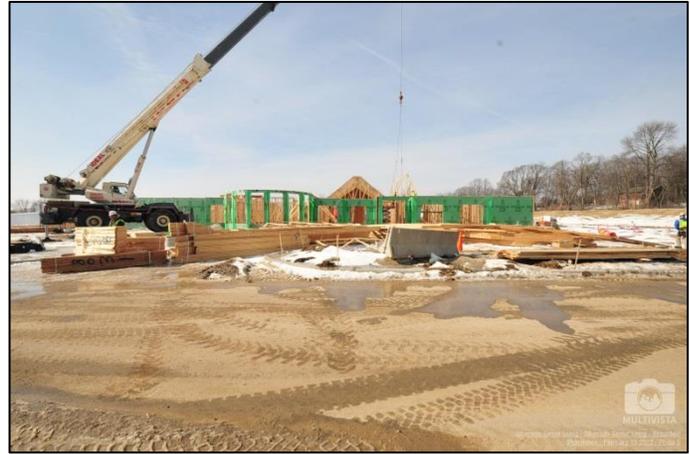
Figure 5 – Roof Truss Construction

The building was split up into four quadrants, and followed a B to C to D to A pattern. In this phase, the slab on grade was being poured in quad D under an enclosure to protect it from the winter conditions. While this was occurring, the shop fabricated roof trusses were being installed in quadrant B. This allowed these two

trades to work without interfering with one another. Truss storage and crane pick locations were located on the east side of the project near Davidson Rd. Concrete staging was on the opposite (west) side of the property next to the residential lots. Because the building surrounds a courtyard, a portion of quadrant B was left open so materials and equipment could be moved to the interior portions of the building. Also, at this point in construction, the slab has not been poured in quadrant A.

This was an appropriate site layout for this phase of the project because it expedited the schedule by allowing both concrete to be poured and trusses to be set at the same time. Concrete trucks could access quadrant D without interfering with setting the roof trusses. Hunzinger took advantage of a relatively open site and used it to stage the large, shop-fabricated roof trusses one quadrant at a time. The focus of this phase was pouring the concrete in the cold winter conditions. This took added effort to ensure the ground was thawed and the concrete had time to cure at the required temperature and humidity levels. By pouring the slab on grade in winter, Hunzinger was ultimately able to save several months in schedule and reach occupancy in the following September. Site layout details for this phase are located in Appendix C.

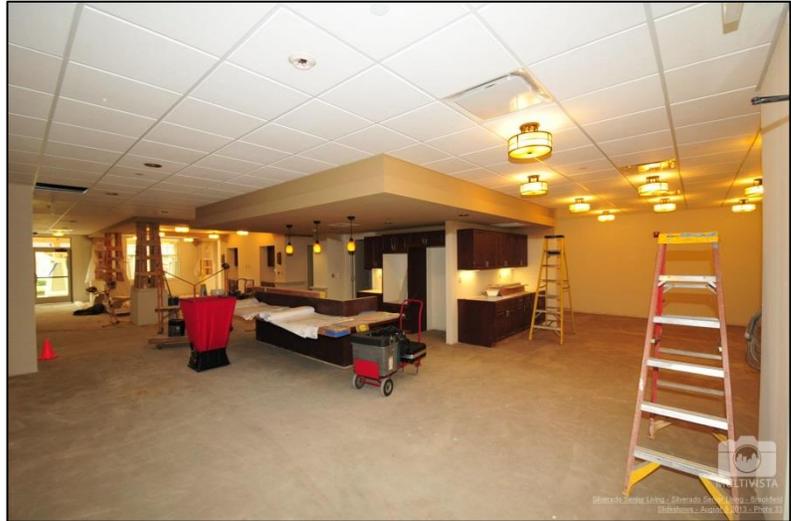
Figure 6 – Interior Light Fixture Installation

This phase required more coordination than the excavation and SOG/Roof Truss phases because of the large number of subcontractors involved. The opening in quadrant B to the courtyard was closed by this point. Many different subcontractors were on-site during this phase, so it was critical to keep them from interfering with each other. Each sub was allowed to stage materials in their respective quadrants which meant they could easily access their building supplies. Electrical and HVAC finishes were working in quadrant A. Behind them was case work and floor/carpet installation in quadrant D. Plumbing finishes was halfway through their work in quadrant C and painting finishes had just begun in quadrant B.

The most critical aspect of this phase was managing the subcontractors in a manner that was efficient and reduced complications in the field. Staging for each trade in their respective locations was critical because many would need to frequently move materials in and out of the building. Also, dumpsters were located by each quadrant to help keep the site clear of waste materials. A site layout for this phase can be seen in Appendix C.

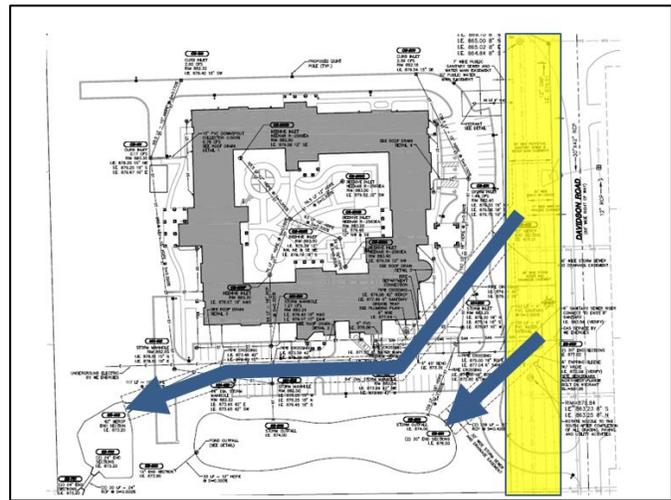
Figure 7 – Storm Sewer Location

Originally, the lot was a field that allowed water run-off to drain to the southern portion of the lot. Since the prospective senior living facility would interfere with the natural slope of the property, two temporary diversion swales had to be installed during the Phase 1 of grading and erosion control. These drained into a temporary construction sediment basin which would ultimately turn into the permanent detention pond.

Once the property was graded according to plan, two storm sewers had to be put in to allow the water run-off to drain into the detention and retention ponds.

These are illustrated by the blue arrows in the figure above. All water discharge needed to be directed toward the southwest corner of the site. Both ponds were designed to withstand 100 year storms. The image to right shows the primary storm sewer leading into the detention pond.

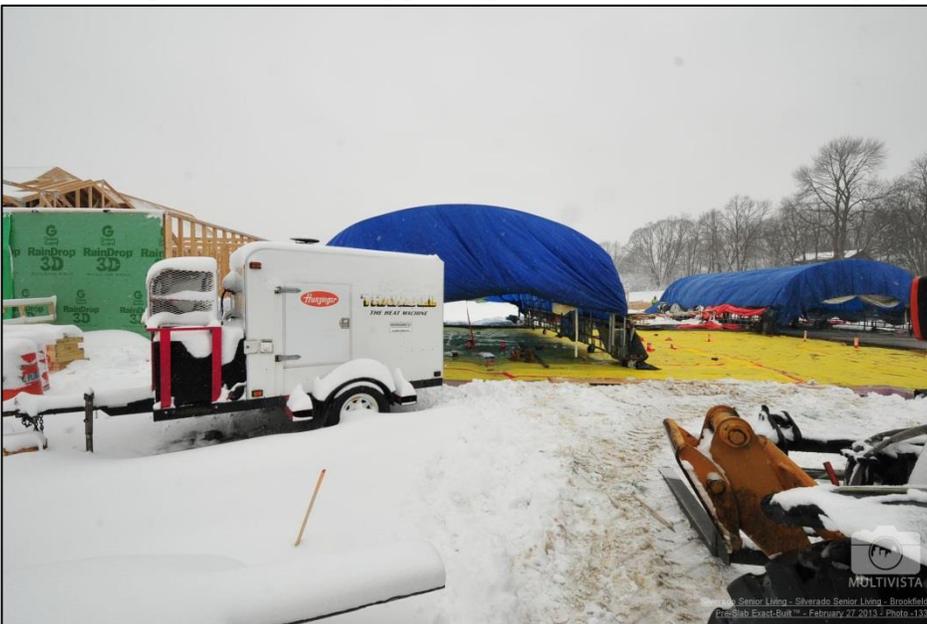
Figure 9 – Cold Weather Concrete Placement

One section was poured under one enclosure at a time, while the next section was being thawed. The typical process involved delivery by truck and ultimately

placed in the correct location by buggy. Once the entire section was poured, the tent would remain for an additional two days to allow the concrete to cure and protect it from freezing. Hunzinger used heaters to maintain the temperature inside the tent and vented flue gases to the outside of the enclosure.

In addition to completing the civil work first, the slab on grade needed to be poured during the winter in order to maintain the desired schedule and avoid a muddy jobsite in the spring. Because of the harsh winter conditions in Wisconsin, this meant that extra measures were taken to ensure the concrete work was done correctly. All snow, ice, and frost needed to be removed from the surface and the subgrade was then thawed under the temporary enclosures that were furnished by Hunzinger who self-performed all of the concrete work.

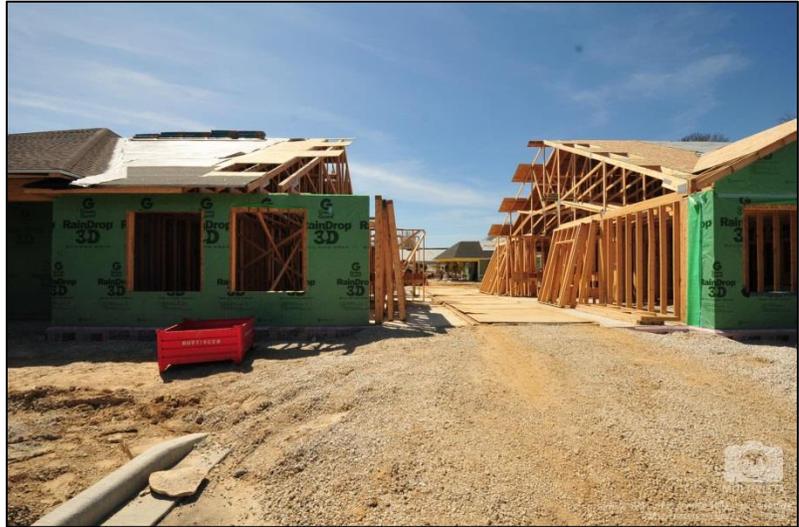
Figure 10 – Opening Leading to Courtyard in Quad A      Courtesy of Hunzinger

The Silverado Senior Living Facility contained an interior courtyard by design which meant that there was a façade on the exterior side of the building as well a façade on the inner portion. In order to get materials to the interior façade, a section of quadrant A was left open. This allowed the equipment and supplies to be moved from staging to final installation locations without disturbing interior construction in the rest of the project. Also, because the major mechanical equipment was located on interior portion of the roof, leaving an opening made installation much simpler.

Sleeping unit facing the courtyard were served PTAC's, which were delivered to their final locations through the opening as well. The courtyard also contained trees, a pavilion, and a putting green, so it was much easier to move equipment and materials through the opening than to plant the trees when it was still too cold out or drop lift them into place by crane.
