Environmental Studies Lab: Expansion

Codi Shine
Tech Report 2
Dr. Anumba
10/16/2013

Executive Summary

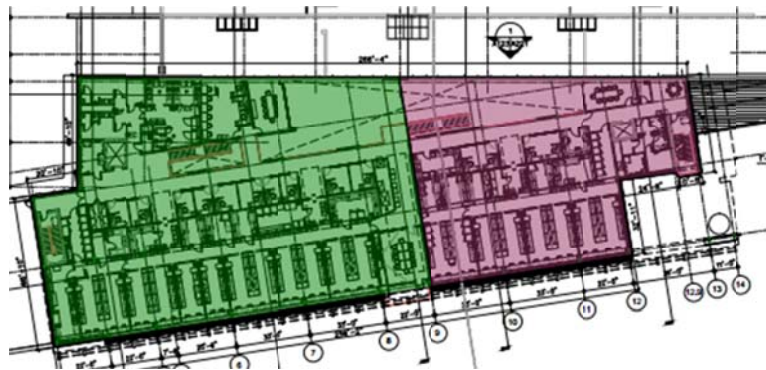
Figure 1 Sequencing

For easier, more manageable construction, the construction was phased into sequences that broke up the building into two sections: S2 and S3. S2 is the east side of the building (green) while S3 was the west side (purple), as shown in **Figure 1**. The basement was only in S3 while the penthouse was mainly in

S2, but entered a little bit into S3. The construction on the inside went from west to east while some of the outside construction went east to west. This may have been because certain subcontractors could finish an area without needing to wait on another subcontractor to finish first.

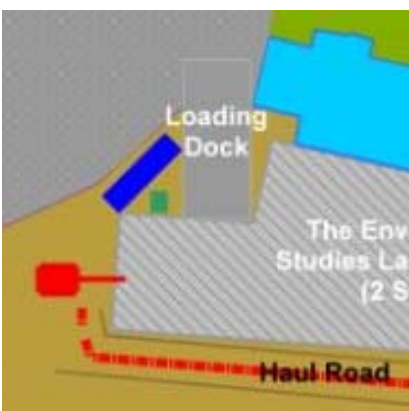
Figure 7 Superstructure Site Plan

The next critical phase of construction was the superstructure. There were two crawler cranes on site for this phase. One crane was for steel and the other was for concrete.

The site only needed crawler cranes because it is only a two story building with a mechanical penthouse, **Figure 7**. Since concrete started this phase, there was a concrete washout area needed for the concrete trucks after a pour. The laydown area was extended and another entrance was added. This is because more subcontractors are starting to come on site in this phase and they need the space for their materials. There was also a loading dock added to the northwest end of the building. In order for the deliveries to get back there, they must go around the existing building. The soil from the excavation was moved to the edge of the site into stockpiles.

Since the site is accommodating wetlands, the general contractor made a pond for the water to runoff into which runs off into a bigger body of water. There is an area of sediment rocks next to the pond that the water runs over. This is to collect any extra unwanted particles in the pond.

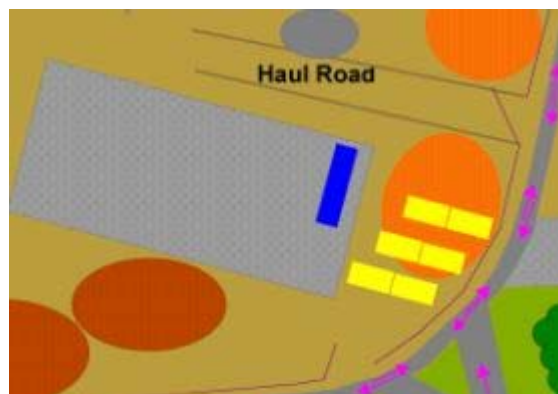
Figure 8 Finishes Site Plan

The final critical phase for this project was the finishes phase. In this phase, more of the site work itself was being developed and work had shifted to mainly inside the building. A parking lot was added for the subcontractors since there was need for different subcontractors. The haul road was moved more south of the building because construction started on the site, **Figure 8**.

There were concrete weir walls being poured on the site to assist with wetland runoff. Most of the construction traffic would enter through the southeast entry way, however when the entry porch was being poured, traffic had to be directed to the loading dock area. This lasted the day of the pour and then foot traffic went back to the front entry porch.

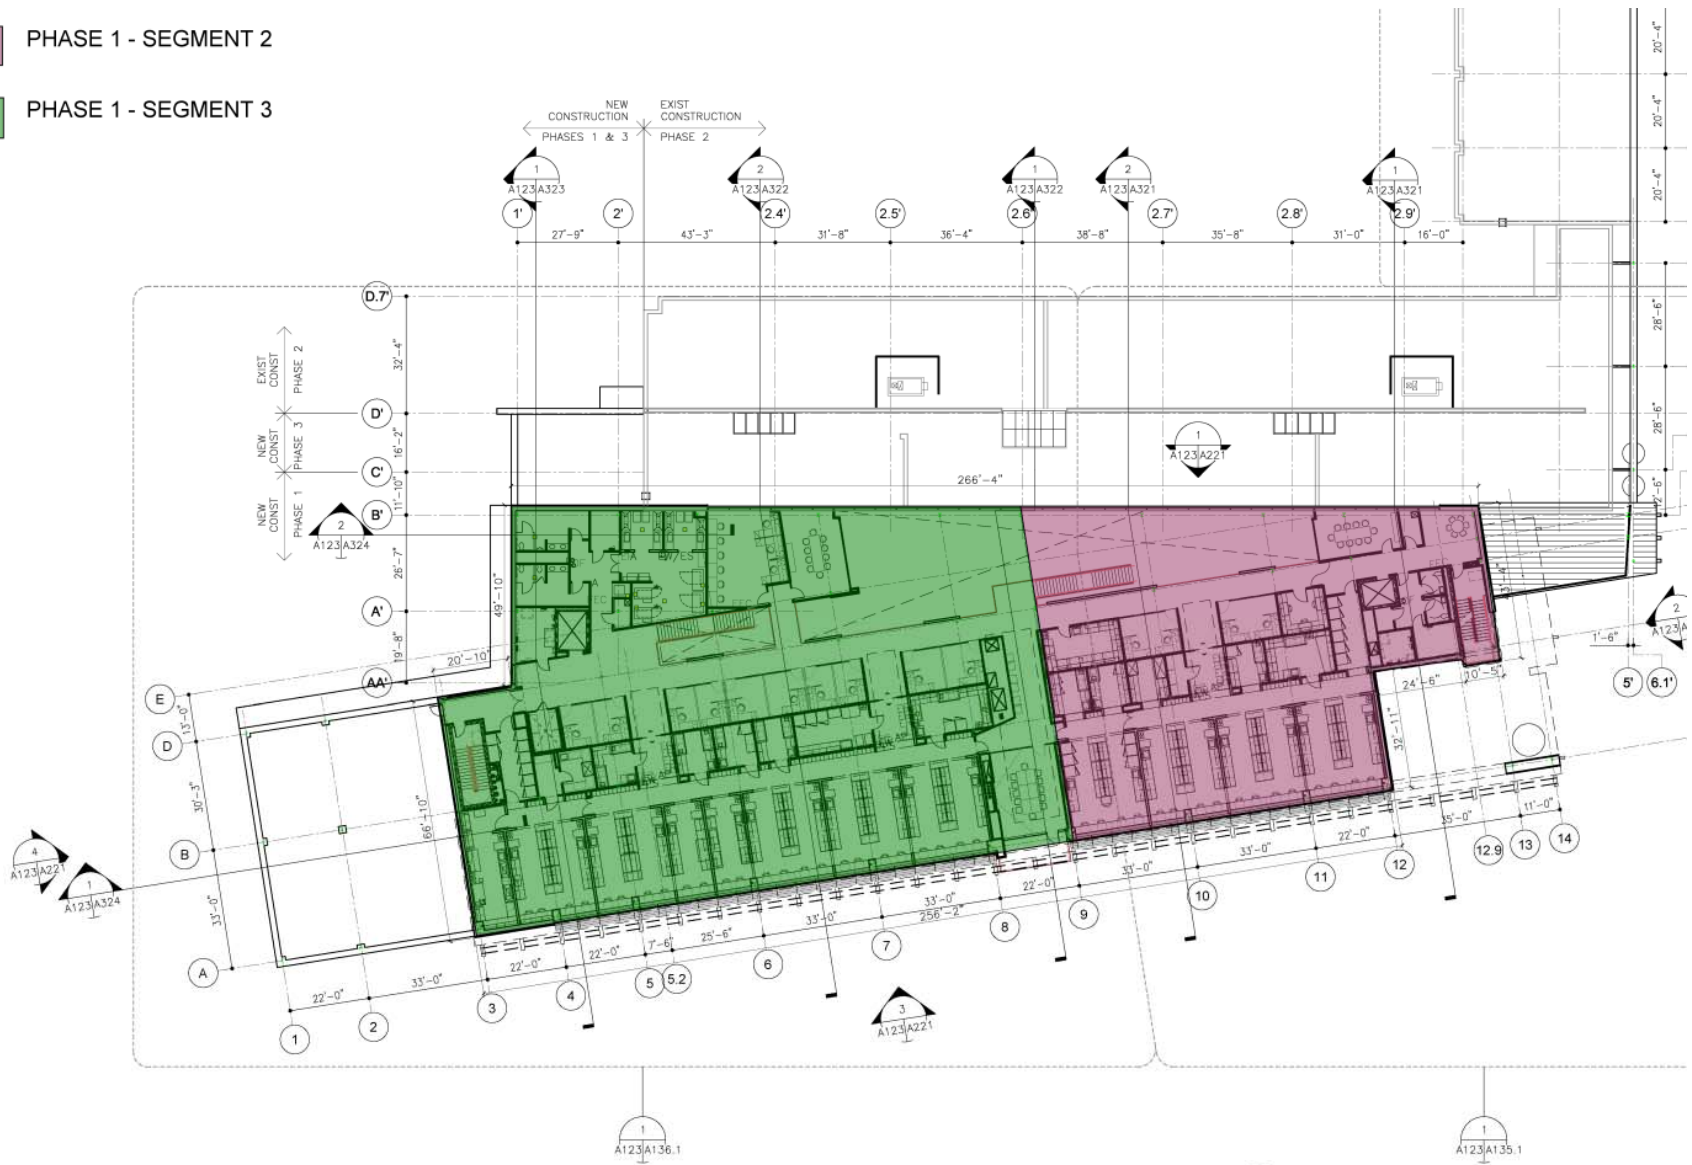
1
A123 OVERALL SECOND FLOOR PLAN - NEW WORK
1/16" = 1'-0"

PHASE 1 - SEGMENT 2

PHASE 1 - SEGMENT 3
