FINAL REPORT

OFFICE/RETAIL BUILDING
WASHINGTON, D.C.

Office/Retail Building - Washington, D.C.

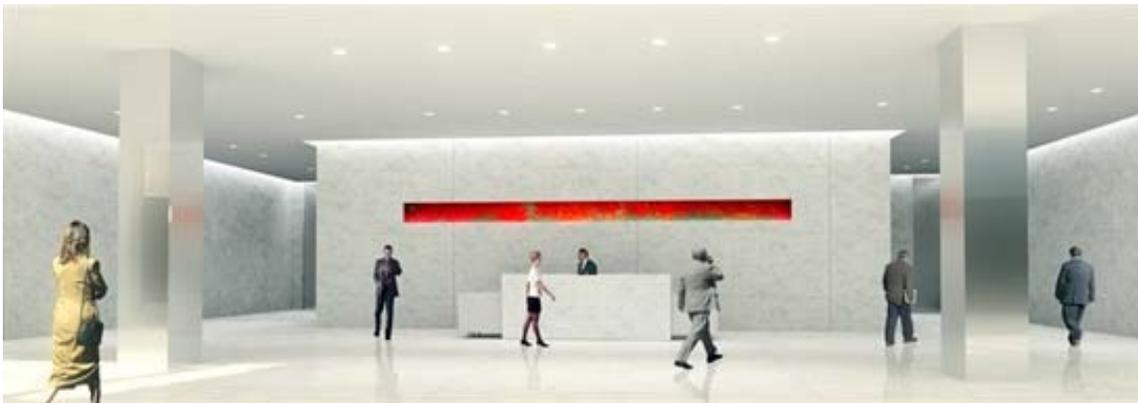
New Entrance Lobby

This existing downtown 10-story office/retail building was fully-renovated with a new façade and state-of-the-art building systems. Located at a street corner of the D.C. business district, this newly developed design prominently sets itself apart from its surrounding buildings. The new “skin” of the building features a glass curtain wall system with white metal panels on the two sides of the building facing the street, which replaces the existing strip windows and brick façade. The floor-to-ceiling glass provides office tenants plenty of natural light along with landmark views of our nation’s capital. This vertically configured design also consists of a new monumental roof cornice to add to its architectural stature. Other new features include an entrance canopy, rooftop terrace, and an enhanced retail storefront at street level. The building footprint is shaped like an “L”, which allows space for a private courtyard in the northwest corner of the site. The new glass vestibule on the east side of the building leads into an elegant lobby area highlighted by Carrara Italian Marble panels with luminous wall panels running along the perimeter.

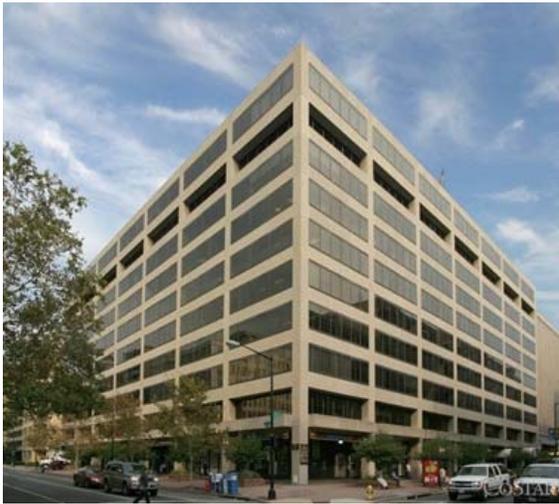
Existing Building

This urban project is pretty standard as far as typical city restrictions on construction. The allowable work hours were 7:00 AM – 7:00 PM, Monday through Saturday. The office/retail building sits at the corner of two busy one-way streets in a developed city block, making it hard to access and providing minimal lay down and delivery space. Aside from the new elevator pit, the soil/subsurface water condition was not really a factor in this case since the building was existing. The methods of construction were typical for a core and shell office building renovation of its type, as employed by many commercial developers throughout Washington, D.C.

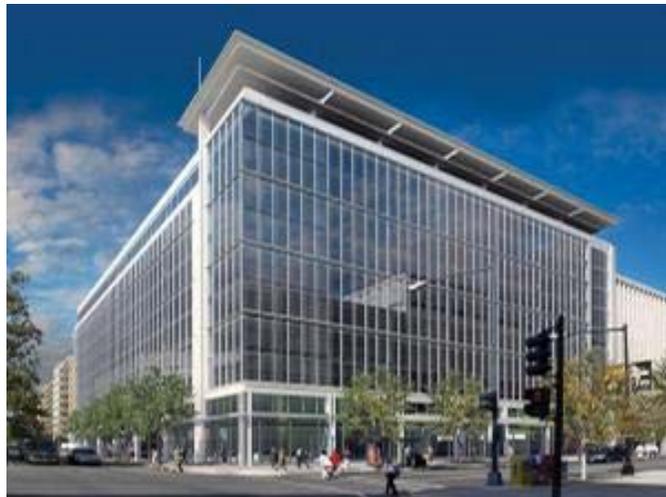
New Construction

The new "skin" of the building features a glass curtain wall system with white metal panels on the two sides of the building facing the street, as well as a portion of the west side. This replaces the existing strip windows and brick façade, vastly improving the supply of natural light to the office tenants and providing landmark views of the city. The two-story high glass panels were put into place by a crane, starting at one end of the building and making its way across to the other side. The curtain wall consultant, WJE, was selected to take the design responsibility. Harmon, the curtain wall contractor, made the necessary in-field modifications to properly erect the panels. The remainder of the building envelope consists of existing brick veneer over metal stud framing surrounding strip windows.

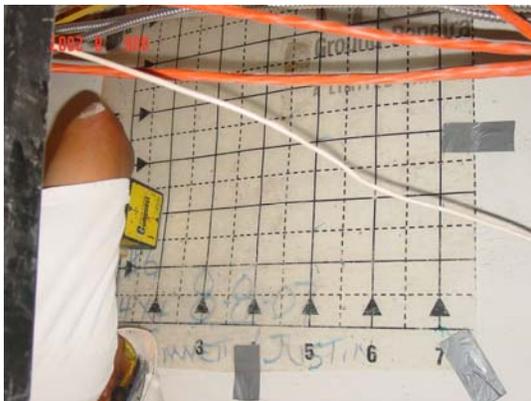
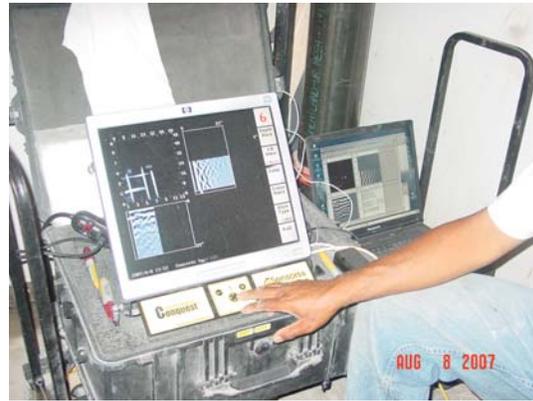
Scanning for existing reinforcing bar – slab penetration submittal process

For this renovation project in particular, a few issues arose that are unique to its type of development. During the interior demolition process, problems came up that significantly delayed the construction schedule. Since demolition was on the critical path, and no work could start before the interior walls were correctly gutted, a careful plan and assessment had to be done. In this case, there was confusion with the demolition contractor's scope of work, which in turn caused the project to not meet important milestone dates. Other schedule delays were caused by the quality of the existing building and the extent of required testing and repairing that turned out to be more than anticipated. This was particularly evident when hydro-testing the new strip windows turned up numerous leaks in the existing flashing system resulting in costly repairs. In addition to the selective demolition and flashing issues, the excessive number of core drilling submittals also produced some delay in schedule. The process for this particular submittal package included scanning for existing top and bottom reinforcing steel for each proposed penetration in the existing slab (see pictures below) and submitting a picture to the structural engineer for his approval. This process caused several time delays, as issues would inevitably come up requiring either new or relocated slab penetrations to be made right away. This could not be done until the contractor properly documented the area in question as a submittal to the structural engineer, who routinely took a couple weeks to review and return for approval.

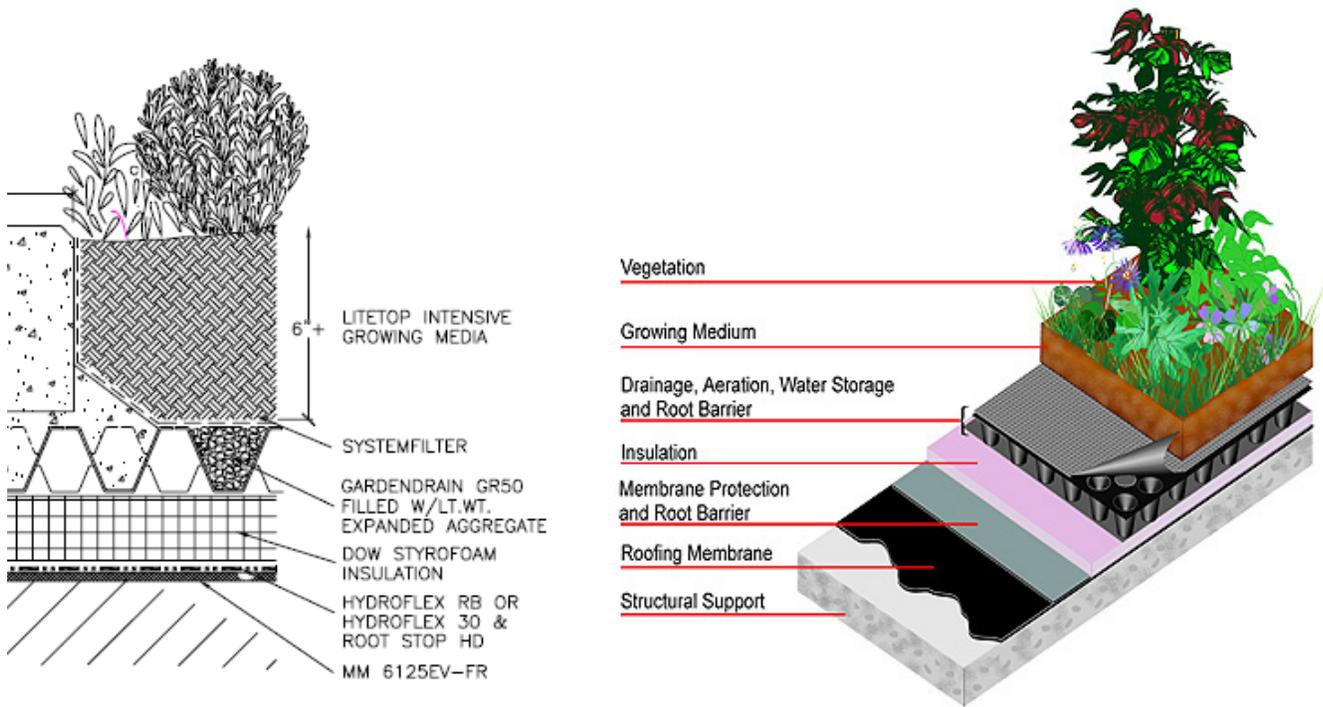
Since the office/retail building renovation was designed for a more interactive rooftop, the proposed green roof assembly was chosen to be an intensive system. To incorporate an intensive system, the depth of the growing medium should be minimal to reduce the cost of further structural support, yet deep enough to maintain flowers and small shrubs. The manufacturer Hydrotech seemed to have a quality intensive green roof system with an overall light saturated system weight (45 psf) compared to the others researched. The system layers and components are listed below, in order, starting from the top layer:

- “Intensive” Vegetation (perennials and shrubs)
- Litetop Growing Media (8” depth)
- Systemfilter
- Gardendrain GR50
- Aggregate (lightweight)
- Styrofoam Insulation
- Rootstop HD and Hydroflex 30
- Monolithic Membrane 6125 EV-FR
- Surface Conditioner
- Substrate / Structural Support

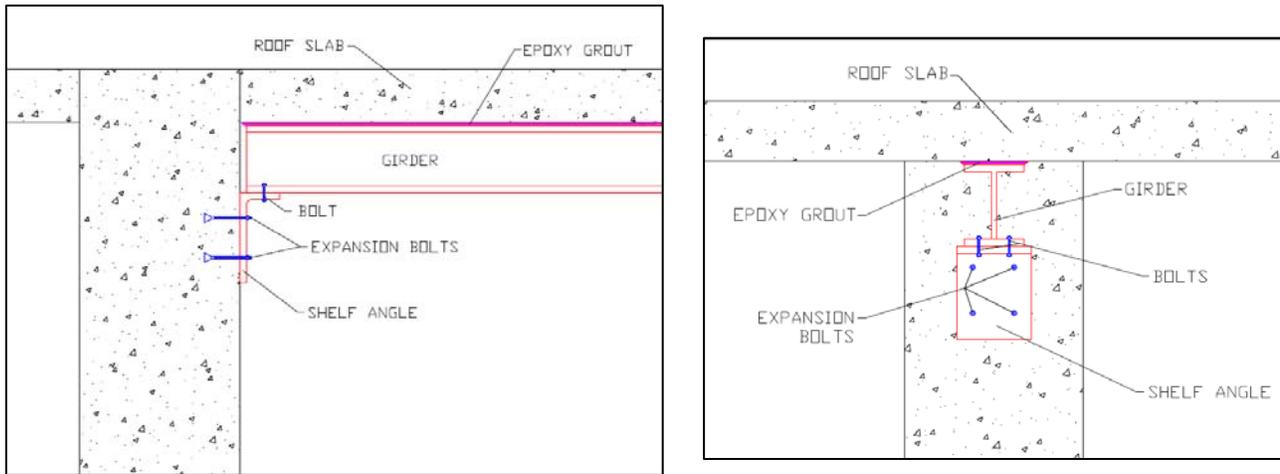
The girders are tied into the existing concrete columns with support provided by shelf angles, which are connected to the columns using expansion bolts. It is important that the existing reinforcing bar is not struck while bolting the shelf angles into the existing columns, as that may result in negatively affecting the structural integrity of the building. This type of connection, as compared to using double angle connections from the girders into the columns, allows for much more flexibility with the position of the expansion bolts to not impact the existing rebar. Also, epoxy grout is placed in the space between the girders and existing slab to tie the support system together. The top of the next page details two different section views of the shelf angle connection that ties the girders into the existing concrete columns.

Section views of shelf angle connection

Steel beams are run perpendicular to the girders, and spaced at each girder end as well as at the midpoint. Similar column and slab connections as the girders are used for the beams. Please reference Appendix J for the hand calculations of sizing the beams and girders involved in the retrofit. The W18x steel beams around the perimeter of the area of the retrofit in the new structural drawings tie into the green roof support system and do not need resized to support the adjoining beams and girders. The beams are connected to the girders with bolted single angle connections. Using Table 10-11 “Bolted/Welded Single-Angle Connections” of the AISC Manual, these angle connections are sized to be L4x3x3/8, with two bolts spaced vertically and a 5-1/2” angle length.

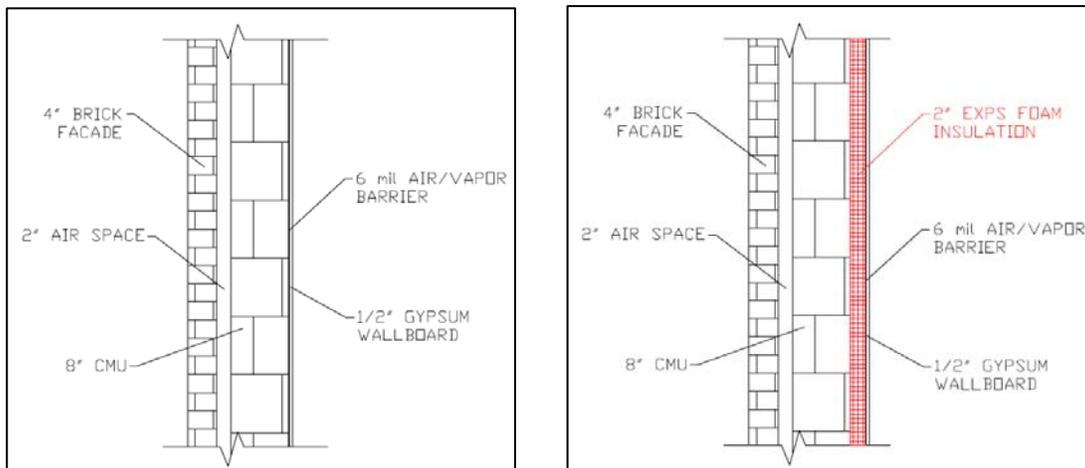
For the newly proposed building envelope system, a two-inch layer of extruded polystyrene (EXPS) foam insulation was added on the inside of the CMU block wall for the north and west façades. The diagram below shows this proposed addition to the wall as a typical section cut out of this area, with the EXPS foam insulation layer labeled in red.

Existing Wall System

Proposed Wall System

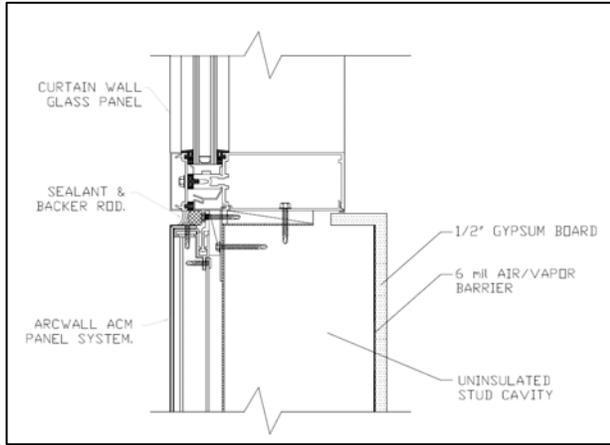
Along with that, R-13 insulation was installed on the interior side of the curtain wall metal panels throughout the remainder of the building. The diagram below shows the proposed addition to the wall as a section cut through the curtain wall sill, with the R-13 fiberglass insulation layer labeled in red.

Existing wall system

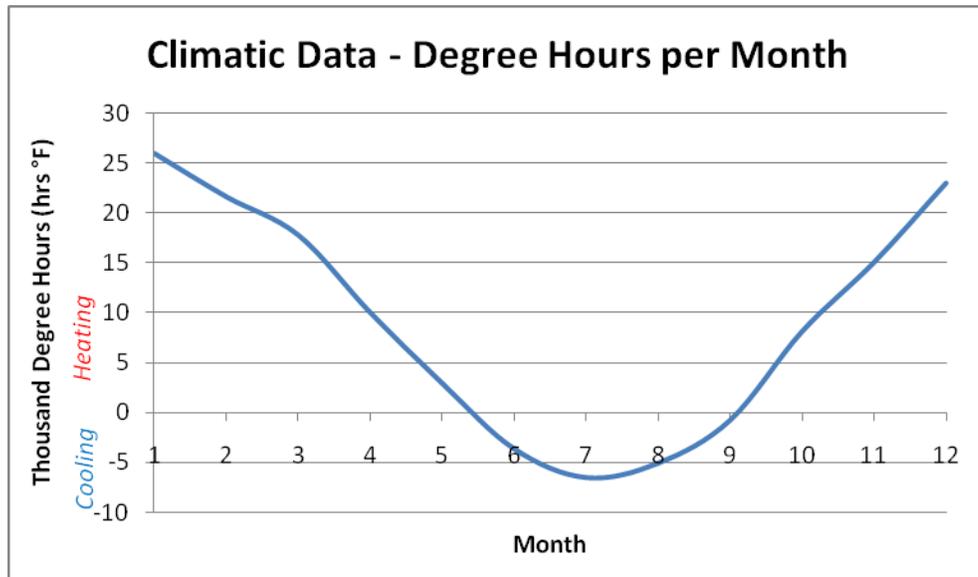
The graph below also represents the degree hours per month (1 – 12 on x-axis) for the Washington, D.C. region. The line dips below the zero degree hours line halfway through the month of May through the beginning of September, which represents cooling degree hours. Data graphed above the zero line, on the other hand, represents heating degree hours.

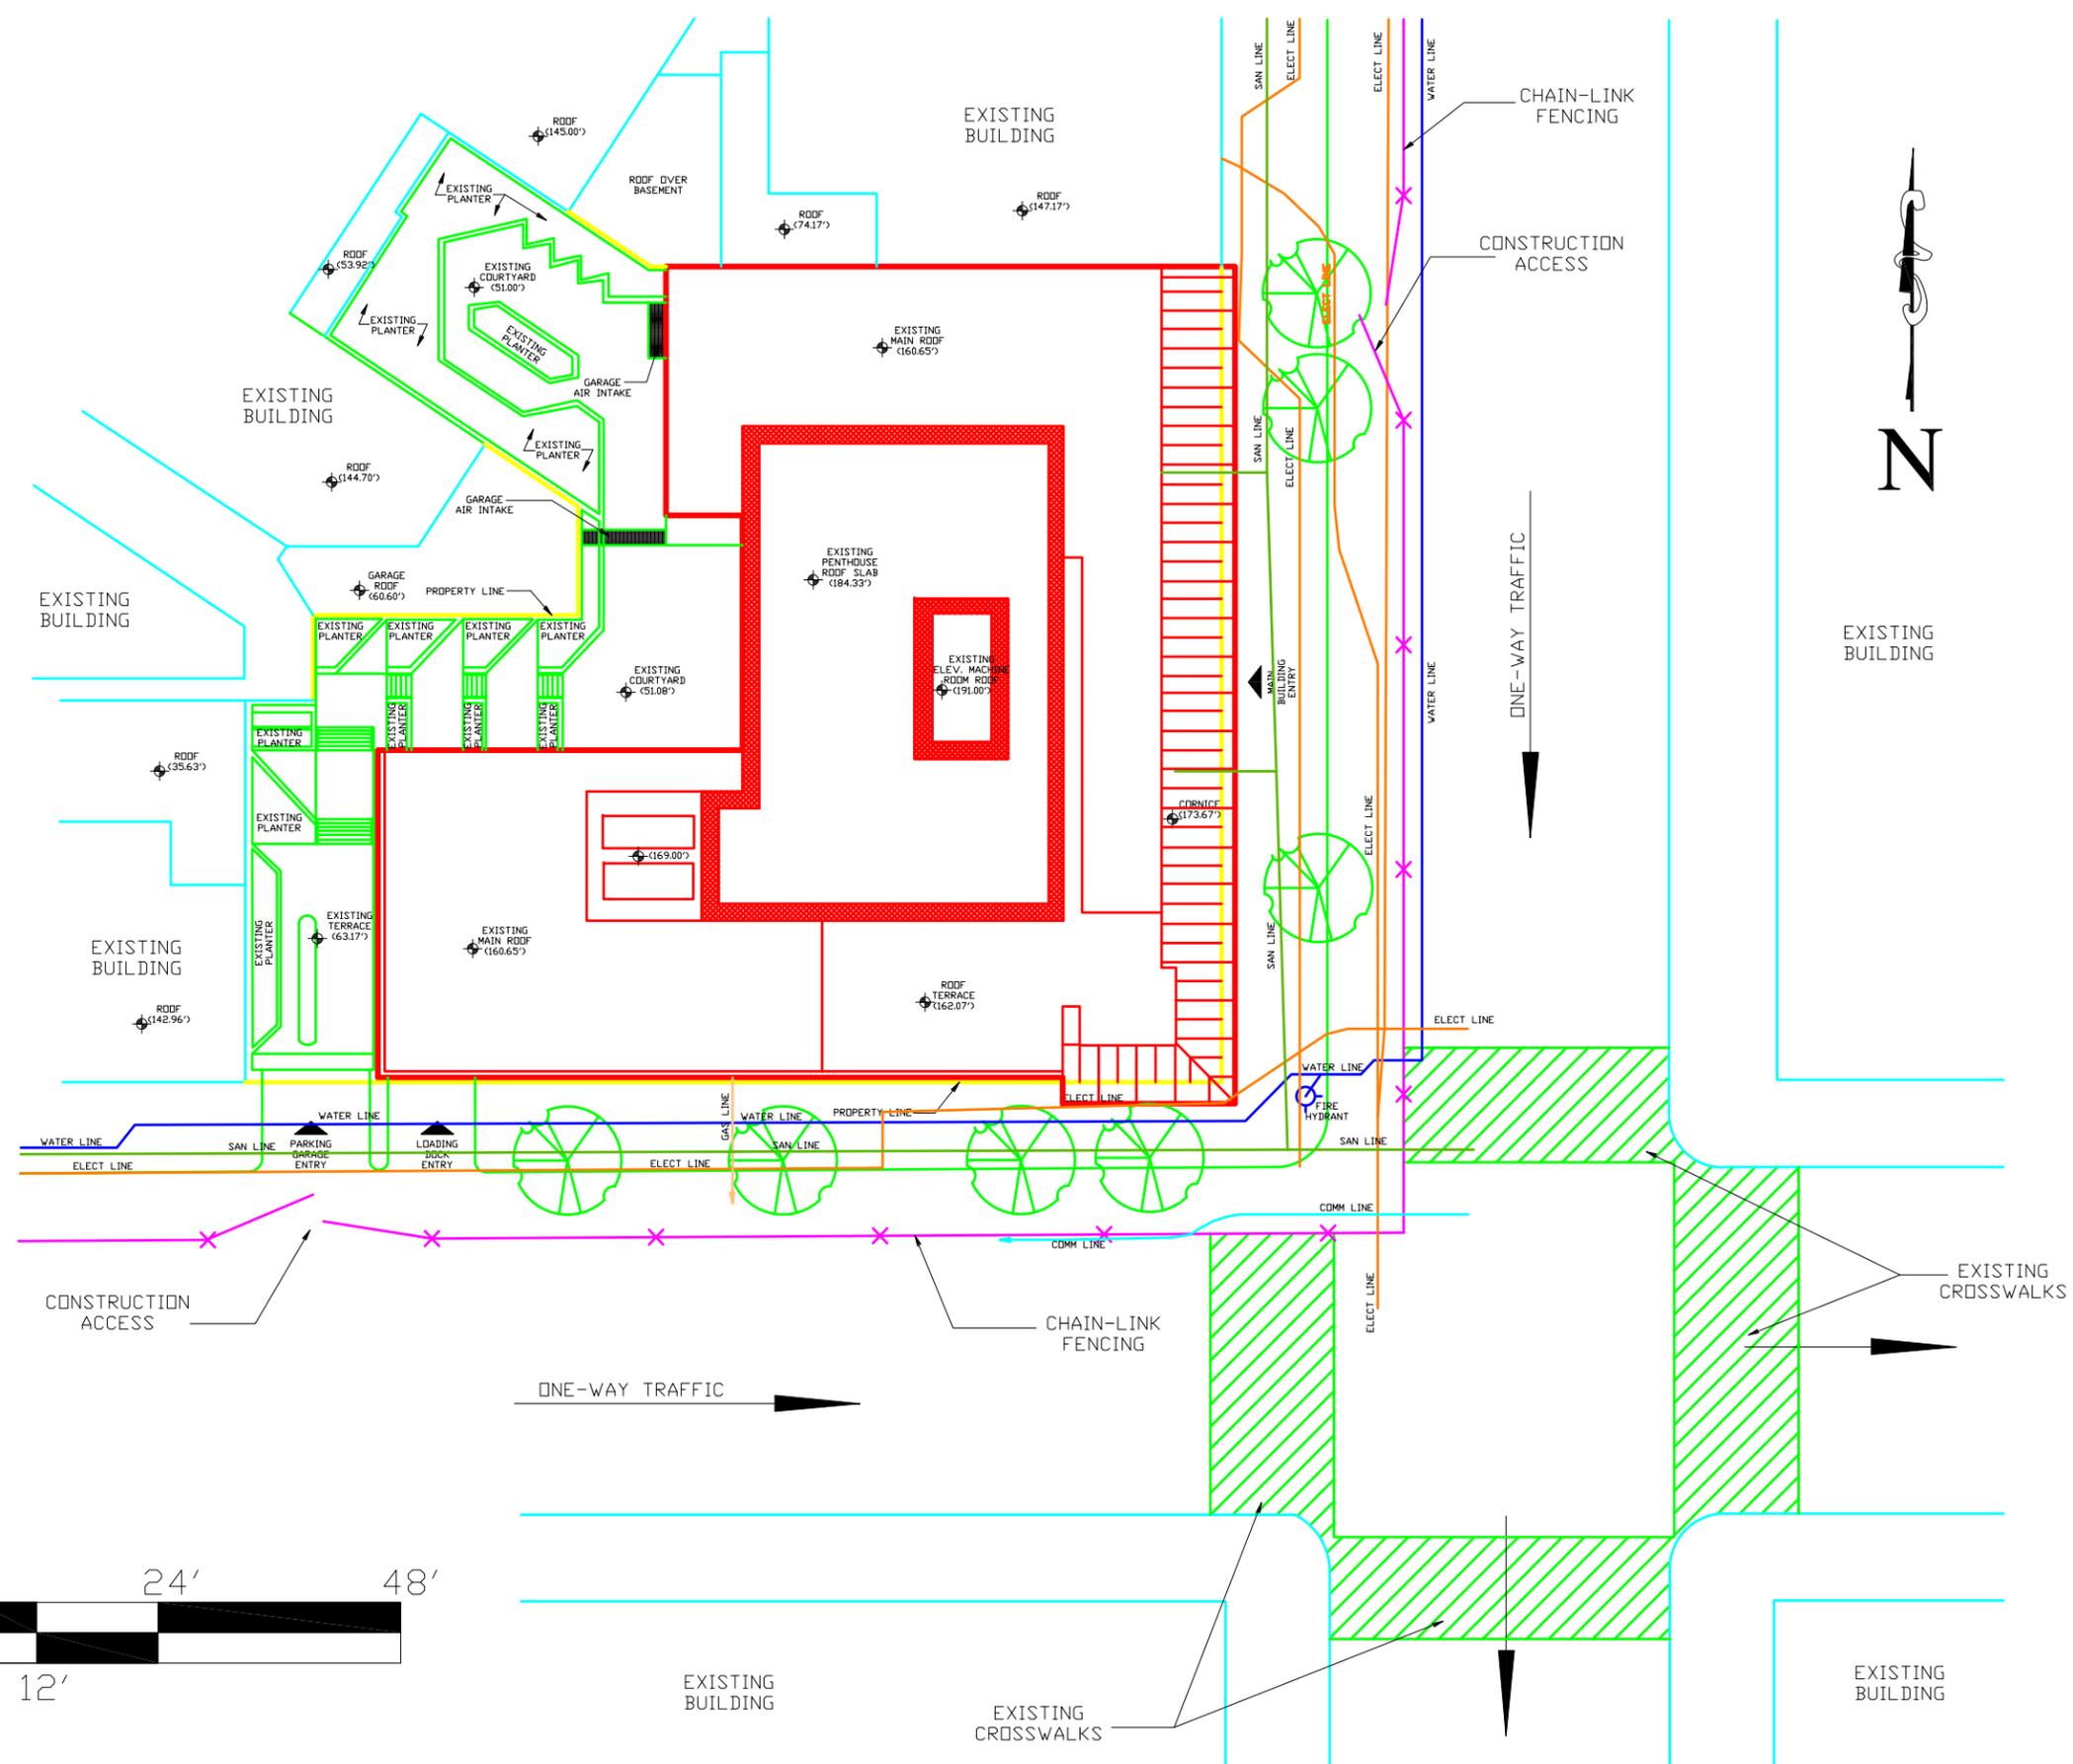
SITE LAYOUT PLANNING

The site plan of existing conditions clearly indicates a congested site in the business district of downtown Washington, D.C. There is a temporary jobsite trailer/office located on the third floor of the existing building. Parking is available on-site in the three levels of underground garage space. A temporary chain-link fence partially blocks off a portion of the street on the south and east sides of the building to allow for crane placement, deliveries, and staging areas. The rear courtyard is used for smaller amounts of stored materials. See Appendix B for a drawing of the site layout planning.

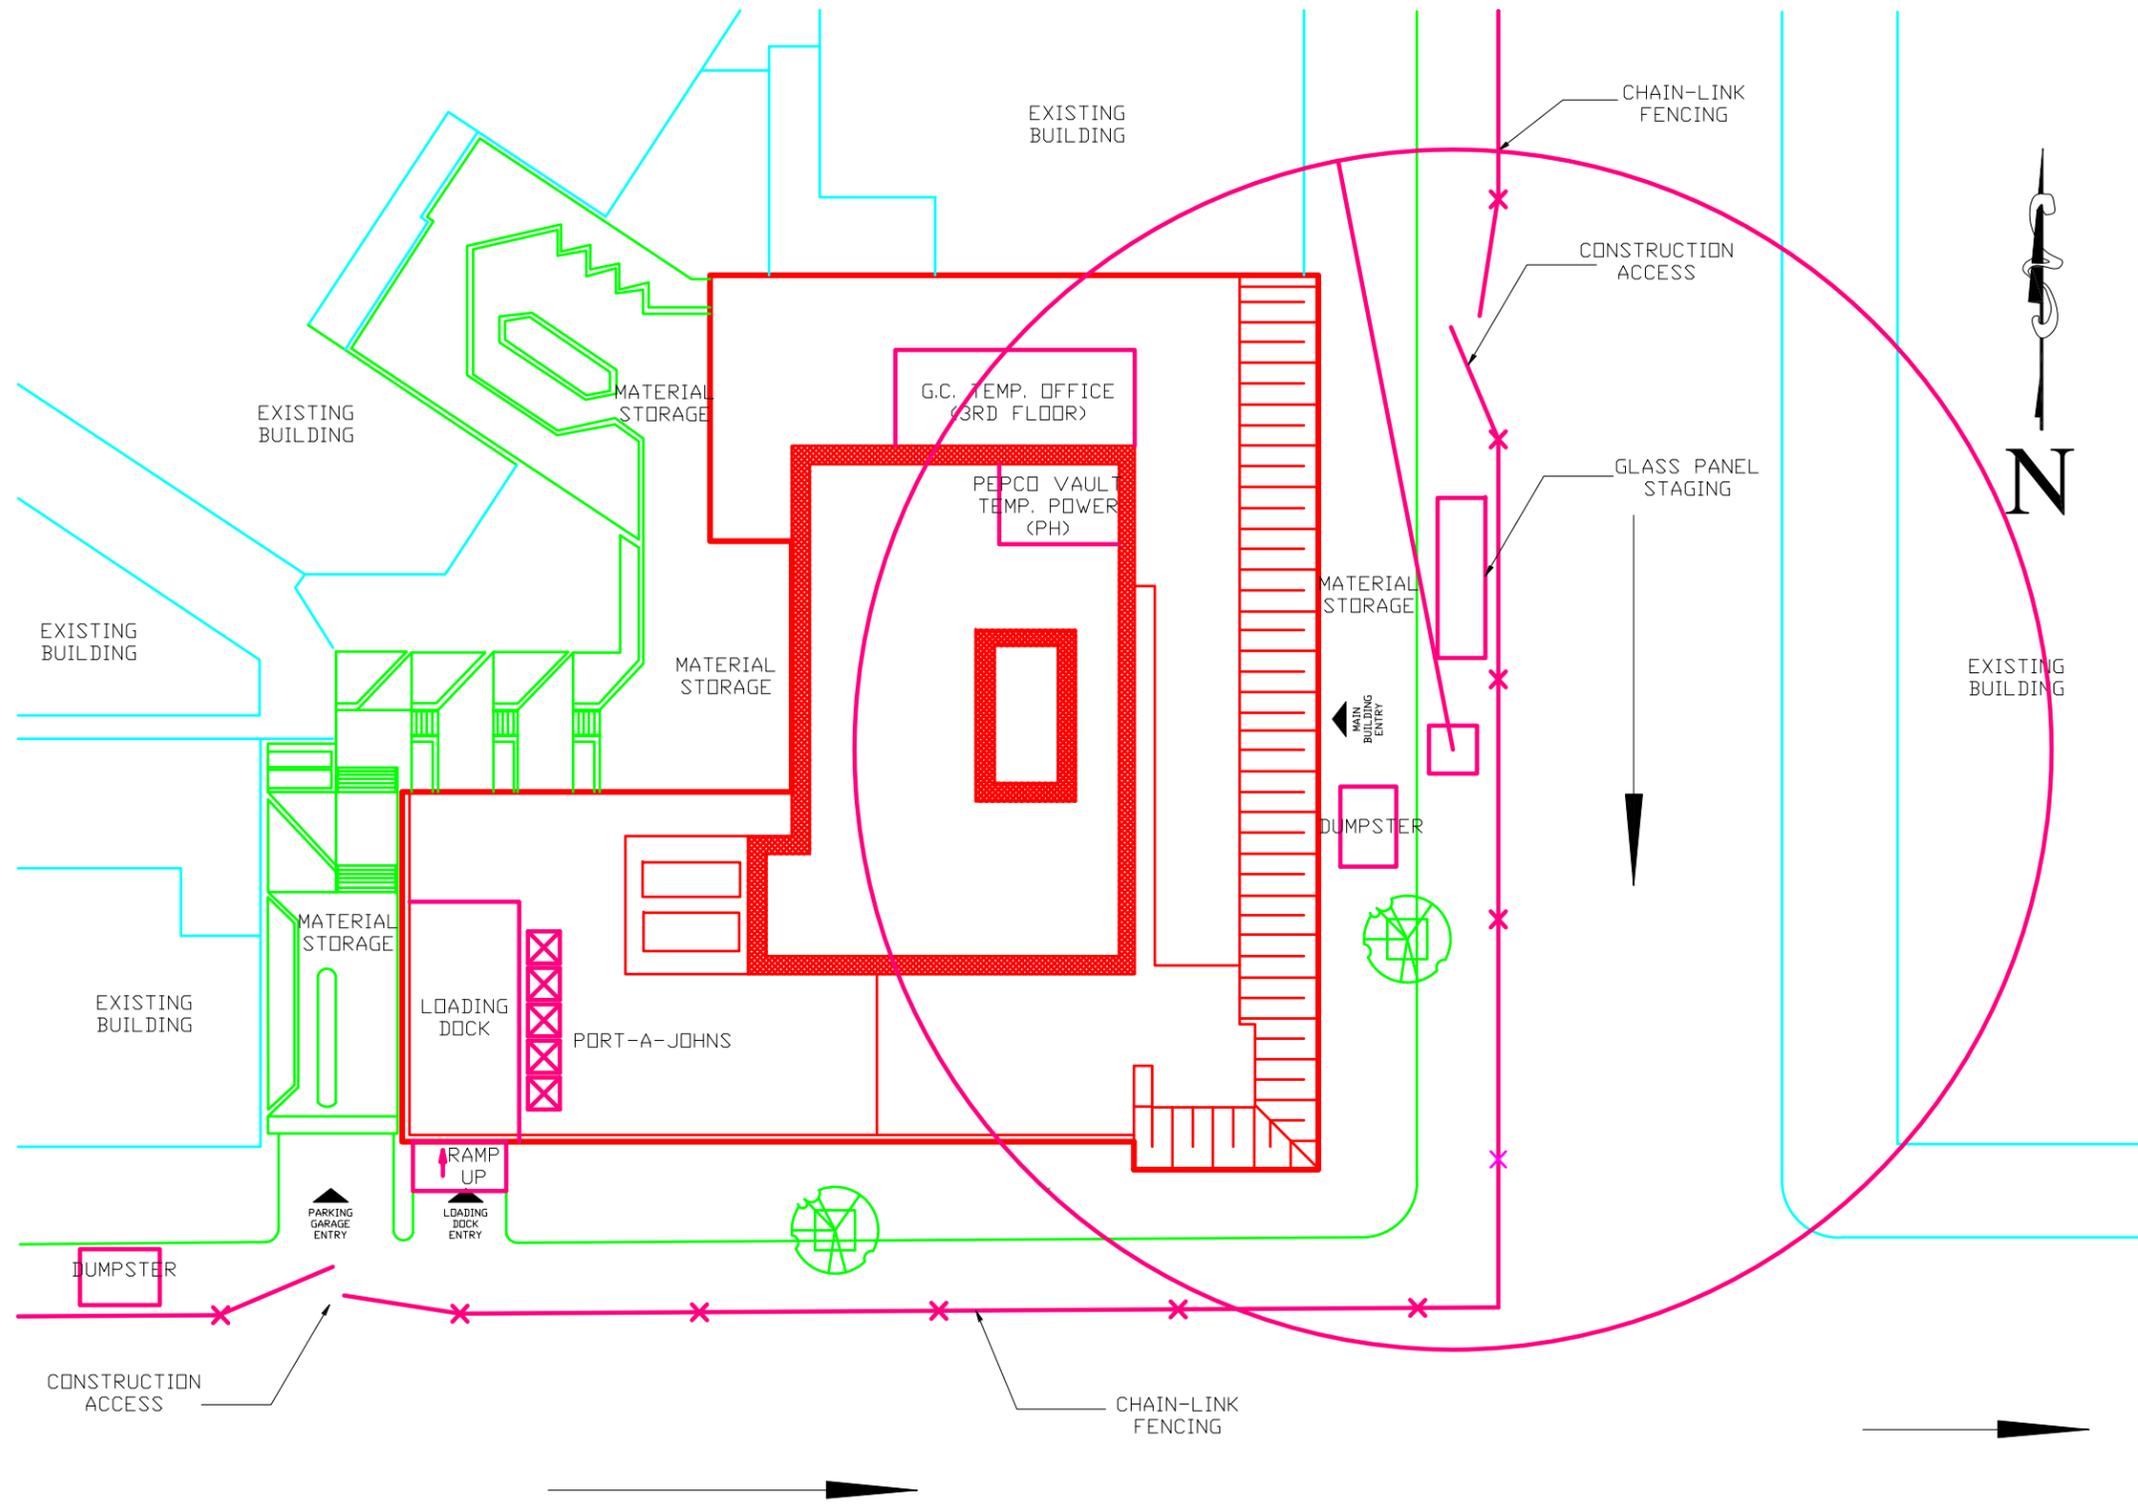
DEREK BAUER
 APPENDIX B-2
 CURTAIN WALL PHASE 2
 OFFICE/RETAIL BUILDING

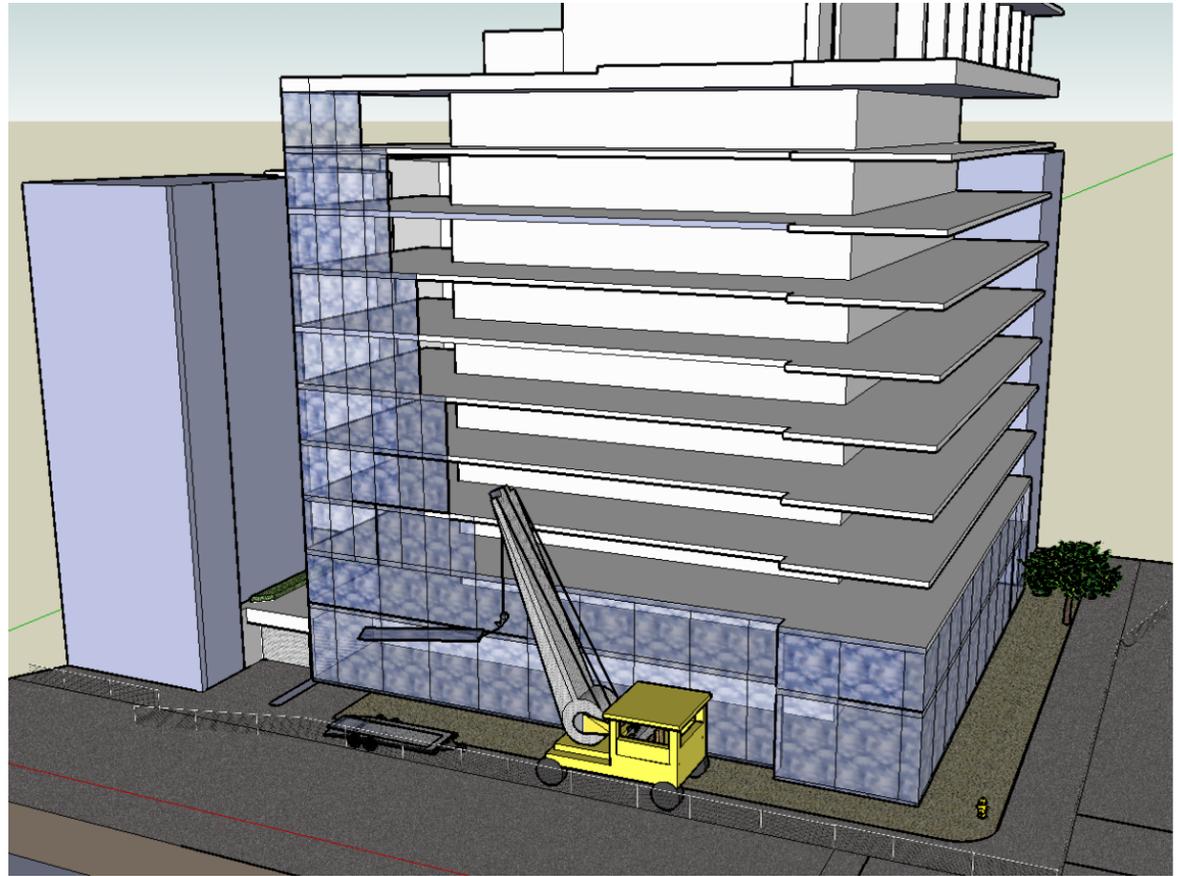
PHASE 1

APPENDIX B-4 – 3-D SEQUENCING OF CURTAIN WALL

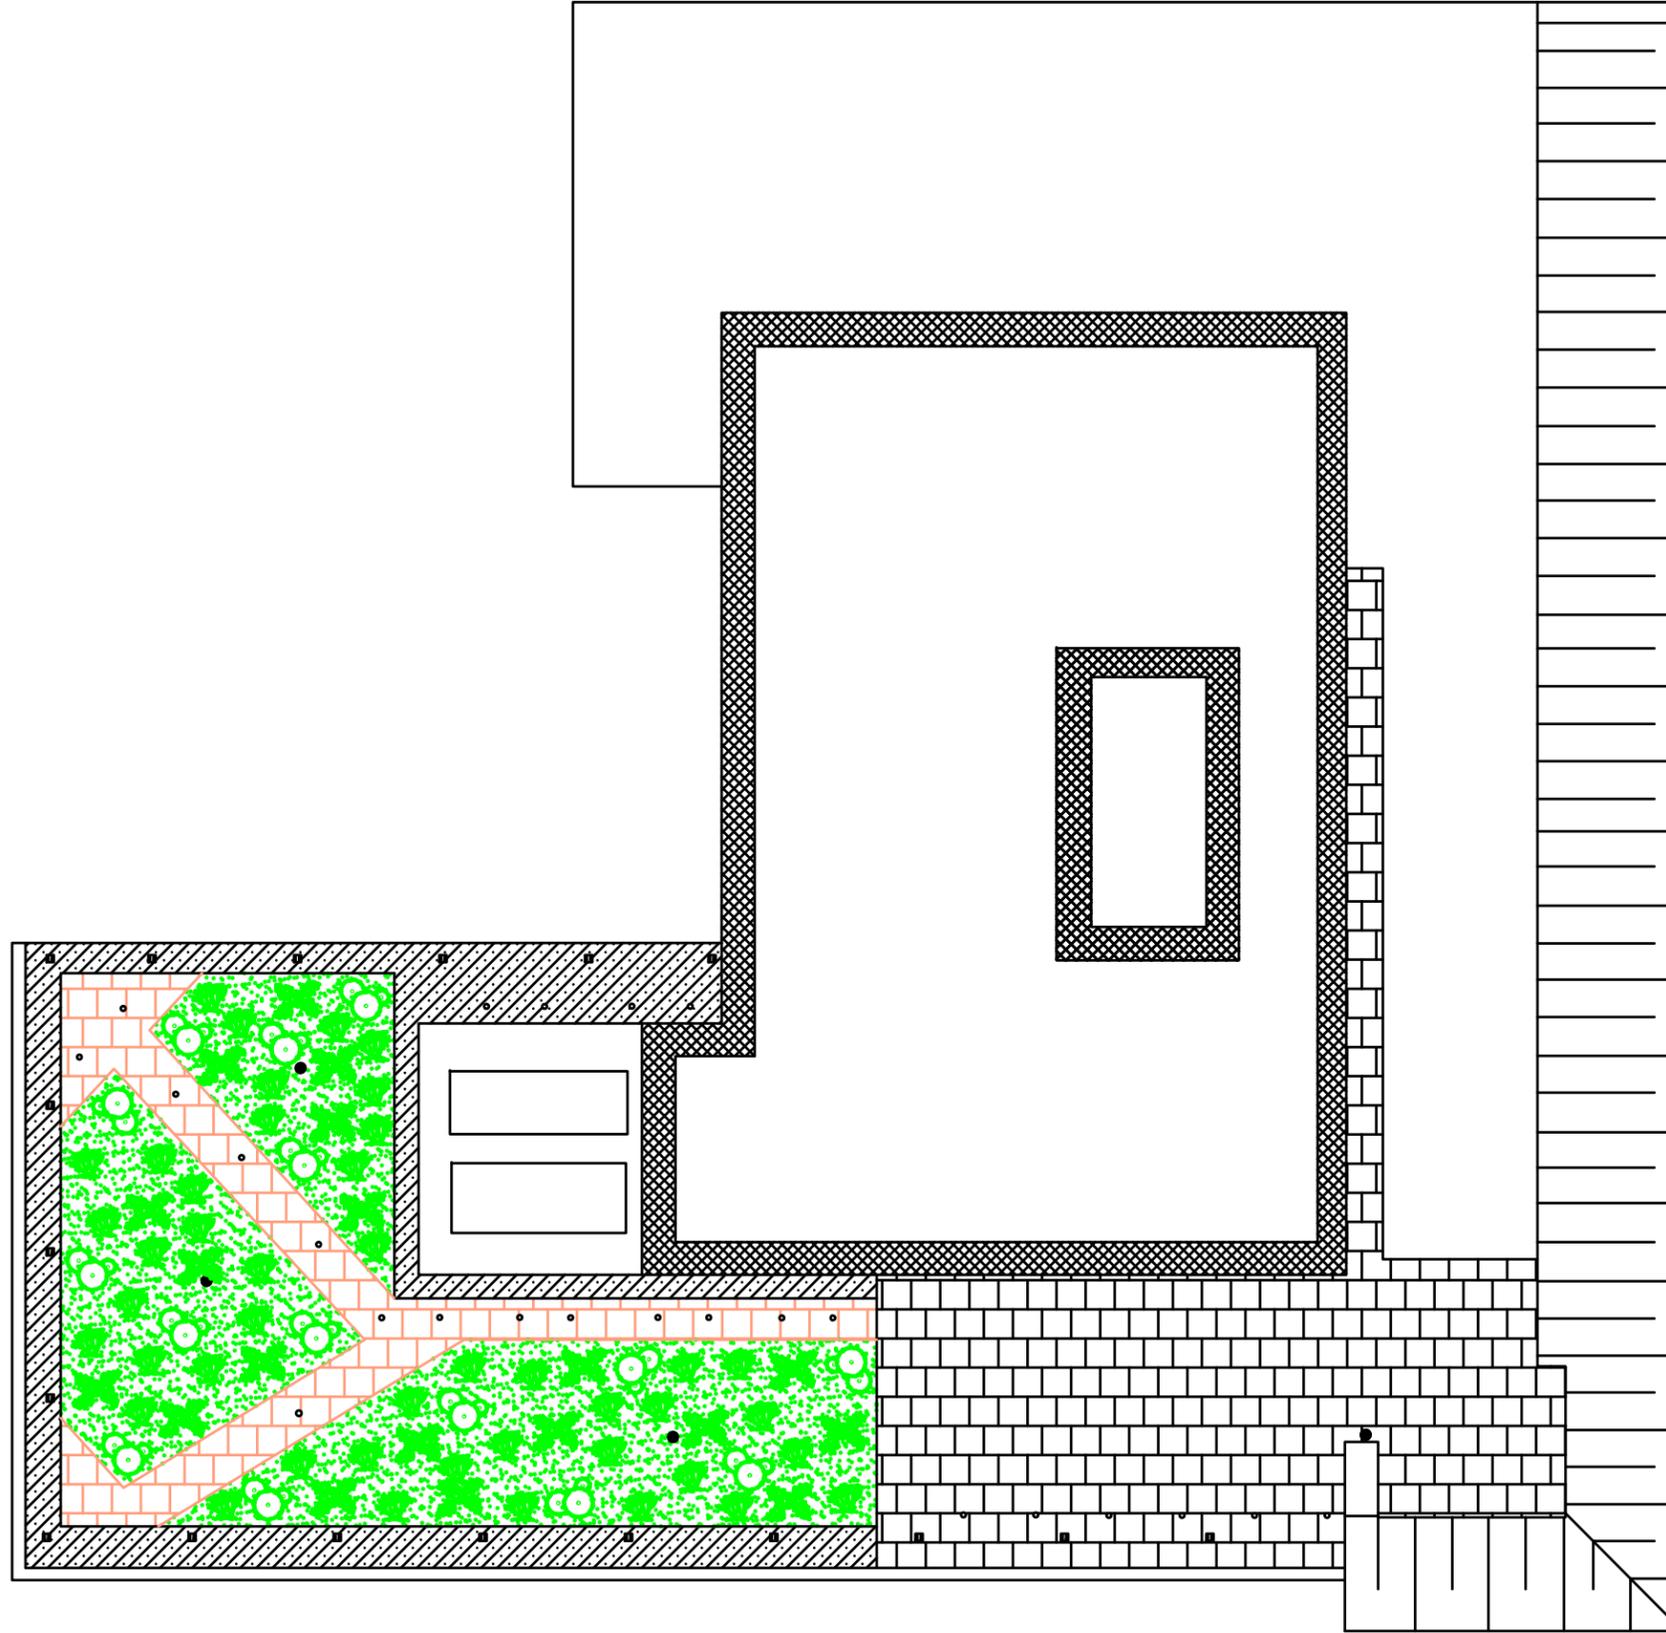
APPENDIX G-1

GREEN ROOF LAYOUT

Appendix G shows the roof layout plan for the proposed area of the new intensive green roof system. The areas were designed around the new rooftop terrace for public access, as well as on the south and west side of the building for maximum exposure to sunlight for vegetation growth. Also, it is important to point out the requirement for vegetation-free zones around the perimeter of the building and at all roof penetrations. These penetrations include a 4” wet stack vent and several davit bases for window washing. To address this issue, there will be 2’ x 2’ walkway pads placed around the roof penetrations, similar to those designed for the rooftop terrace. The existing roof drains are located around the center of each of the three major areas of vegetation, which could effectively serve as the drainage point for the rainwater that was not absorbed from each vegetation area.

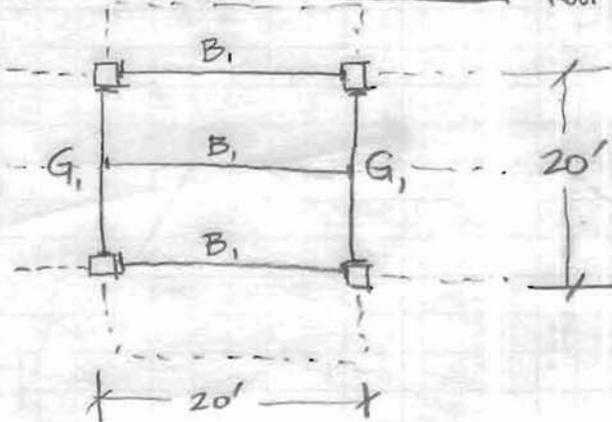
TYPICAL INTERIOR SPAN (BENEATH ROOF SLAB)

EXISTING ROOF SLAB CONDITIONS

8" SLAB THICKNESS
