# Loyola/Notre Dame Library

## Baltimore, MD

Technical Report 2 : Cost and Methods Analysis

**Sandra M. DiRupo**

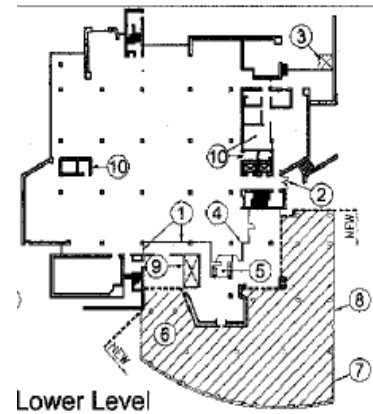
#### Phase I:

- 1.) Install dust partitions to separate existing library space from area of new addition. Provide and maintain access from existing library space to existing women's restroom. Restrooms shall be designated as men's on lower level and second floor

- 2.) Disassemble existing curtain wall and provide temporary entrance at lower level elevator lobby
- 3.) Utilize dock lift for temporary entrance during phase 1 & 2

- 4.) Existing partitions to remain as temporary dust partitions
- 5.) Maintain use of women's restroom. Designate as men's restroom on lower level & second floor

- 6.) Demolish steps, site wall, & paving as required for construction addition
- 7.) Construct deep foundations and new site utilities
- 8.) Construct four story addition shell and primary MEP systems (NO finishes or fit-out)

- 9.) Erect new shaft walls and cut new floor openings per structural drawings. Install new main plumbing riser
- 10.) Demo maintenance area and construct new server room. Preserve existing data and electrical risers

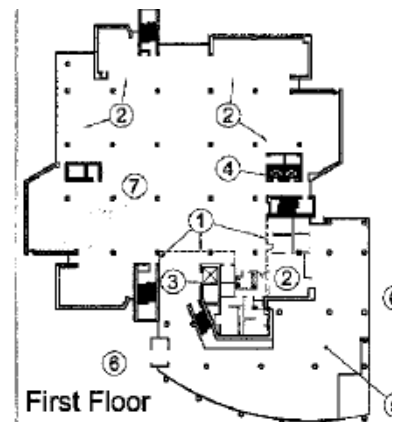
#### Phase II:

- 1.) Remove dust partition & complete demolition work
- 2.) Perform all first floor demolition and renovation to existing building as indicated on drawings to complete fit-out
- 3.) Complete new elevator with operable service to all floors
- 4.) Replace existing elevator machinery
- 5.) Fit-out first floor addition
- 6.) Construct site walls, steps, ramp, and paving
- 7.) Install existing bookshelves with new end panels

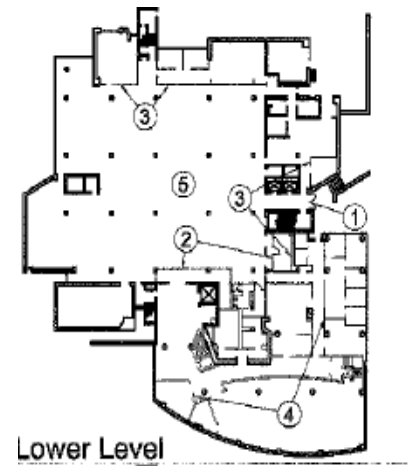
### Phase III: Lower Level Floor Fit-out & Finishing

- 1.) Temporary Entrance becomes construction entrance
- 2.) Remove dust partition & complete demolition work
- 3.) Perform all lower level renovation to existing building as indicated on drawings to complete fit-out
- 4.) Fit-out lower level addition
- 5.) Install existing bookshelves with new end panels

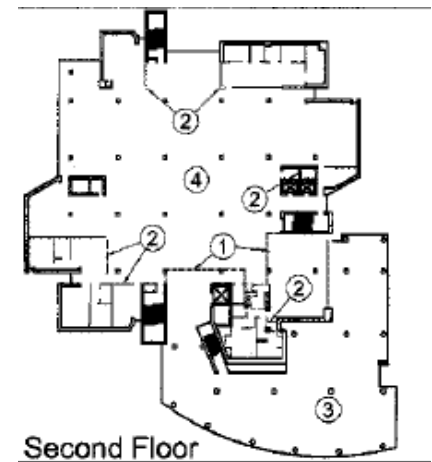
### Phase IV: Second Floor Fit-out & Finishing

- 1.) Remove dust partition & complete demolition work
- 2.) Perform all second floor renovation to existing building as indicated on drawings to complete fit-out
- 3.) Fit-out second floor addition
- 4.) Install existing bookshelves with new end panels

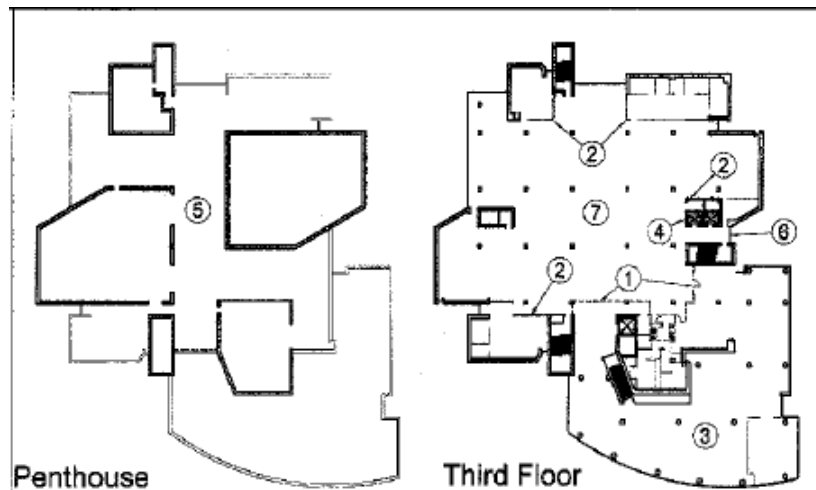
## Phase V: Third Floor Fit-out & Finishing

- 1.) Remove dust partition & complete demolition work
- 2.) Perform all third floor renovation to existing building as indicated on drawings to complete fit-out
- 3.) Fit-out third floor addition
- 4.) Replace existing controls and finishes in existing elevator cabs
- 5.) Replace existing roof
- 6.) Remove temp entrance at lower level & reassemble curtain wall
- 7.) Install Existing bookshelves with new end panels

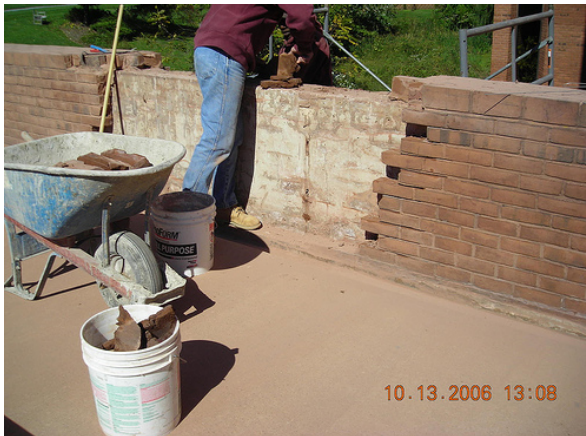
Fig. 1: Removal of wall and steps

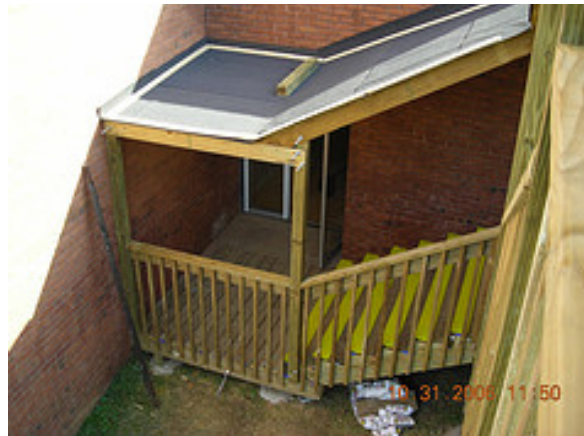
Fig. 2: Temporary steps for public access to library at west entrance

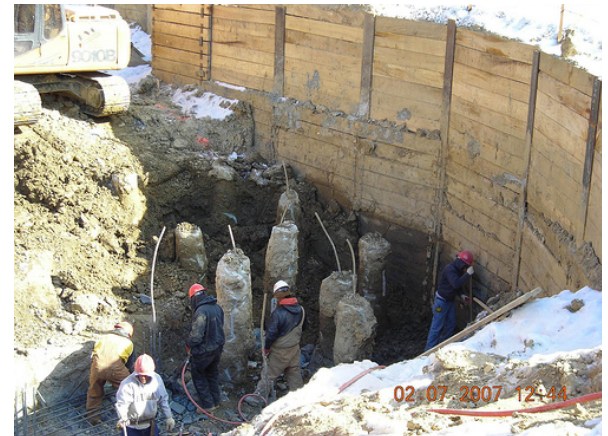
Fig. 3: Auger cast mini piles

03 31 Structural Concrete								
03 31 05 - Normal Weight Structural Concrete								
Reference	Description	Qty	Unit	Mat	Labor	Equip	Total	Cost
03 30 53 Concrete in Place - Foundations								
1200	Mini Piles: Deep foundation, augured (16" dia)	197	CY	\$465.00	\$400.00	\$39.50	\$904.50	\$178,186.50
5900	Spread Footings: Pile caps, under 5 CY, pumped	207	CY	\$160.00	\$76.00	\$0.46	\$236.46	\$48,947.22
1950	Perimeter Footings, Incl. Grade Beams: Continuous, shallow, pumped	155	CY	\$133.00	\$85.50	\$0.51	\$219.01	\$33,946.55
4200	Foundation Wall: 8" thick, 8' tall	248	CY	\$177.00	\$166.00	\$16.45	\$359.45	\$89,143.60
3940	Interior Footings, Incl. Grade Beams: Continuous, shallow (24"x12")	30	CY	\$133.00	\$85.50	\$0.51	\$219.01	\$6,570.30
6200	Retaining Wall: 10' high	68	CY	\$133.00	\$61.00	\$6.05	\$200.05	\$13,603.40
4050	Mat Slab: Over 20 CY	62	CY	\$173.00	\$72.50	\$0.44	\$245.94	\$15,248.28
<b>GRADE BEAMS, RETAINING WALLS, CONTINUOUS FOOTINGS, AND A 1'-6" MAT SLAB IN THE AUDITORIUM</b>

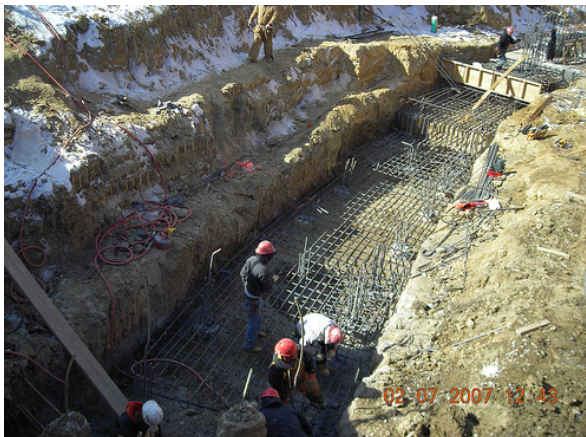
Fig. 4: Pouring footings along curved foundation wall

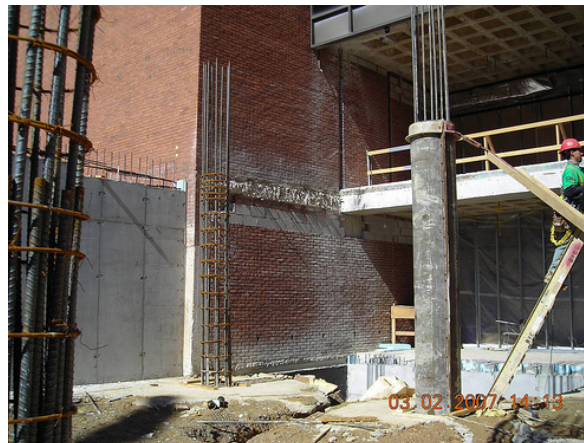
Fig. 5: Pouring columns in lower level addition

03 30 53 Concrete In Place - Columns & Slabs								
1440	Columns: 24" thick, pumped, Max Reinforced	219	CY	\$685.00	\$420.00	\$41.00	\$1,146.00	\$250,974.00
2750	Two Way Slabs: 25' span	1020	CY	\$216.00	\$222.00	\$21.00	\$459.00	\$468,180.00

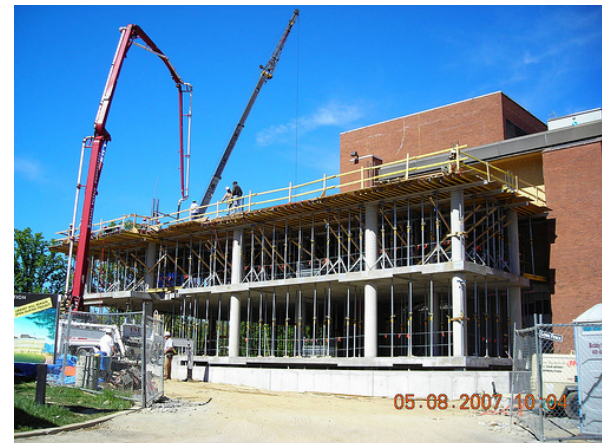
Fig. 6: Pouring slabs with truck and pump

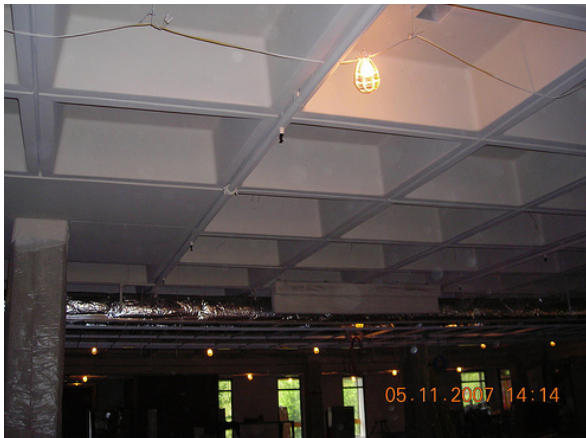
Fig. 7: Insulating duct work & painting existing waffle slab on first floor

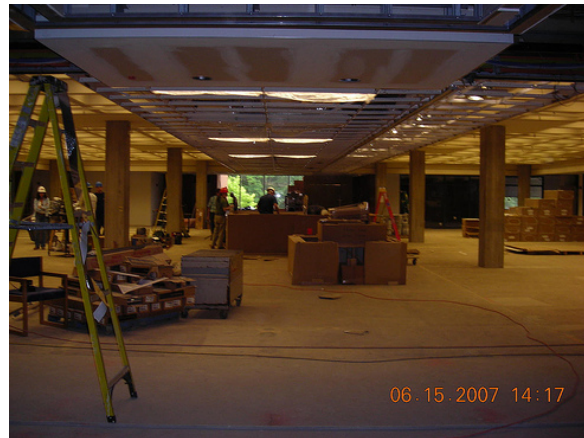
Fig. 8: Installing light fixtures

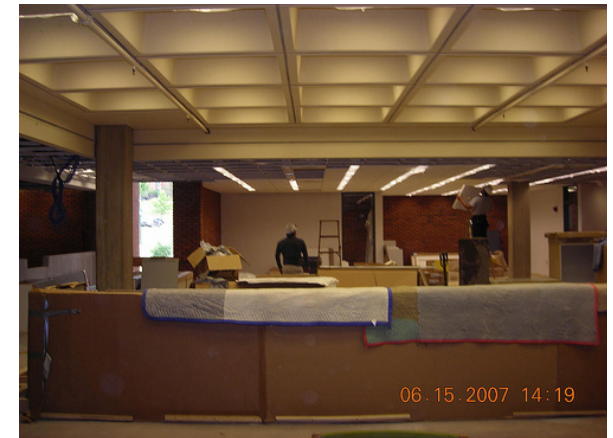
Fig. 9: Millwork Installation

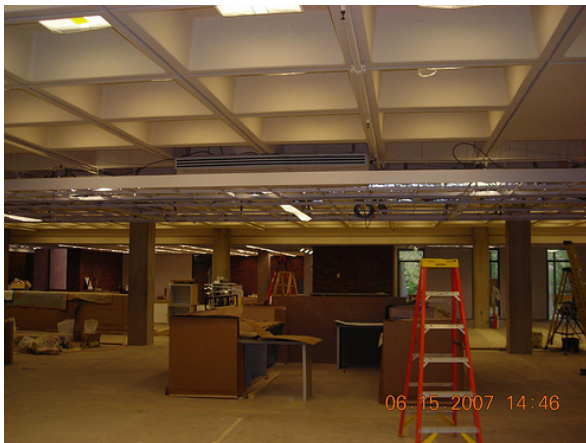
Fig. 10: Hanging of Floating Ceiling

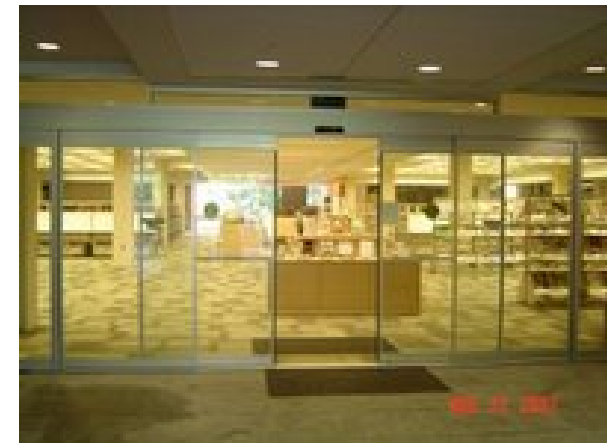
Fig. 10: New automatic sliding doors from gallery to newly renovated space

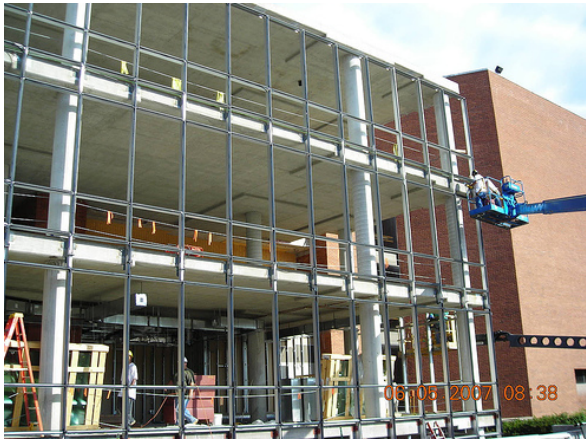
Fig. 1: Applying aluminum grid around addition perimeter

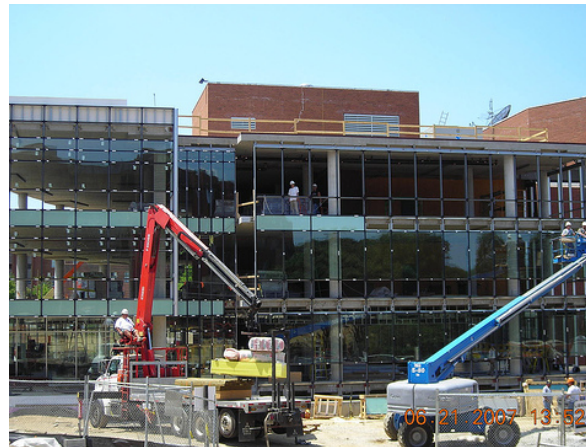
Fig. 2: Two genies erecting glass

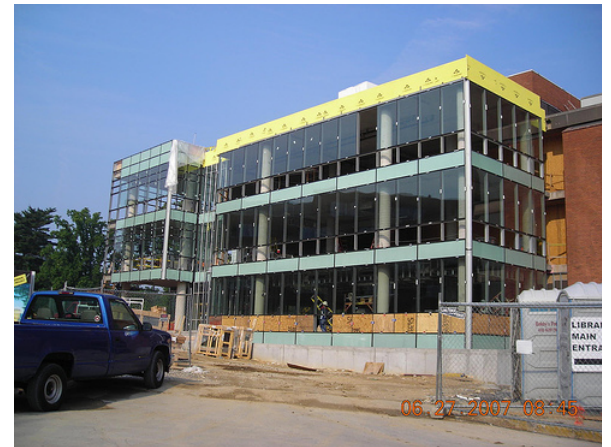
Fig. 3: Applying insulation at top of third floor

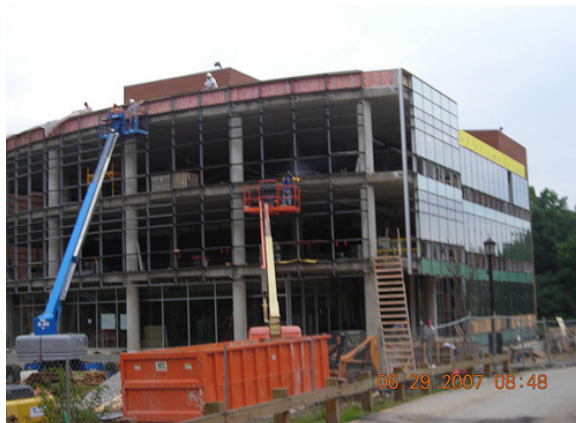
Fig. 4: More glass and insulation installation

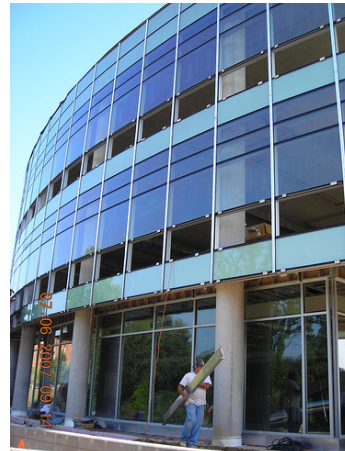
Fig. 5: Close Up after installation of clear and spandrel glass

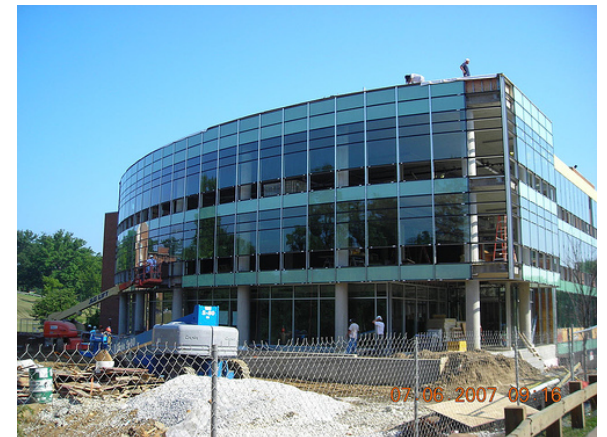
Fig. 6: New addition curtain wall 85% complete
