SENIOR THESIS FINAL PROPOSAL

SUPPORT SERVICES BUILDING

PENN STATE MILTON S. HERSHEY MEDICAL CENTER – HERSHEY PA

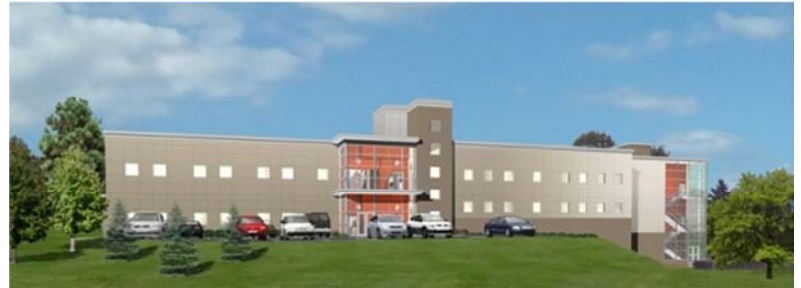
Figure 3: Architectural Rendering of Exterior

curtainwall. Figure 3 shown at right and on the cover page is the architects rendering of what they exterior of the building will look like. Interior finishes include exposed polished concrete and exposed ceilings, as well as conventional ACT ceilings, VCT floor tile, and ceramic tile. Upon completion the project is expected to achieve a LEED Certification rating under the LEED Version 2.2.

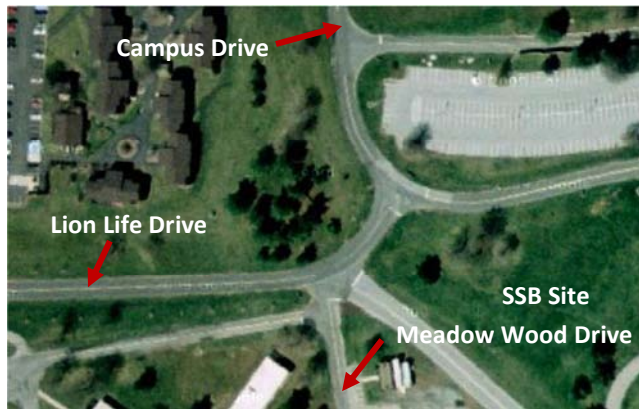
Figure 4: Old Lion Life Drive & Campus Drive Intersection

Another major part of the project is the re-alignment of Lion Life Drive with Campus Drive. Currently vehicles on Lion Life Drive have to wait at a stop sign and let vehicles on Campus Drive pass before turning left onto Campus Drive. With Lion Life Drive being the main access point to the hospital from west, the intersection quickly backs up during shift changes at the medical center. This is also the route in which all the medical supplies are delivered to the hospital. Figures 4 and 5 below show the existing intersection and what the new intersection will look like.
