Kaiser Permanente Largo Medical Office Building – Largo, MD

Christopher Pozza
Construction

Technical Assignment 2

October 12, 2012

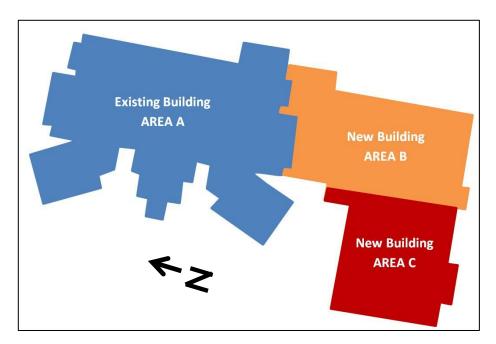
Figure 1 - The flow of construction is typical for almost all trades throughout construction of the addition. Area B and C make up the adddition. Work starts in Area B and flows to Area C. The existing building, Area A, will be getting renovated once the addition is complete.

This phase began with the Notice to Proceed from Kaiser Permanente on June 10, 2011. Immediately site mobilization started, however no major work could be done until the Owner Provided Building Permit was received. Once it was received, underground utility work began prior to preparations for foundations. The building rests on spread footings and perimeter foundations. The slab on grade dates caught my attention on the schedule. Structural steel began before the slab on grade did, therefore; the slab had to be poured a few days after the crane was able to move from Area B to Area C. The breakdown of areas can be seen in Figure 1. Laydown areas for steel were east of Area A and south of Area C.

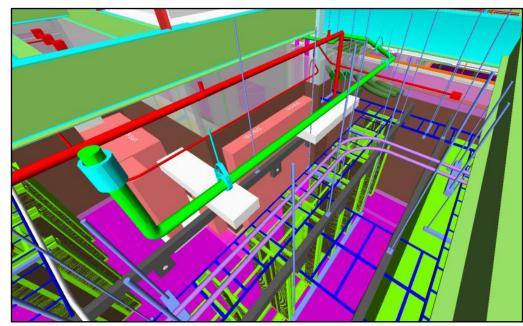
Figure 2 - At a quick glance, it would be hard to notice a clash in this image. That is partially due to its size but the bigger reason is there actually is no direct clash. The problem is the green pipe in the center of the screen is a sanitary line which is directly above a second floor Telecommunications Room. This pipe was required to be moved to eliminate any potential water hazards near equipment.

- Imaging area tight ceiling areas in imaging suites created problems with coordination of complex systems
- Design of arched ceilings working around arches made it challenging to place MEP systems around structure in certain spaces
- Ducts ceiling height and limited space on the 2nd floor made very tight squeezes for large ducts
- Operating Rooms more ceiling height restrictions present problems for MEP systems and boom supports which were
- Drains and risers -(seen to the right in Figure 2) presented a challenge due to the third floor slab being poured before model coordination was finished. That required penetrations to be core drilled. Several drains ran and pipes were out of place and protruding through walls which would've required bump outs if not otherwise moved.

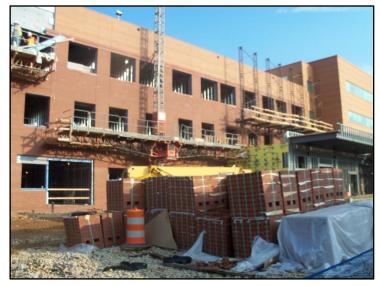
Figure 3 - The east elevation is shown almost completed. A Fraco lift can be seen in the center, with a Mason King manual cranked scaffold equipment sits on the canopy roof. Notice the amount of space currently taken up by the mason subcontractor. Personal photograph taken by Chris Pozza.

Other than making up for lost time, there were now Fraco Lifts on site much longer than expected. The site is not extremely small, but very busy and having Fraco Lifts wrap entirely around the south and east side of the building limited flow of construction traffic and took away valuable lay down area. Figure 3 shows an image of the east façade as work is wrapping up, although the large laydown area is still being used by the mason. Figure 4, taken the very same day on the south façade, shows the amount of space this equipment occupies. No work can be done underneath and building exits get blocked by them or are impassable depending on where work is. Delay of the exterior façade also affected the critical path and forced the Watertight Milestone to be pushed back. In an effort to try making up for the lost time early, the mason crew quickly doubled and tripled in size. More laborers on site allowed a larger area of façade to go up at a time as the Fraco Lifts were able to be utilized. People were also required to work weekends. Comparing a brick façade to precast panels could be a potential research topic.

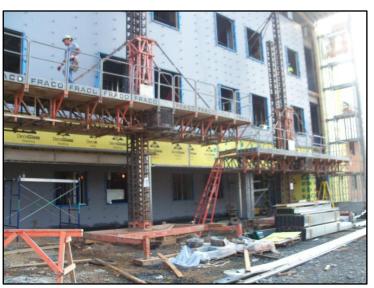
Figure 4 - Image taken the same day as Figure 10. Masons preparing for the next phase at the south elevation. Work can never take place underneath Fraco Lifts. Personal photograph taken by Chris Pozza.

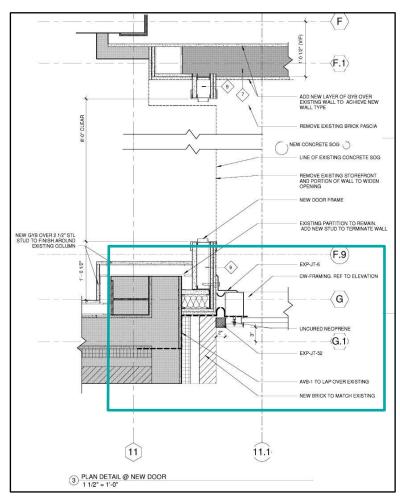
Figure 5 - Detail of a corridor entrance from the addition into the existing building. Notice in the lower central part of the image the bold dashed line that extends into the darker shaded area. This line is Air/Vapor Barrier (AVB) which is shown intruding into the existing brick extremely far as it is intended to overlap the existing AVB. Image courtesy of Ellerbe Becket.

Another challenging feature can be found in the northwest of the addition. Tying into the existing building was expected in this precise area, but the drawings present a tricky connection as seen in Figure 5. Between all parties involved, no one has ever used a connection quite like this. With curtain wall coming from the south (as seen to the left of Figure 6) to connect to new brick via an expansion joint, there won't be much room for error as the new brick is intended to land perfectly flush with the interior wall. This area is important as timely planning is necessary to deal with demolition involving occupied space.

The challenge has become to find a way to overlap the new Air/Vapor Barrier (AVB) over existing AVB. DPR is currently underway working with subcontractors to prepare a cost effective alternative solution. Drawings and sketches have been passed between subs, superintendents, and architects. The process is of finding a solution is ongoing.

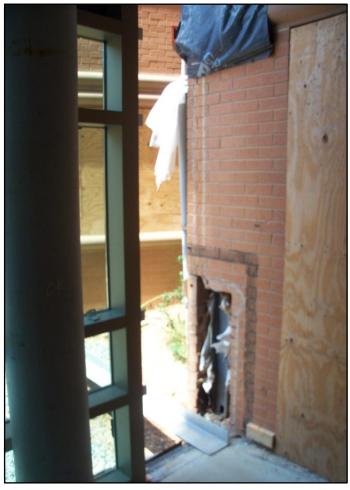
Figure 6 - Photograph taken from the interior of the addition looking at the corner of the existing building. The challenge is ging to be demolishing small areas of existing facade and tying Air/Vapor Barrier to AVB behind that façade which will be getting opened. Personal photograph taken by Chris Pozza.

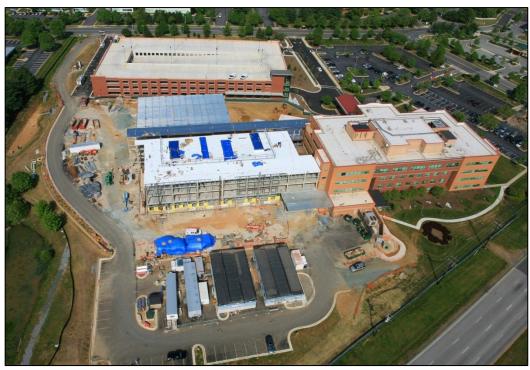
Figure 7 - An aerial progress photo taken on April 21, 2012 shows the temporary roof just 12 days after its construction began. Take notice that there is no framing on the east façade. Image courtesy of DPR Construction.

In response to there being a roof with virtually no walls, the superintendents worked to make sure the interior would remain as dry as possible at all times. With open floors in every direction, this was a challenge and laborers would repeatedly need to sweep the water out of low spots, but it was necessary to keep equipment and stored materials dry, especially if they were in the open building. Temporary plastic sheets were draped prior to storms and materials were stored away from the perimeter of the building when possible. Leaks in the mechanical room, located in Area C and had temporary roofing overhead for an extended period of time, required installation of new drywall, insulation, and fireproofing at different locations within the space. Although that might not sound overly impressive, it became habit because making sure safe working conditions were maintained inside and outside the building is top priority.
