FINAL  
REPORT

U.S. GENERAL SERVICES  
ADMINISTRATION  
HEADQUARTERS  
MODERNIZATION PHASE I  
1800 F ST. NW, WASHINGTON, D.C.

FINAL REPORT

# GENERAL SERVICES ADMINISTRATION HEADQUARTERS MODERNIZATION

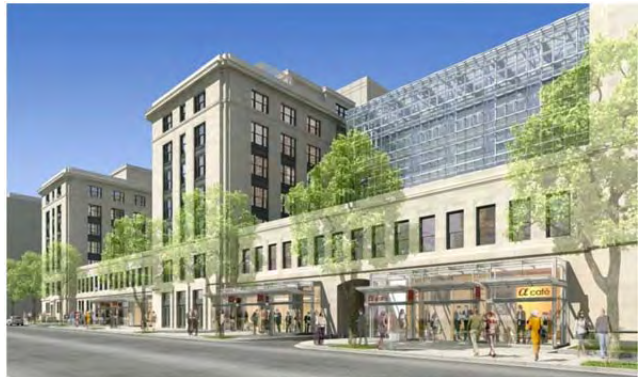
Figure 1: Rendering of the GSA Headquarters from E Street NW – Courtesy of the Whiting-Turner/Walsh Joint Venture

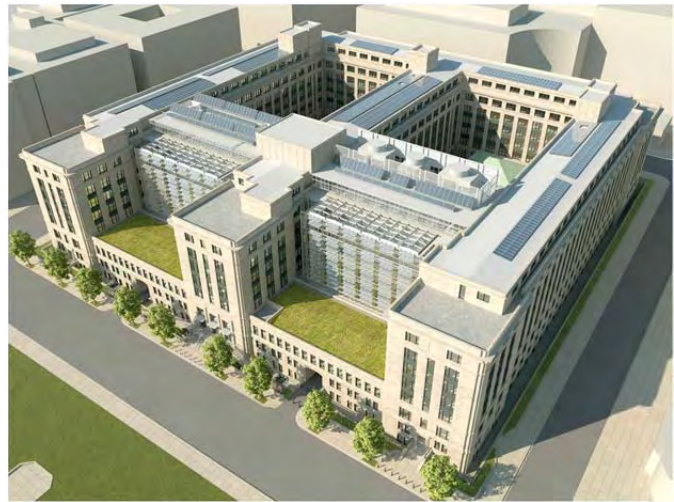
Figure 3: Rendering of the GSA Headquarters exterior – Courtesy of the Whiting-Turner/Walsh Joint Venture

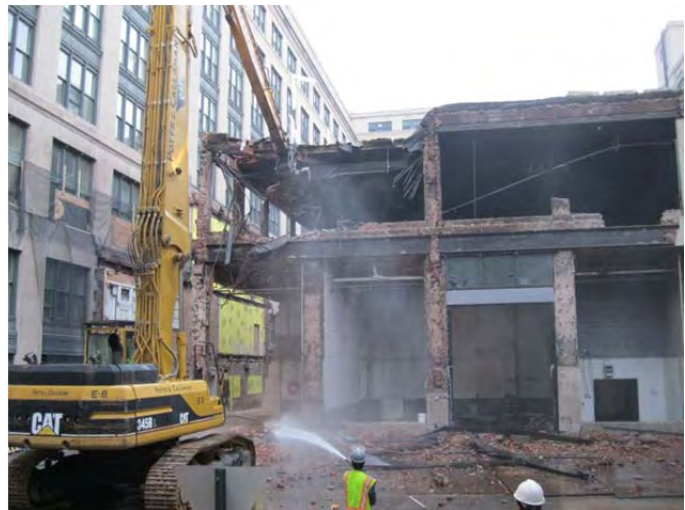
Figure 7: Demolition in the East Courtyard - Courtesy of the Whiting-Turner/Walsh Joint Venture

For Phase 1 of the U.S. General Services Administration Modernization, a total of four buildings in the East Courtyard were demolished. Figure 7 shows the demolition of one of these buildings. Additionally, a significant amount of items in the existing Wing 0, Wing 1, and Wing 2 were demolished. This extensive list includes radiators and pipes, mechanical equipment, cabinetry and shelving, elevator shafts, stairwells, security equipment, plumbing fixtures and toilet accessories, ceramic floor tiles and cement floor toppings, and

insulation board from walls and ceiling. In general, the existing HVAC, electrical, plumbing, communication, and fire and life safety systems were all demolished and replaced.

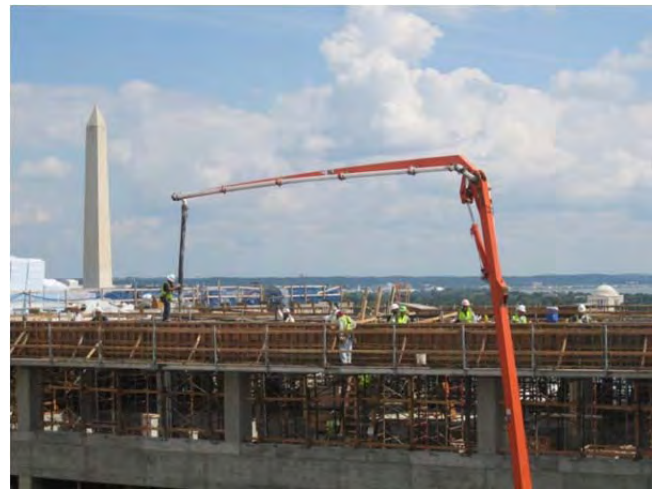
Figure 8: Roof slab of the New Addition – Photo Taken by Ramuel Holgado

Cast-in-place concrete was primarily used for the construction of the New Addition. Common in Washington D.C., this method was used for the slab on grade, grade beams, and foundation walls. In addition, the columns, walls, and deck for each floor were poured with concrete. Wooden formwork and a pump truck were used to frame and pour all concrete on the project. Figure 8 shows the pouring of concrete for the roof slab of the New Addition.

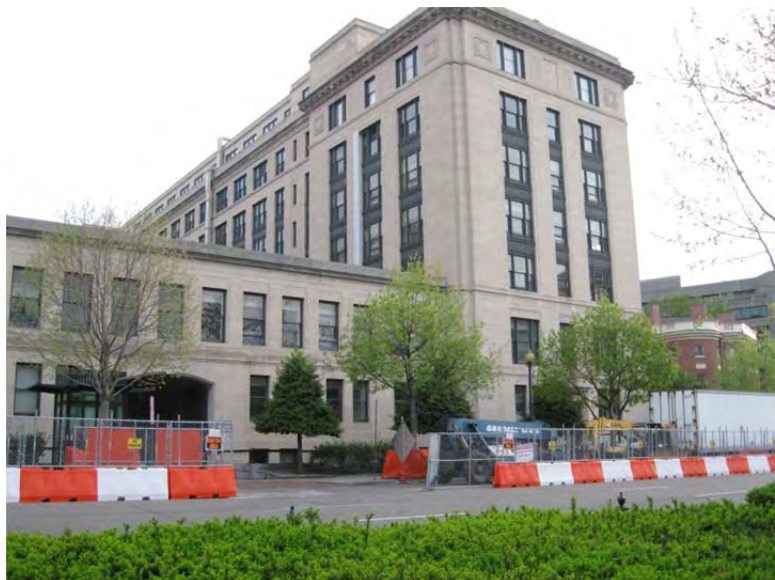
Figure 12: Construction Parking along E Street NW - Courtesy of the Whiting-Turner/Walsh Joint Venture

Due to the nature of the location of the project, construction parking at the U.S. General Services Administration Headquarters is extremely limited. The General Contractor utilized space in the East Courtyard and along E Street for deliveries, lifts, cranes, and construction vehicles, such as excavators and skid-steer loaders. Construction workers and members of the project team, including the Project Managers and Superintendents, were not allowed to park on site. Instead, they were required to find parking in the local parking garages or on the surrounding streets, which had two-hour parking limits. Figure 12 illustrates the construction parking along E Street NW.

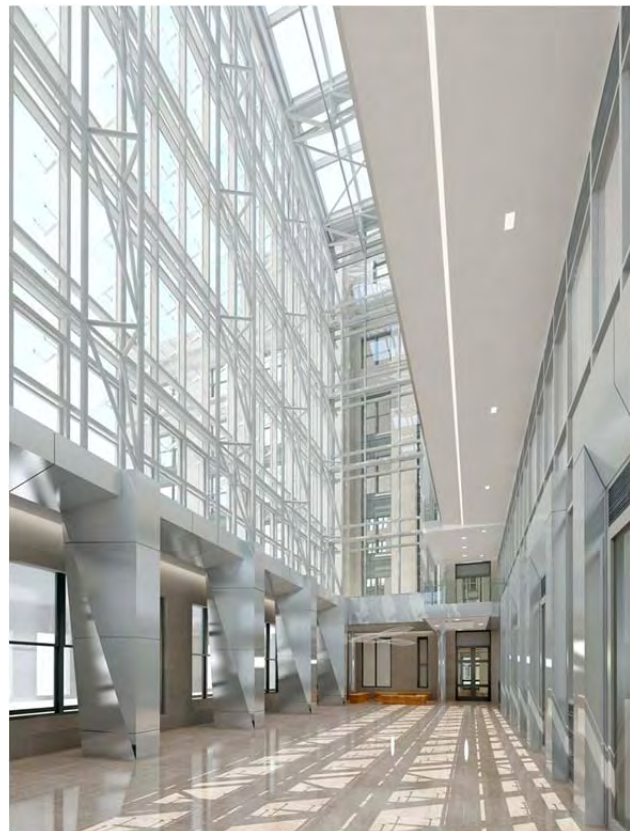
Figure 13: Interior rendering of the atrium showing the curtain wall system – Courtesy of the Whiting-Turner/Walsh Joint Venture

The curtain wall system on the south façade of the New Addition of the GSA Headquarters, as seen in Figure 13, rises over 78 feet in height and spans the entire length of the atrium. It is composed of seven 78-foot built-up truss columns consisting of HSS 5x5x3/8 members that are connected to 27-foot roof trusses. A 90-ton hydraulic truck crane, which will be located on E Street NW, will erect the atrium steel into place.

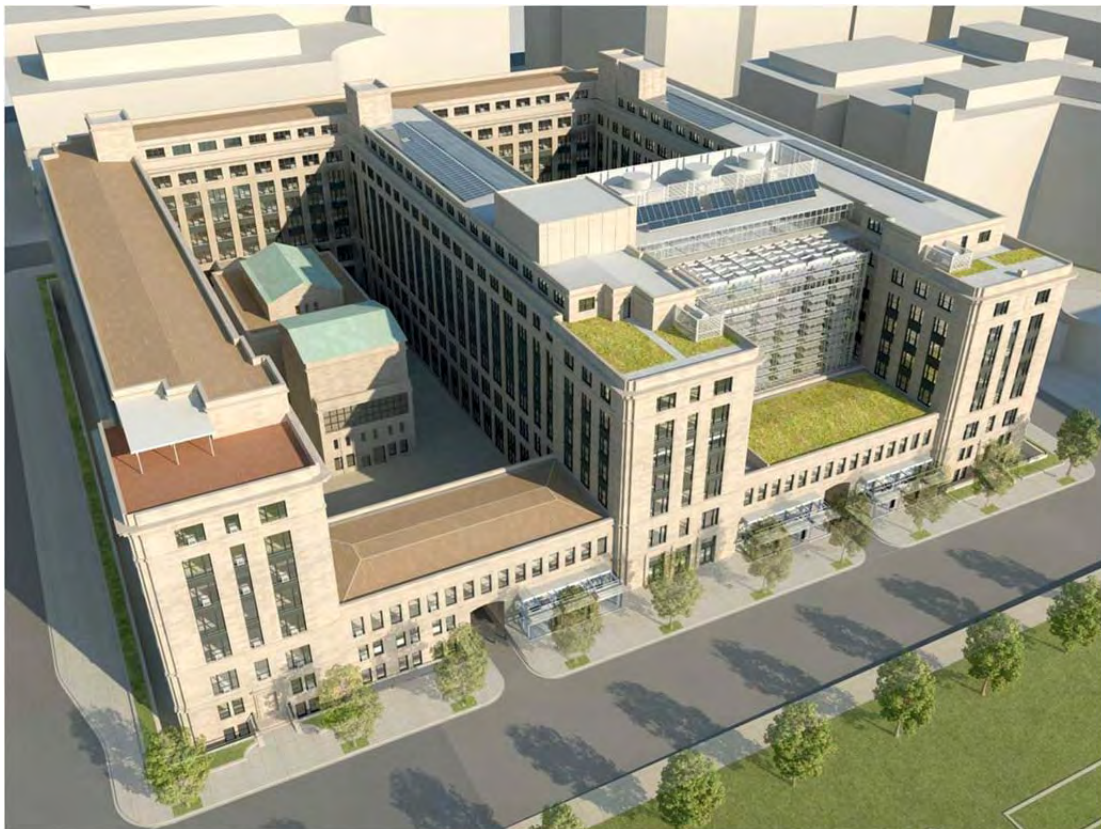
Figure 14: Exterior rendering of the atrium showing the curtain wall system of the New Addition in the East Courtyard – Courtesy of the Whiting-Turner/Walsh Joint Venture

The original façade assembly is located at the south façade of the New Addition in the East Courtyard, as seen in Figure 14. The atrium steel contains seven 78-foot built-up truss columns consisting of HSS 5x5x3/8 members that are connected to 27-foot roof trusses. A seated connection will be used to attach the roof trusses to the concrete beam on the Seventh Floor of the New Addition. A 90-ton hydraulic truck crane, which will be located on E Street NW, will erect the atrium steel into place. When fully erected, the lower 16 feet of the truss columns will be encased in concrete with stainless steel cladding and enclosed by the curtain wall system.

The curtain wall system is composed of an in-fill atrium exterior vertical glazing made of 1 3/16" clear, insulated argon, laminated, low-emissivity glass and an in-fill atrium horizontal glazing made of 1 5/16" clear, insulated, laminated, low-emissivity, fritted glass. The vertical glazing also consists of sunshades and motorized operable awning windows located along both the top and bottom of the curtain wall. The horizontal glazing contains operable windows at the skylights, extruded aluminum gutter assemblies with galvanized steel grating, and electrochromic glazing light sensors, which can automatically control the amount of light and solar energy that can pass through the glazing. The total surface area of the vertical glazing is approximately 9,575 square feet, while the total surface area of the horizontal glazing is about 3,600 square feet.

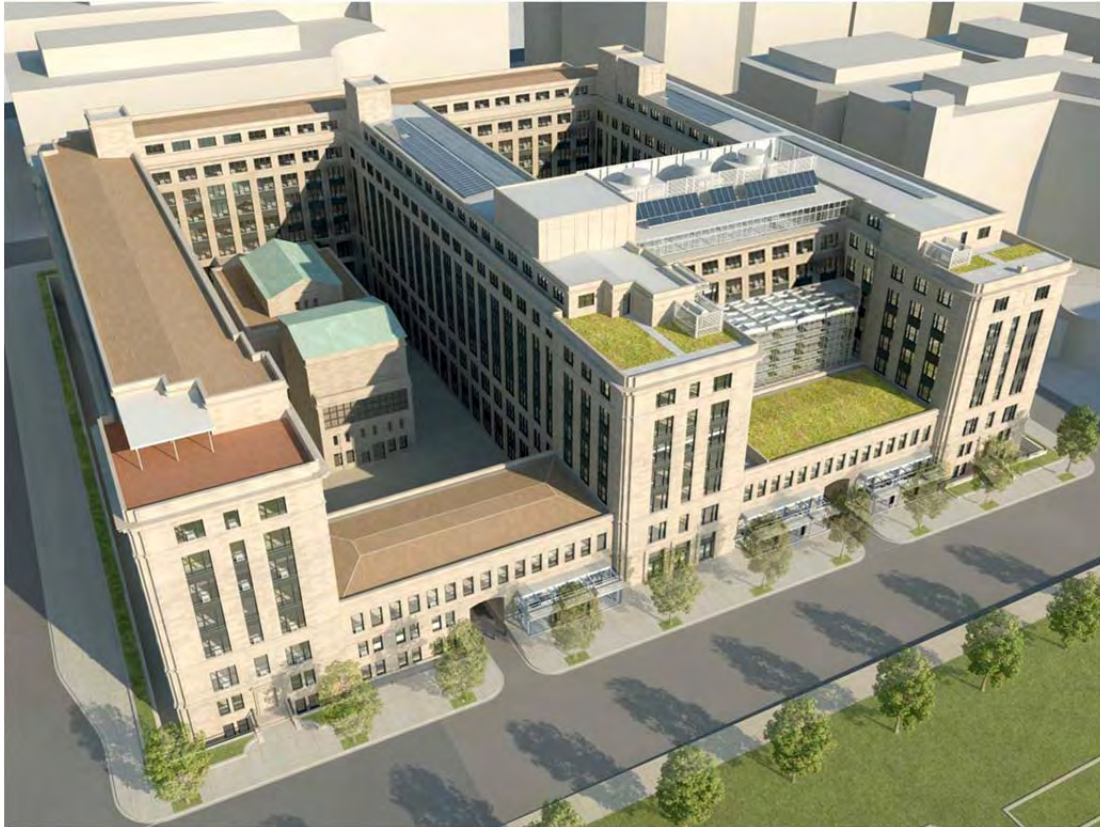
Figure 15: Exterior rendering of the proposed alternate atrium showing the curtain wall system of the New Addition in the East Courtyard – Rendering Edited by Ramuel Holgado – Original Rendering Courtesy of the Whiting-Turner/Walsh Joint Venture

masonry backup and 2-1/2" rigid insulation. The windows will be constructed with 1-1/16" clear, insulated, laminated, low-emissivity glass with an aluminum frame that matches the existing windows. A rendering of the alternate south-facing façade of the New Addition may be seen in Figure 15.

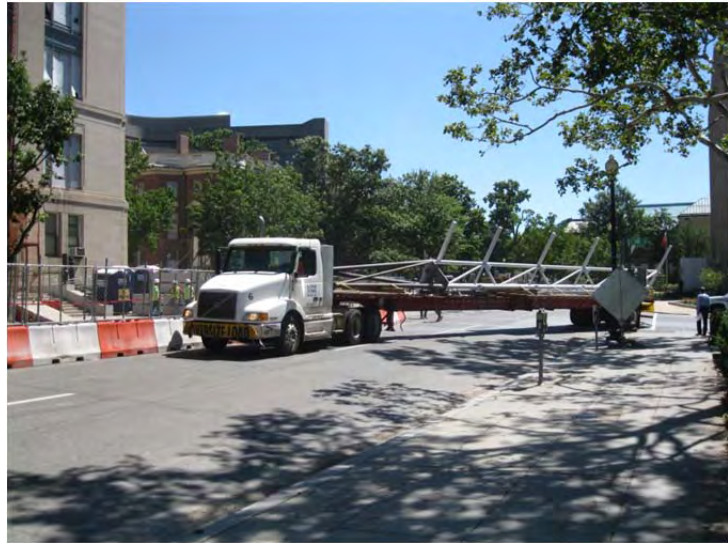
Figure 17: Atrium Built-Up Truss Column Delivery on the intersection of 18<sup>th</sup> Street NW and E Street NW – Courtesy of the Whiting-Turner/Walsh Joint Venture

The alternate façade may not have completely fixed any of these issues, but it certainly would have helped. Less belt courses would have needed to be notched out because the curtain wall is smaller. In addition, the shorter truss columns would have been easier to deliver to downtown Washington, D.C. and it may have been possible to deliver multiple daily. Although shorter truss columns may have allowed for a smaller hydraulic truck crane, ultimately, the actual 90-ton crane must be selected due to its extended boom length.

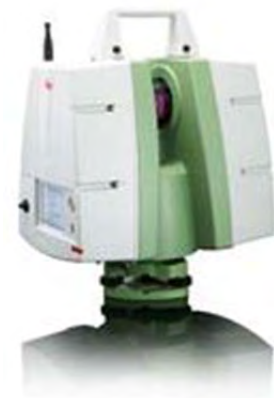
Figure 23: Leica ScanStation C10 –  
Courtesy of Leica

On renovation projects in the construction industry, the use of 3D laser scanning is a highly efficient way of capturing and analyzing the existing conditions of a building. Leica is a company that creates exceptionally accurate 3D scanners and software that can be utilized for building construction and BIM. The Leica ScanStation C10, as seen in Figure 23, is a versatile and cost-effective scanner that integrates a high-accuracy and long-range scanner, tilt sensor, data storage, and auto-adjusting video camera and laser plummet. It is also encased in a compact and portable design that can be easily carried around on the construction site. As noted by Dr. Craig Dubler, a virtual facilities engineer at the Office of Physical Plant and professor of the Department of Architectural Engineering at the Pennsylvania State University, the Leica ScanStation C10 is currently the best and most popular scanner in the industry.

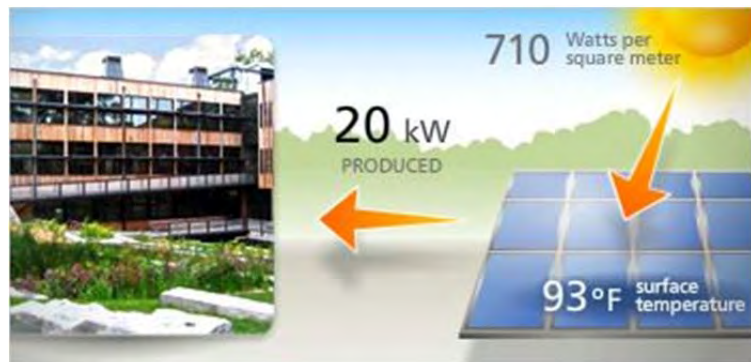
Figure 24: Data-Enabled Illustrations of the Renewables App – Courtesy of Lucid Design Group

Within Building Dashboard Network are Apps. Apps are tools that help users understand and learn how to better manage building energy and water use. The Comparison App enables users to compare their usage across their building or organization. Data can be compared during custom time periods between individual floors and wings, apartments, and end uses, among others. Real-time resource use reduction competitions can then be held by comparing collected data. These competitions can be held from a variety of levels, ranging from individual floors or areas within a building to entire organizations. The Renewable App enables users to see the performance of renewable resource technologies of their building with the use of data-enabled illustrations, as seen in Figure 24. For example, occupants will be able to visualize the efficiency, savings, and payback for solar photovoltaic, geothermal, and rainwater collection systems.

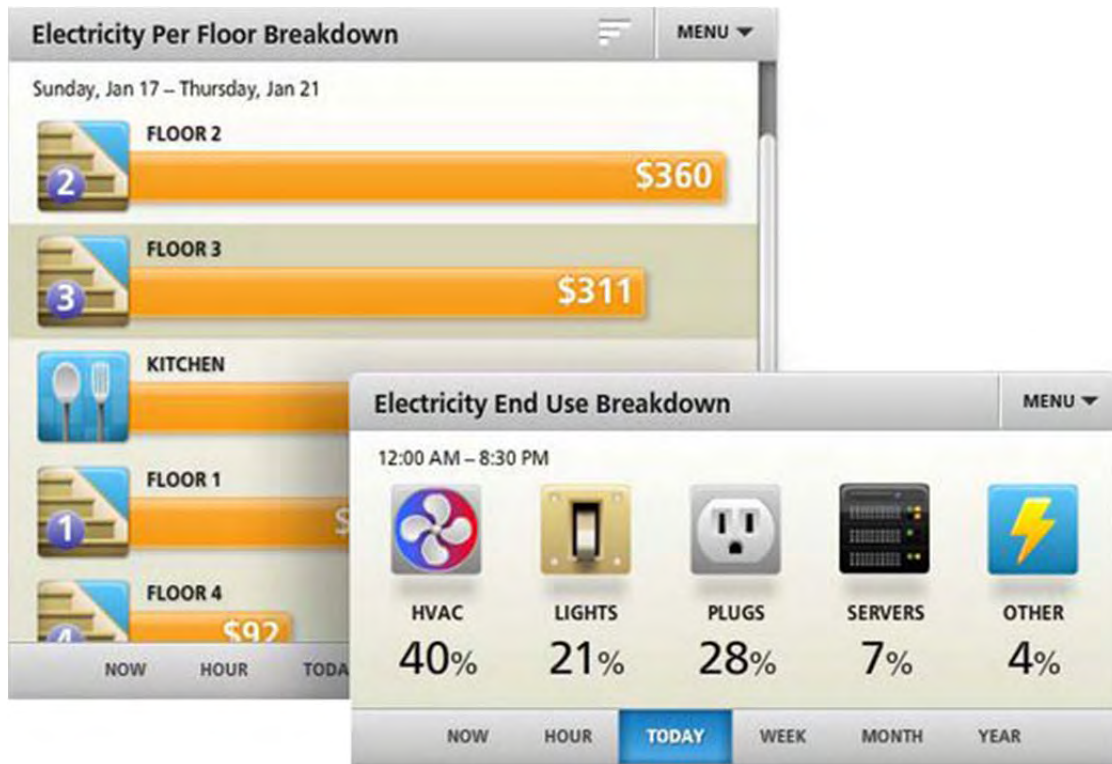
Figure 25: End Use Breakdowns – Courtesy of Lucid Design Group

the resource, progress is measured in kilowatt-hours, gallons, carbon dioxide emissions, or dollars. Another vital component of Widgets is its ability to display end use breakdowns. This lets occupants see exactly where all of their energy and water is being used. In addition, further breakdowns enable users to see energy and water use per room, floor, or wing. Figure 25 shows an example of end use breakdowns.
