CNBC GLOBAL HEADQUARTERS

Englewood Cliffs, NJ

Christine Cajilig | Lighting/Electrical | Thesis 2005

Presentation Outline

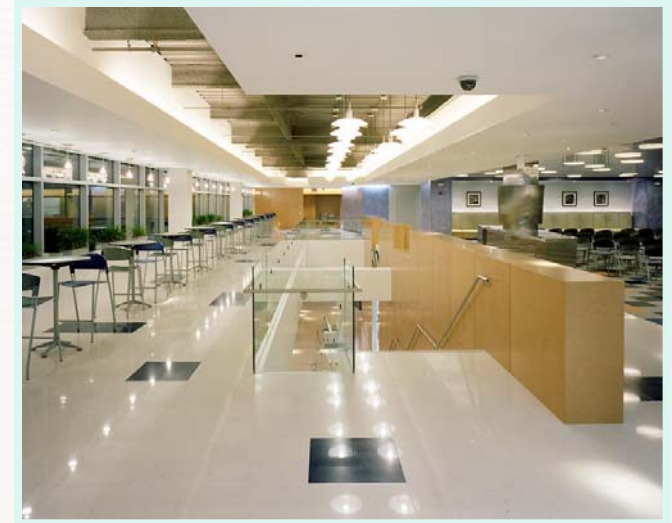
- Anigre wood paneling on stair walls
- Blue terrazzo accent walls, terrazzo floor tiles
- Metal fabric ceiling on middle section of cafeteria

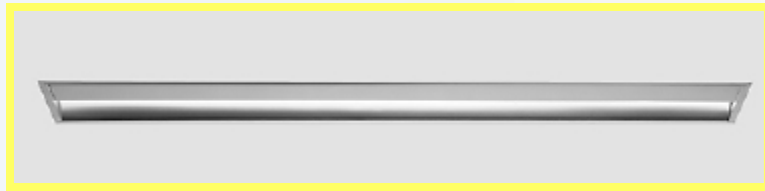
- F1 – Fluorescent wall wash (F28T5/835)

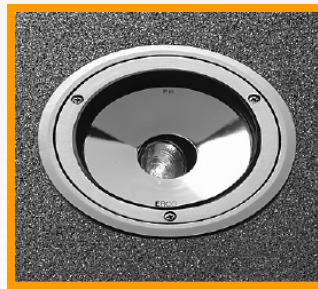
- L1 – Low voltage spot light (50MRC16)

- L2 – Low voltage directional uplight (20MRC11)

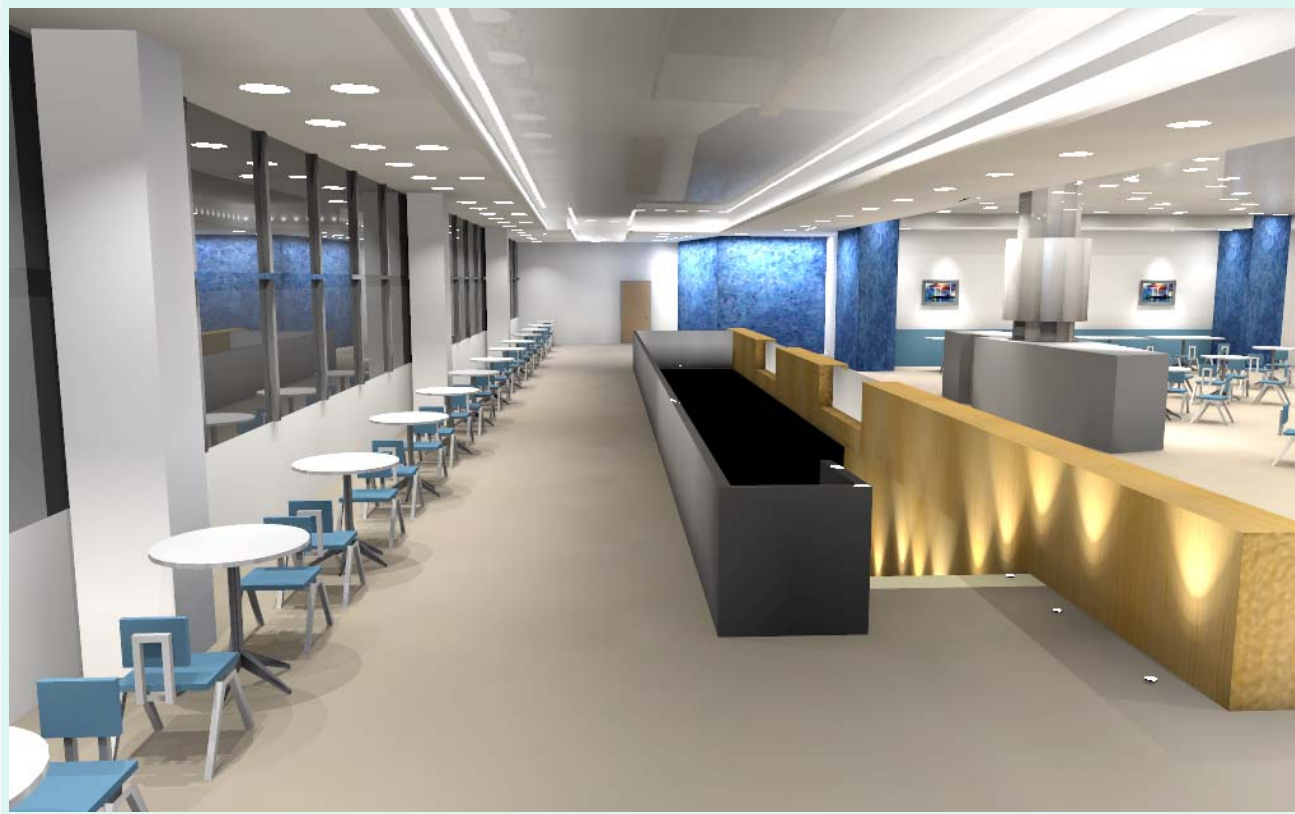
North end: 14.4 fc horizontal, 4 fc vertical illuminance

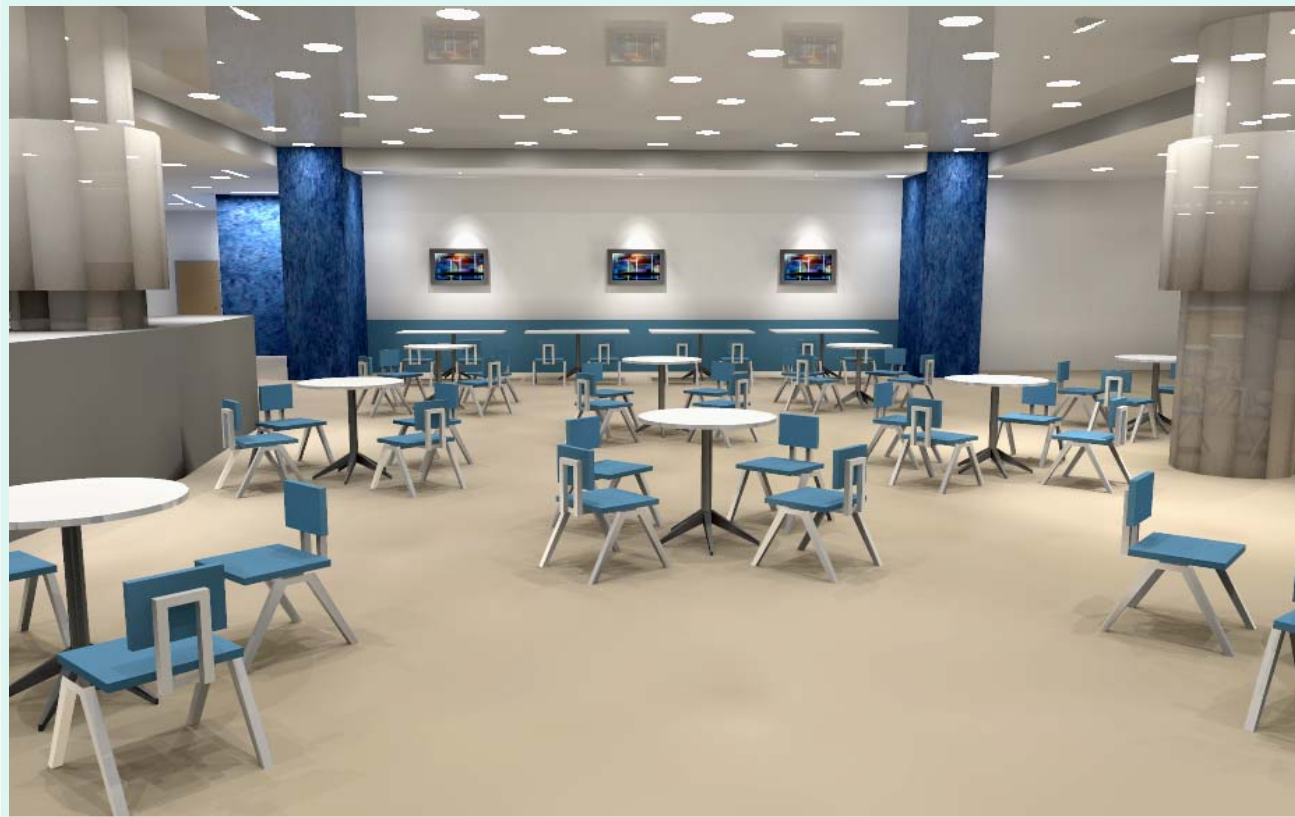
Middle: 21.3 fc horizontal, 9 fc vertical illuminance

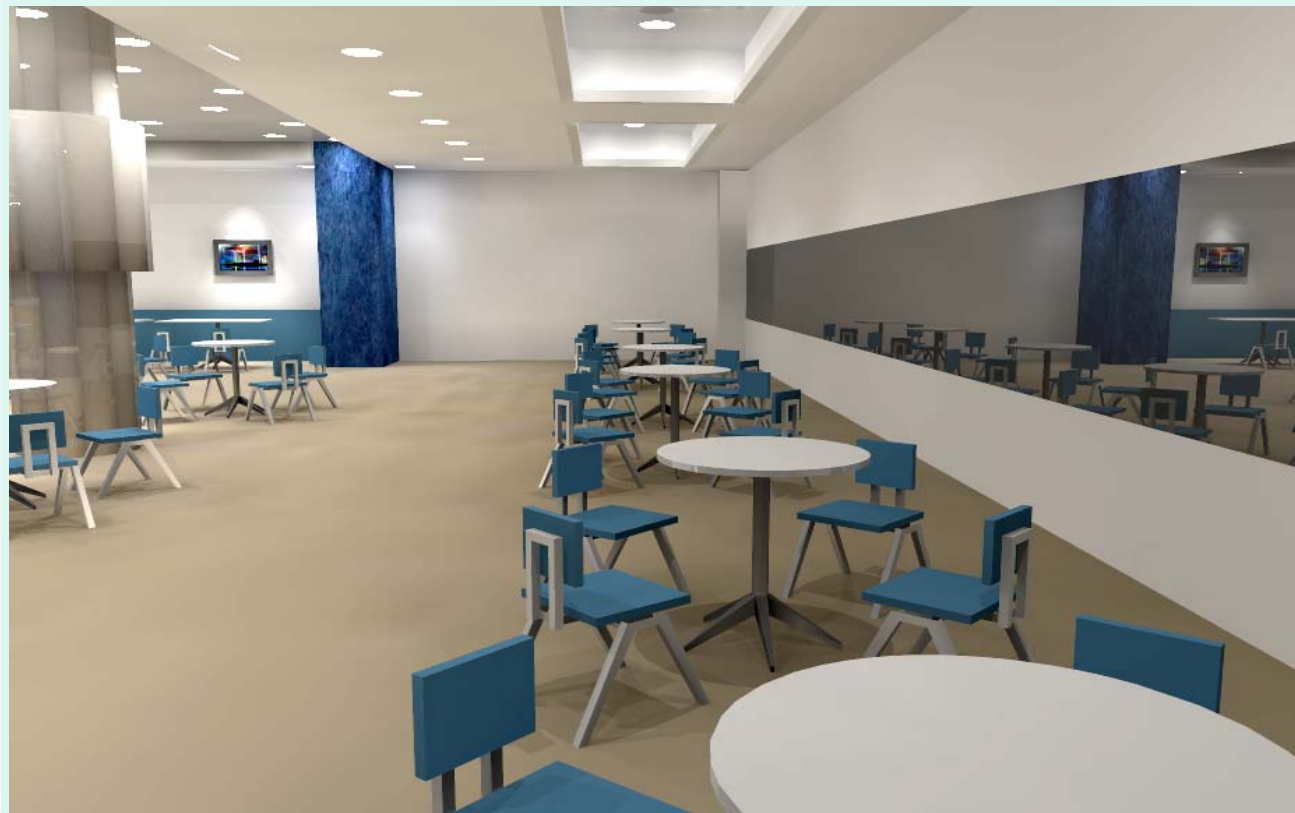
South end: 10 fc horizontal, 3 fc vertical illuminance

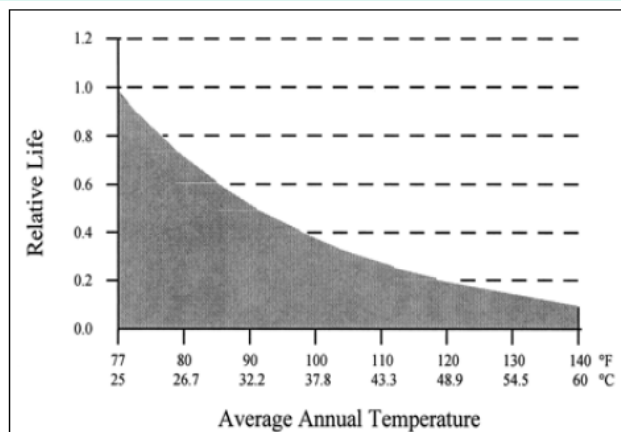
- Battery life over average annual ambient temperature shows decline in life as temperature increases

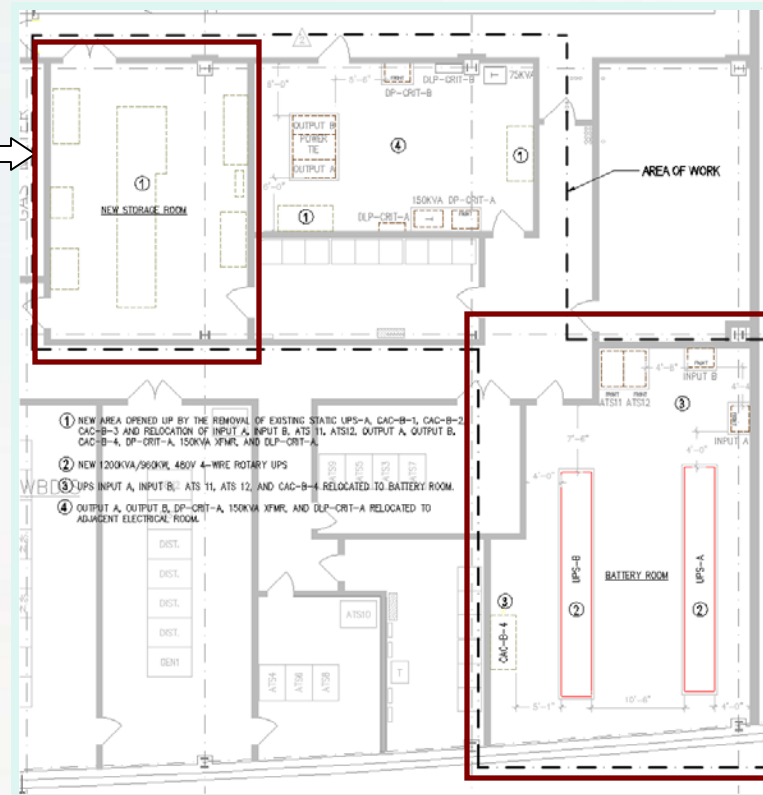
- More compact – occupied 30% less space

Reclaimed space →

← New location of UPS
