# **Amanda Gerstenberg**

**Senior Thesis**

**Structural Option**

**The 400  
Bremerton, WA**

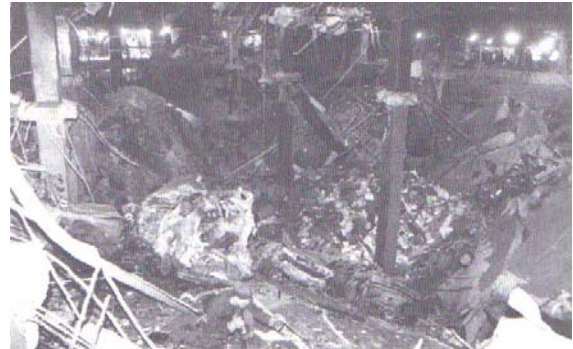
Figure 3: Location of Explosion World Trade Center Bombing

This book was written in 1995, so the extent of the World Trade Center tower research was the terrorist car bomb which exploded on February 26, 1993. This explosion killed six people, injured some, and created hundreds of millions of dollars in repairs. The bomb was about 900 kg of explosives and was located along the south wall of the north tower. It was detonated two levels below grade in the parking garage, where most of the damage occurred. Smoke clogged up many of the air locks, causing more problems with other building functions and accessibility throughout the building, such as communication, life-safety, electrical, and control center operations. As shown in Figure 3, there was significant localized damage, but the structural portion of the building as a whole did not suffer any major damage. The hotel next door, the Vista Hotel, did sustain substantial damage.

This example of an explosion proves that not only should the structural integrity of your building be evaluated for loads of blasts occurring inside the building, but the loads that can affect your building from an explosion nearby should also be considered. Luckily, The 400 is currently the largest building or comparable to the largest building in the area, so The 400 should be able to withstand damage from an explosion in a nearby building as long as it is designed to resist that same explosion inside The 400.

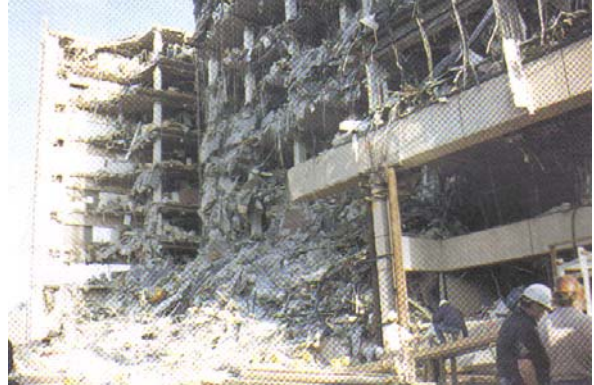
Figure 4: Damage to the North Side of the Alfred P. Murrah Building

A second building researched by The National Research Council was the Alfred P. Murrah Federal Building of Oklahoma City, Oklahoma, better known as the Oklahoma City Bombing. This blast occurred on April 19, 1995 and was even more catastrophic than the World Trade Center explosion. The blast killed 167 victims and injured an additional 782 victims. The homemade car bomb used in a rental truck on this building contained approximately 2177 kg of explosives and was within 5 meters of the building. As expected, the most extensive damage was located where the bomb exploded on the north side of the building, as shown in Figure 4.

This nine-story building was made of reinforced concrete slabs and was two bays wide, limiting the redundancy of the structure. Losing one transfer girder would cause a 40 ft x 35 ft part of the structure to collapse while losing one primary column could cause an 80 ft x 35 ft part of the structure to collapse. The actual impact then caused three out of the four front columns and one centerline column to be destroyed, causing 8 of the 10 bays located on the side of the explosion to collapse.

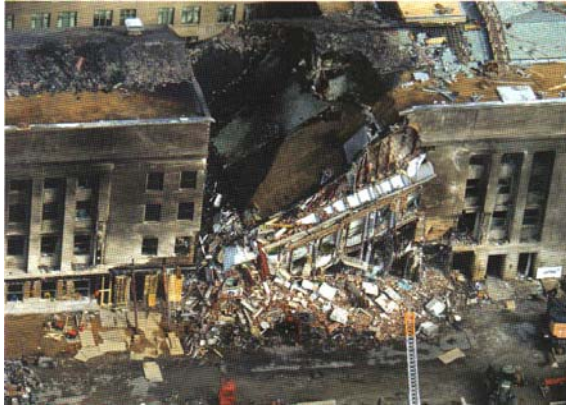
Figure 7: Aerial View of the Pentagon Blast

broken were from the actual fire or firefighters instead of the plane itself. An aerial view of the destruction to the Pentagon is shown in Figure 7. It is very clear that this plane crash caused a localized collapse of The Pentagon. The analysis team concluded that approximately 30 first-floor columns were completely destroyed by the crash and about 20 additional columns along the line of the crash were destroyed as well. The crash created a total damaged area of approximately 75 feet by 230 feet. Figure 8 shows a plan of the columns which were damaged due to the impact of the plane. Following the crash, the fire caused from the fuel then caused spalling of the concrete in a few areas as well as heat damage to other areas.

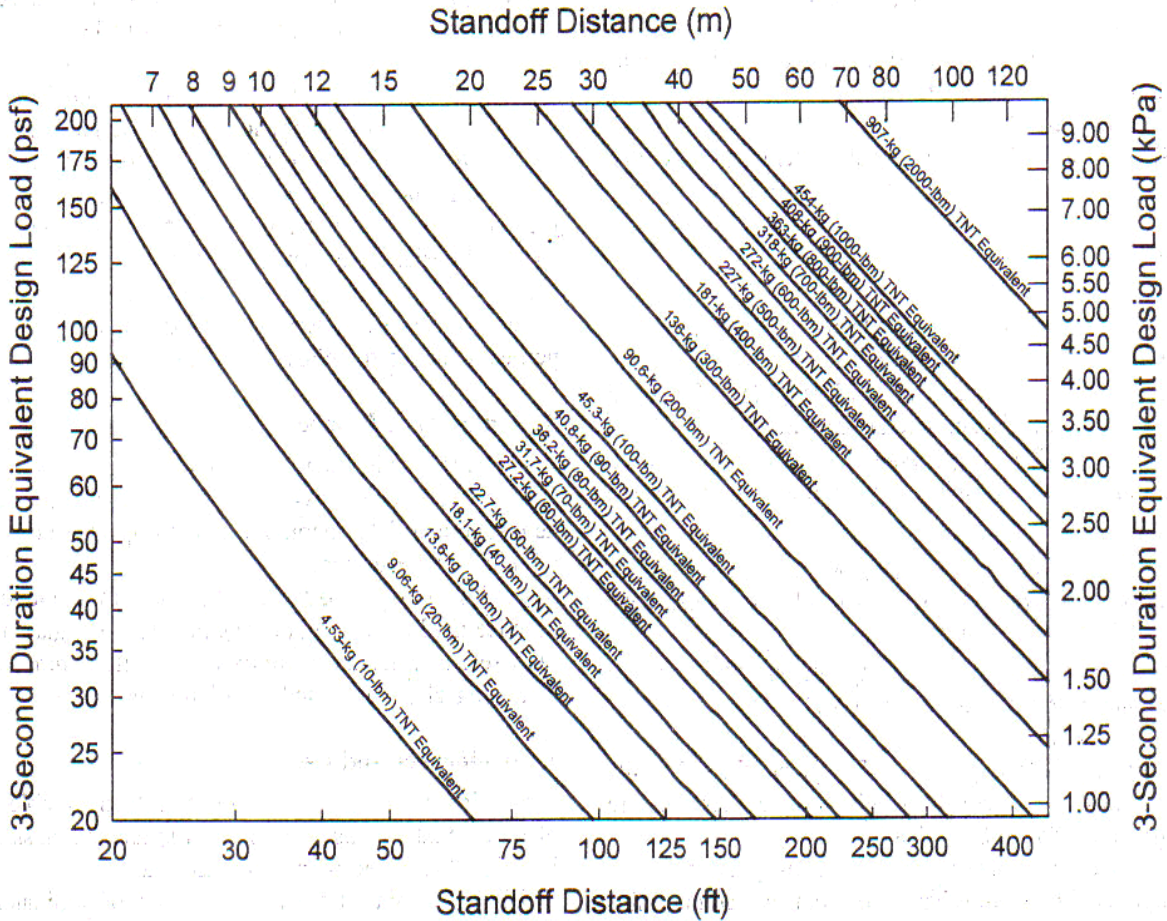
**Figure 25: Design Load for Gazing Based on Standoff Distance and Blast Load**

Glazing is the part of a building envelope which often fails during a blast but is rarely ever evaluated to become blast resistant according to ASTM F2248-03. Failure of the glazing on a structure allows the pressure from the blast to enter the building, increasing the building damage. An increased blast resistant glazing will most likely limit the number and size of glass particles formed during a blast. Since glass missiles are extremely destructive during an explosion, blast resistant glazing would prove to be a worthwhile investment. Figure 25 on the following page shows a chart in which the

equivalent loading which the glazing must be designed to resist based on the standoff distance and the size of the bomb is shown. As expected, the larger the bomb to resist, the larger the design load for blast resistant glazing.
