DEREK C. BAUER
CONSTRUCTION MANAGEMENT
DR. MICHAEL HORMAN

TECHNICAL ASSIGNMENT #1

OFFICE/RETAIL BUILDING
WASHINGTON, D.C.

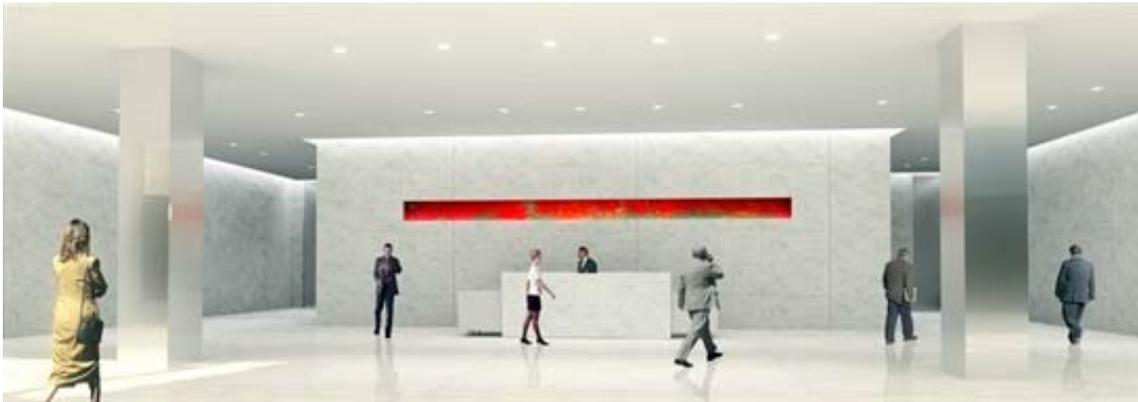
NEW ENTRANCE LOBBY

This existing downtown 10-story office/retail building was fully-renovated with a new façade and state-of-the-art building systems. Located at a street corner of the D.C. business district, this newly developed design prominently sets itself apart from its surrounding buildings. The new “skin” of the building features a glass curtain wall system with white metal panels on the two sides of the building facing the street, which replaces the existing strip windows and brick façade. The floor-to-ceiling glass provides office tenants plenty of natural light along with landmark views of our nation’s capital. This vertically configured design also consists of a new monumental roof cornice to add to its architectural stature. Other new features include an entrance canopy, rooftop terrace, and an enhanced retail storefront at street level. The building footprint is shaped like an “L”, which allows space for a private courtyard in the northwest corner of the site. The new glass vestibule on the east side of the building leads into an elegant lobby area highlighted by Carrara Italian Marble panels with luminous wall panels running along the perimeter.

The majority of the new masonry work consists of two new elevator CMU shaftwalls and other various CMU walls throughout the first floor and penthouse. The new lobby area is highlighted by Carrara Italian Marble wall and floor panels.

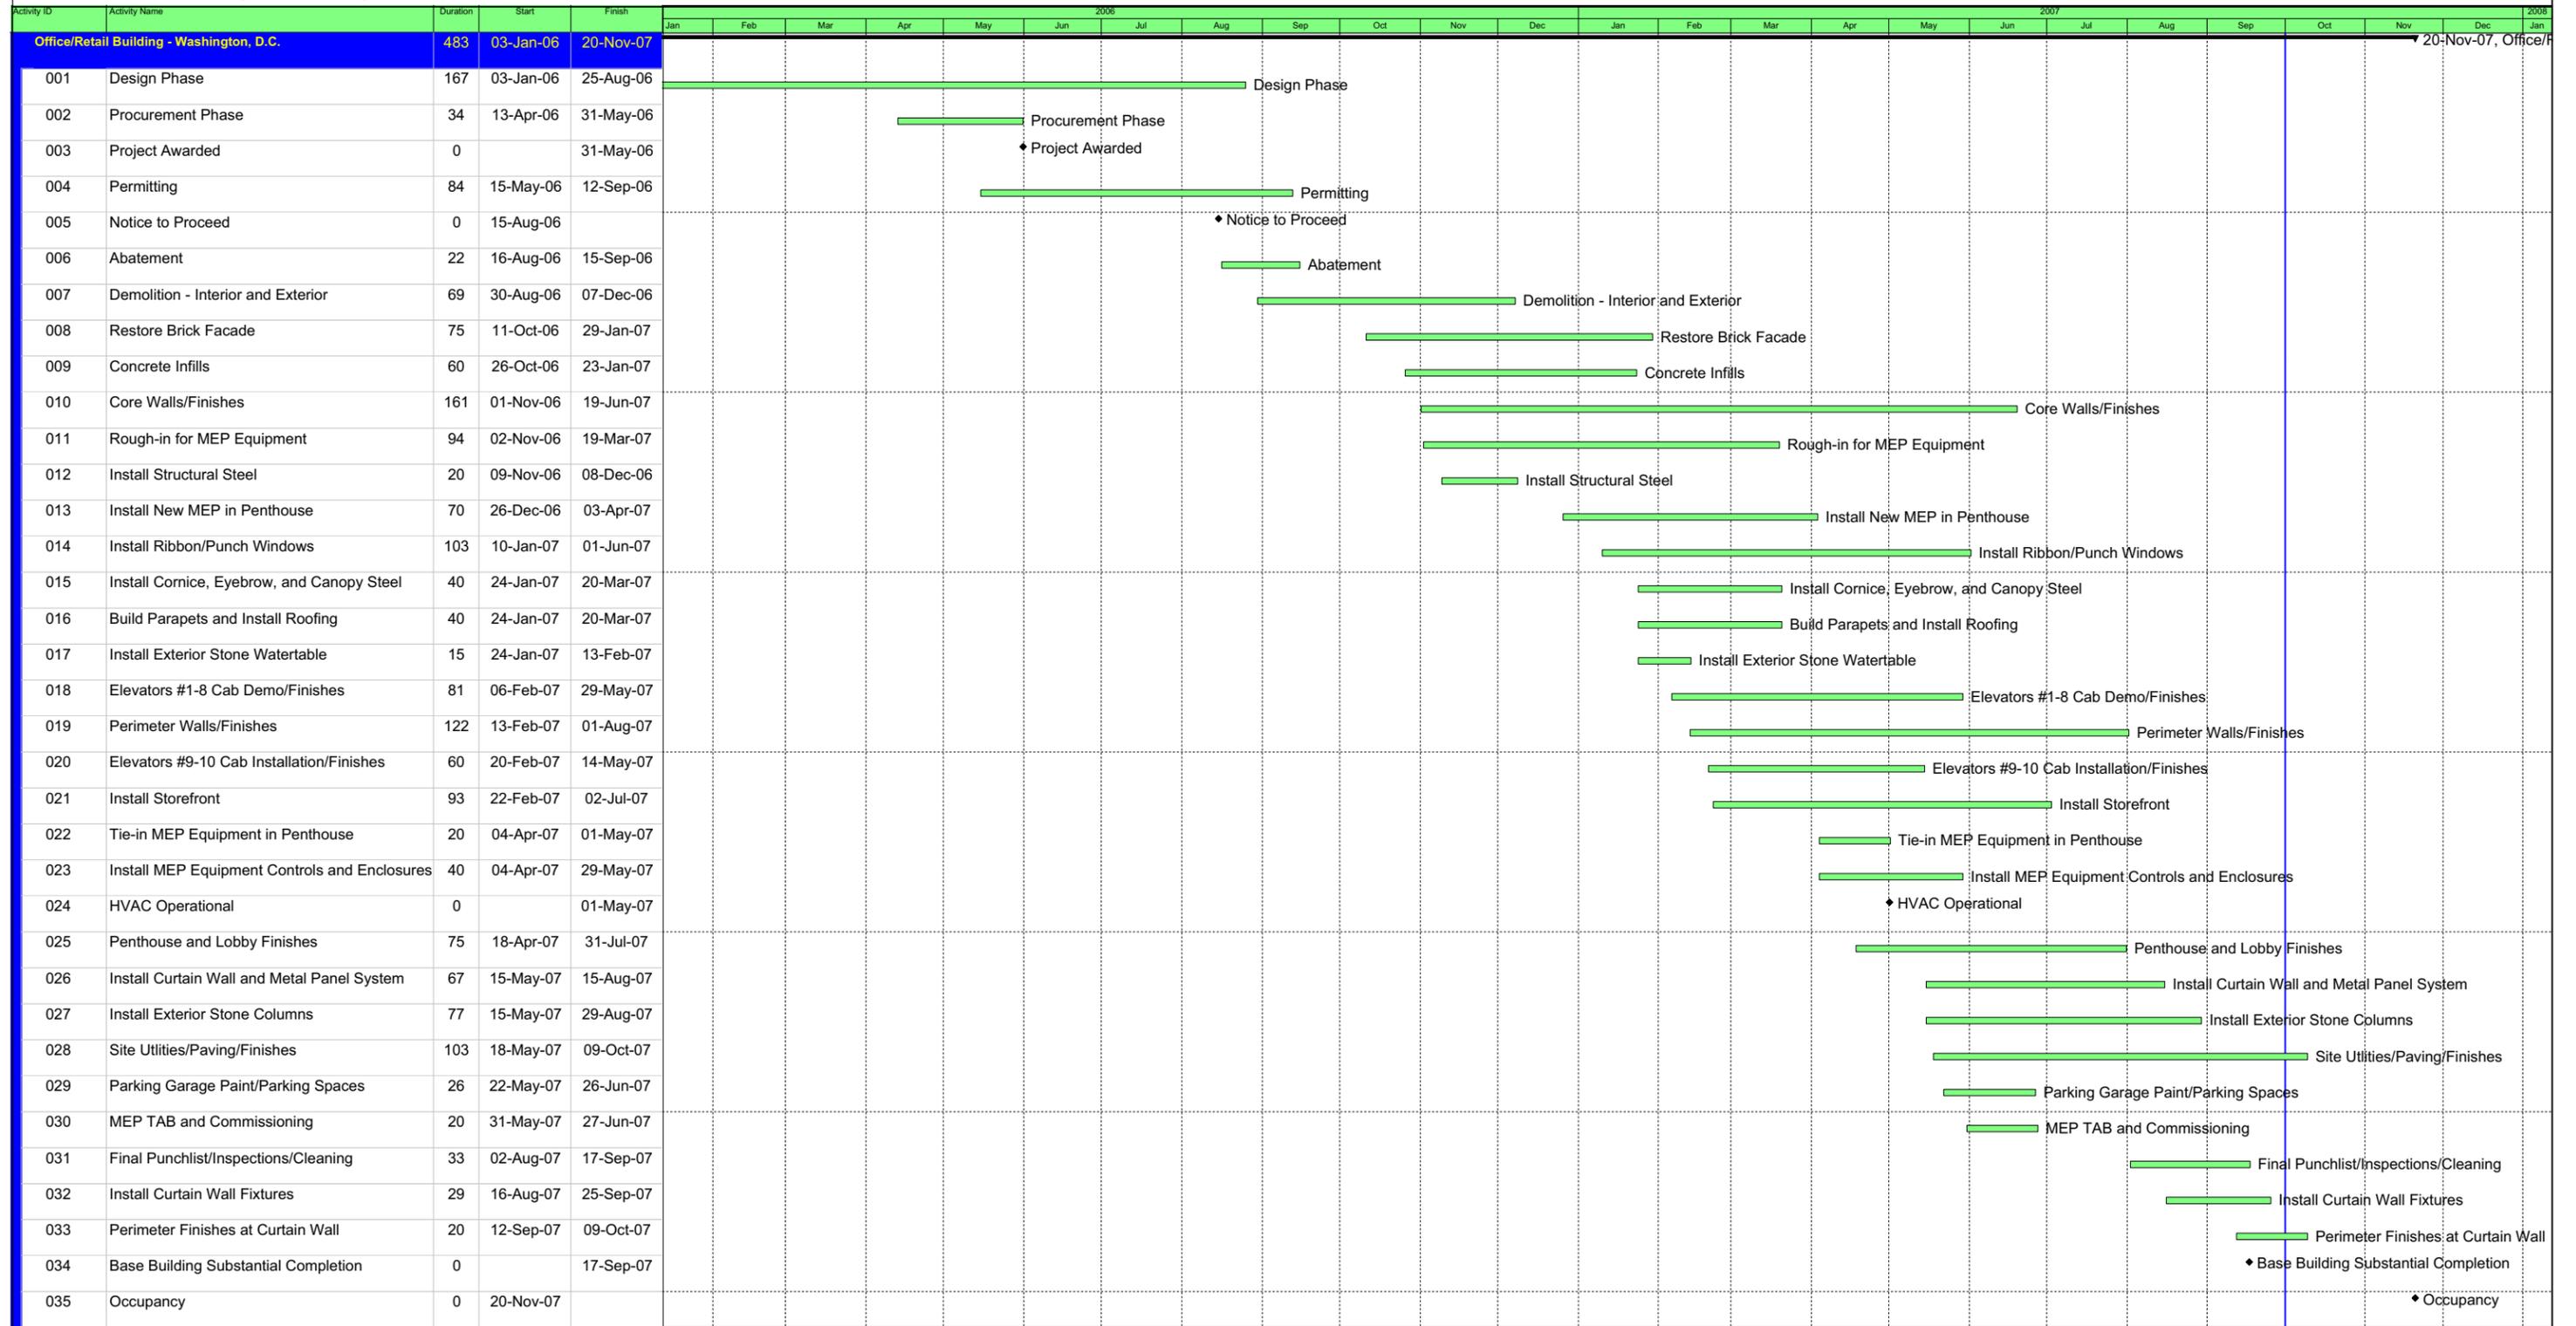
Office/Retail Building - Washington, D.C.

The schedule for the office/retail building renovation project is a fast-paced 13 months, which includes extensive demolition and abatement. The foundation and structural systems of the building were slightly modified from the existing building with the new elevator pit for elevators #9-10 and steel bracing beneath the penthouse floor and throughout the major mechanical shafts. The finish sequencing for the core included a “top-down” approach for the interior and an “end-to-end” method for the curtain wall installation. Per the owner’s interest, the bathrooms and electrical rooms were finished starting at Level 10 and working down to Level 2. It is important to point out that the owner had a special agreement with the curtain wall subcontractor which allowed them to complete their work after the general contractor’s substantial completion date. Also, the tenant contractor was still performing work after substantial completion, which is why the occupancy milestone is placed towards the end of November.

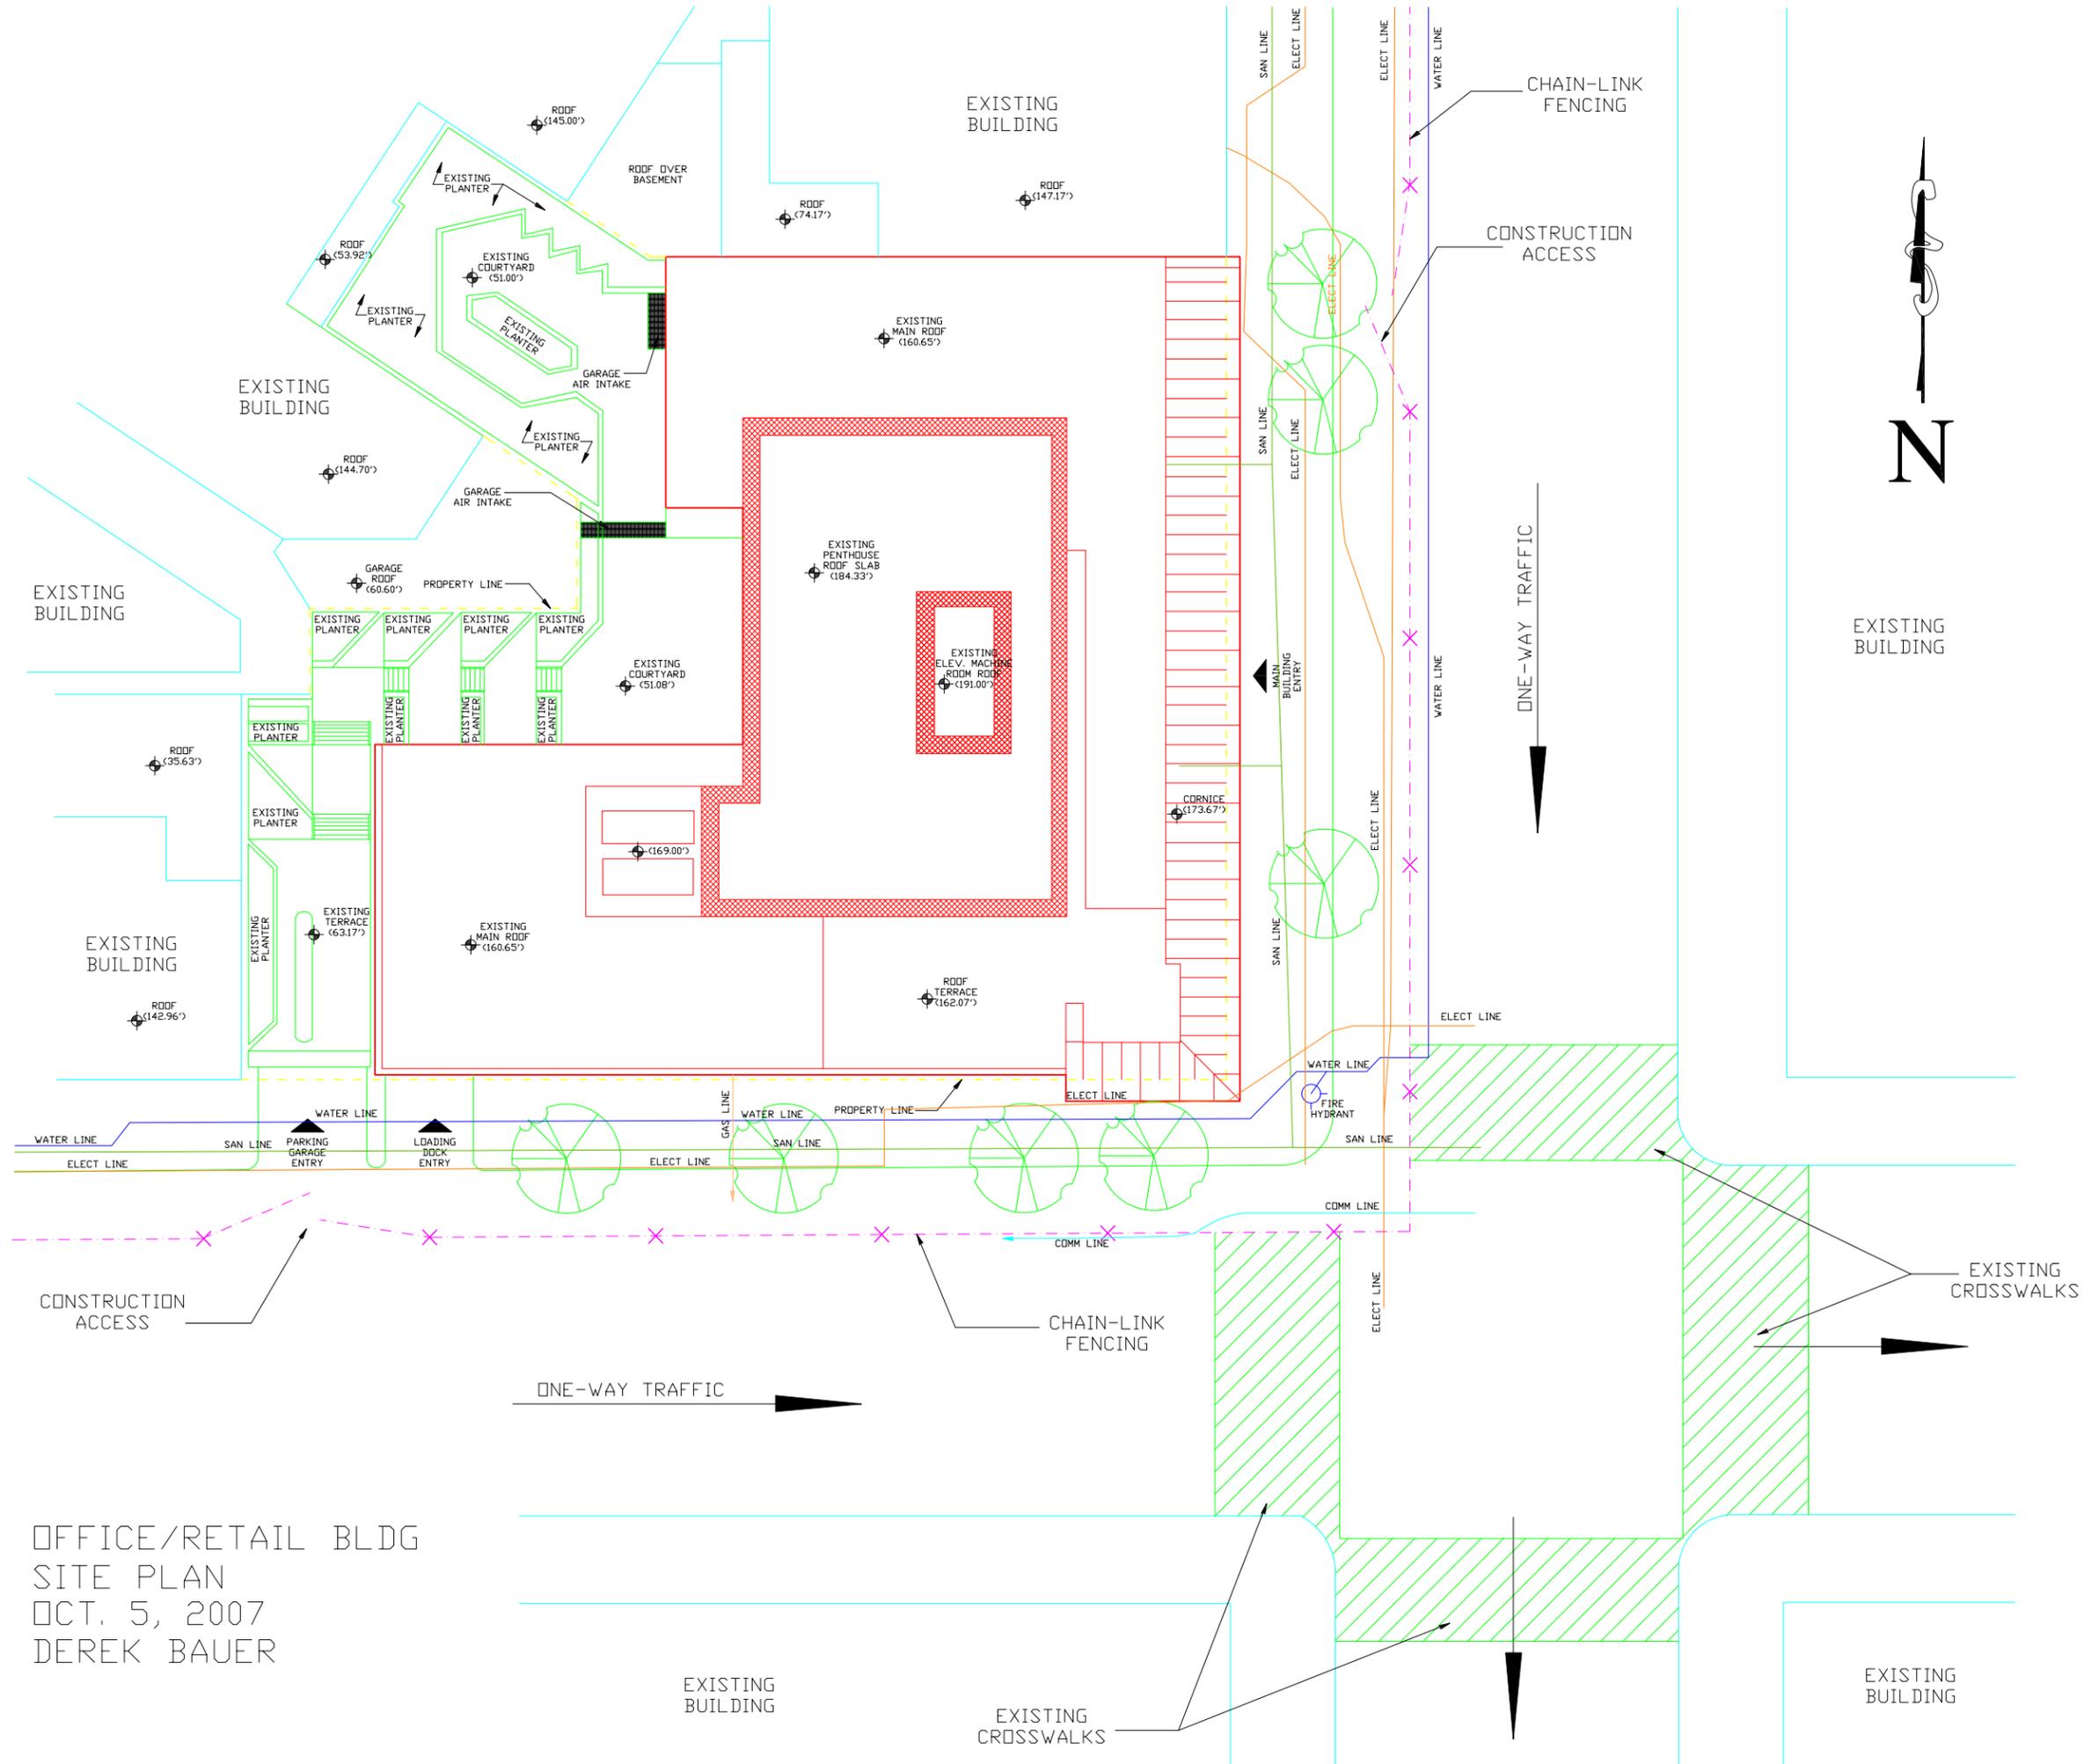
OFFICE/RETAIL BLDG
 SITE PLAN
 OCT. 5, 2007
 DEREK BAUER

The site plan of existing conditions clearly indicates a congested site in the business district of downtown Washington, D.C. There is a temporary jobsite trailer/office located on the third floor of the existing building. Parking is available on-site in the three levels of underground garage space. A temporary chain-link fence partially blocks off a portion of the street on the south and east sides of the building to allow for crane placement, deliveries, and staging areas. The rear courtyard is used for smaller amounts of stored materials.

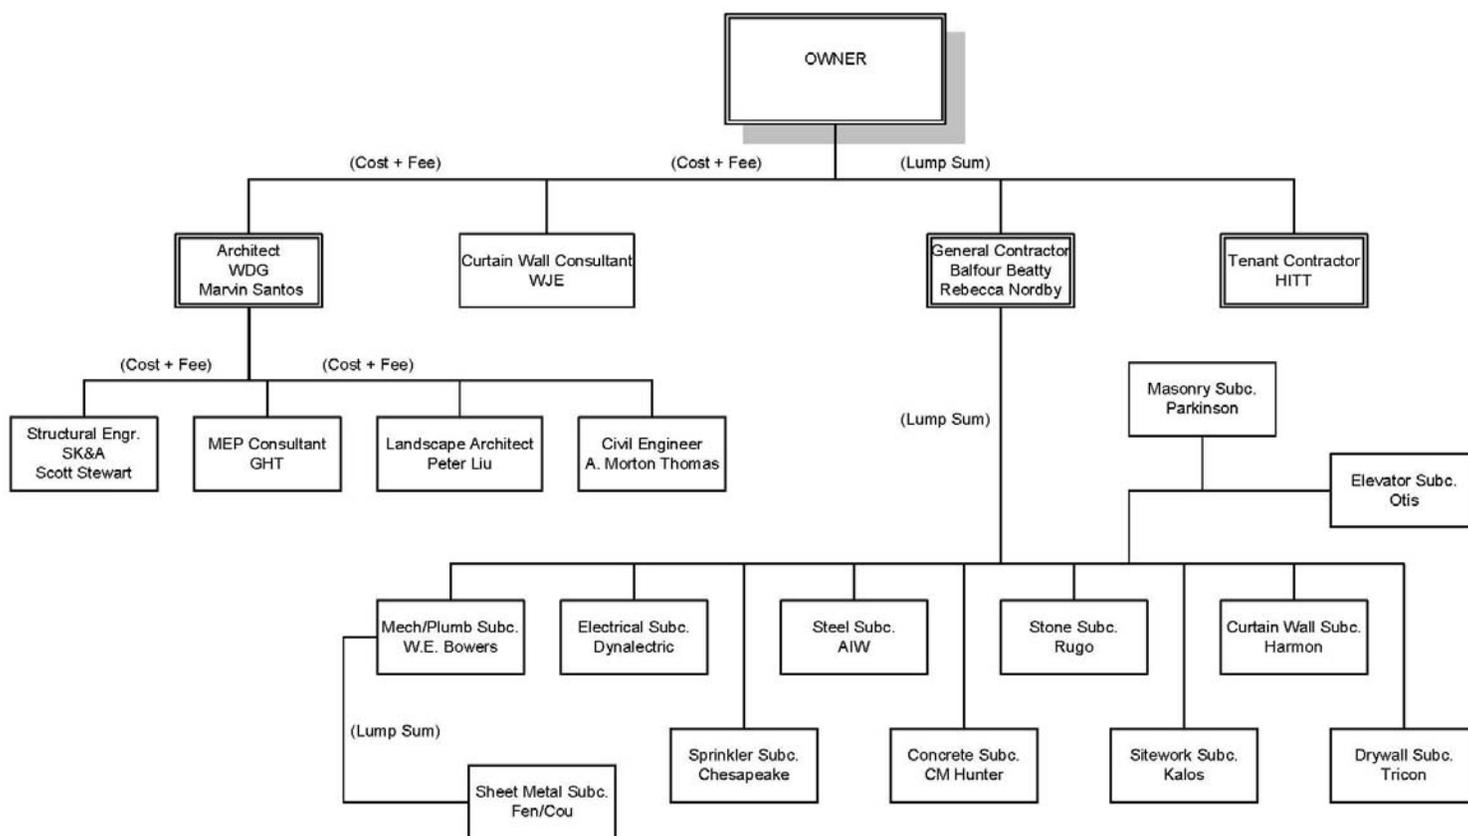
The project delivery system used in this office/retail building project was design-bid-build. This approach was taken to use competition to get the best price and value possible for the owner. The owner held “cost plus fee” contracts with the architect, WDG, and the curtain wall consultant, WJE. The contract between the owner and the general contractor was a “lump sum” agreement. The general contractor, Balfour Beatty, held “lump sum” contracts with each of their subcontractors and suppliers. The major subcontractors are indicated in the diagram below.

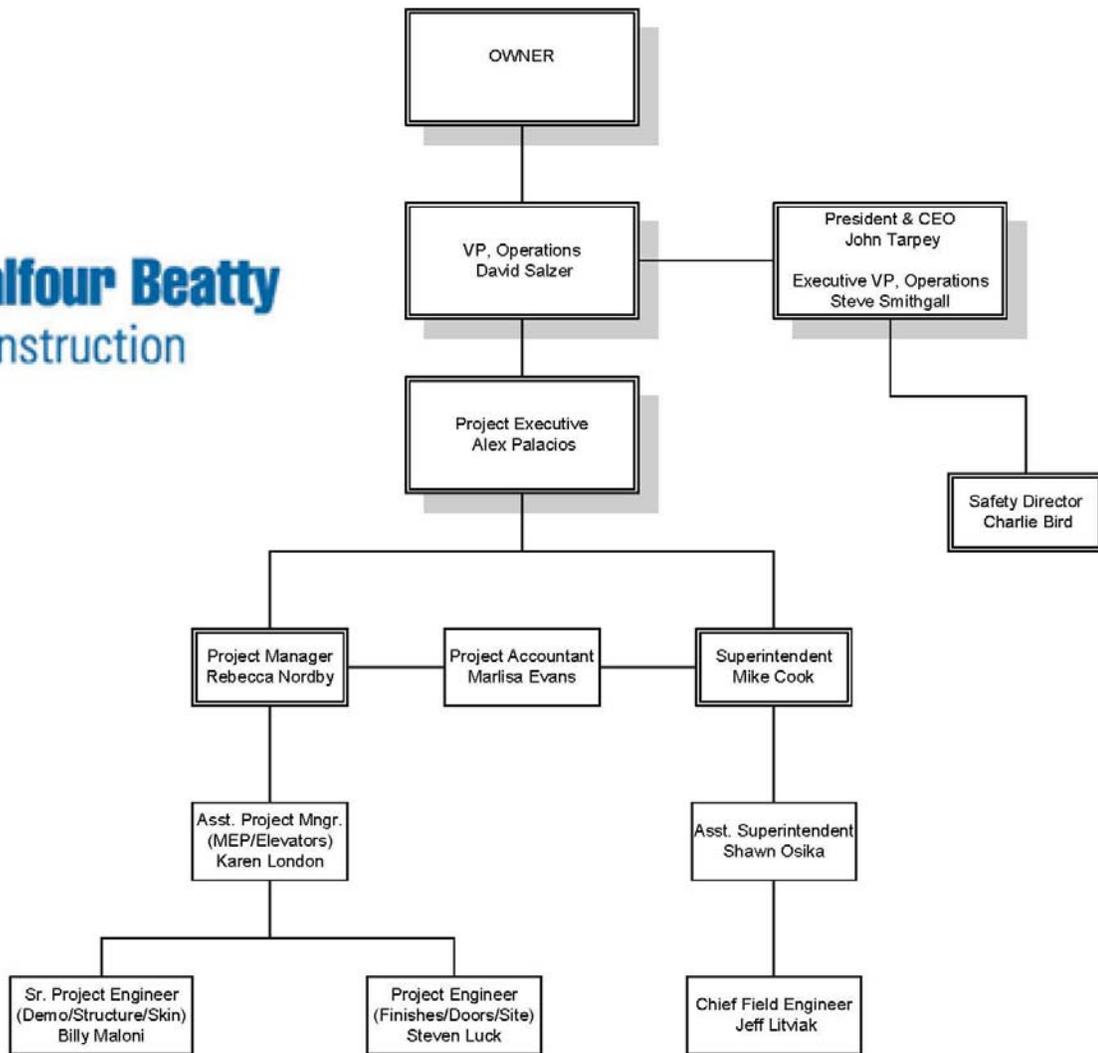
As outlined in the organizational chart below, the general contractor staffing plan of the office/retail building involves several hierarchical relationships, with the Vice President of Operations acting as the “middle man” between the company executives and the Owner. The Project Manager and Superintendent each have important management roles and report directly to the Project Executive, who in turn reports to the Vice President of Operations over him. The Assistant Project Manager reports to the project manager while also overseeing the Senior Project Engineer and the Project Engineer positions. The responsibilities of the major trades of the project are divided amongst the three sub-positions of the Project Manager. The Superintendent is also assigned an Assistant Superintendent who oversees the Chief Field Engineer of the project.
