Nicole C. Jenkins
Construction
Management
April 15, 2008

Mercy Medical Center - Replacement Tower

Replacement Clinical Tower

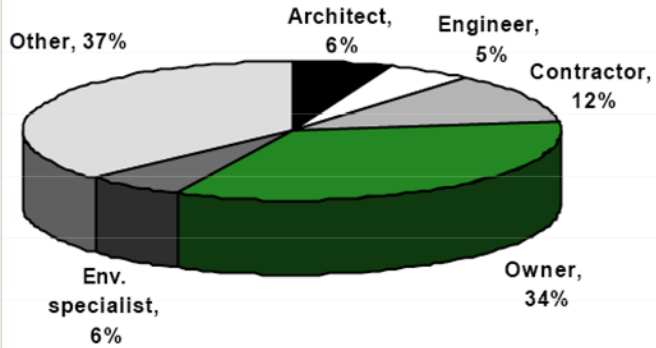
Actually Responsible for I.C.

- ▶ More than a third (34%) of respondents cite owners as the individuals who were responsible for infection control planning and execution on their last project. Contractors (12%), environmental specialists/industrial hygienists (6%), architects (6%), and engineers (5%) are also cited as responsible parties.

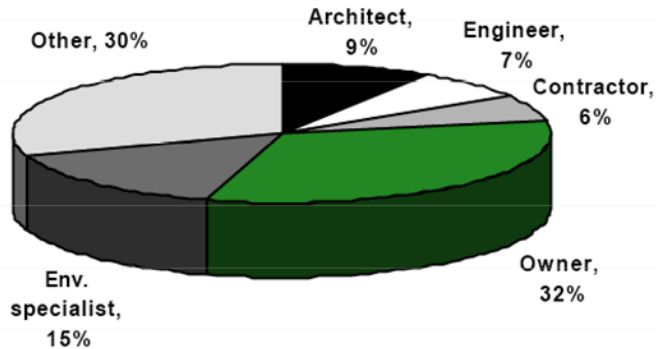
Should be Responsible for I.C.

- ▶ When asked who *should* be taking the lead in infection control planning and execution, respondents say that fewer owners (32%) and contractors (6%) should be responsible, while more environmental specialists (15%), architects (9%), and engineers (7%) should be responsible.
- ▶ Other individuals cited by respondents as being responsible on past projects, as well as who *should* be responsible, include infection control practitioners/specialists/nurses or teams of individuals.

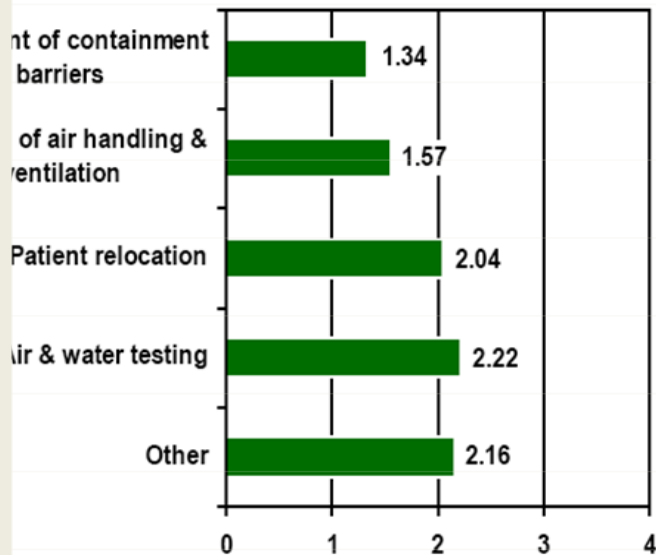
Placement of Containment Barriers Most Frequently Employed Infection Control Measure

Average Rank of Infection Control Measure Use (1 = frequently, 3 = not often)

- ▶ Respondents ranked the frequency infection control measures occur on their projects in the following order (average ranks): placement of containment barriers, isolation of air handling and ventilation, patient relocation, and air & water testing.
- ▶ More than half (55%) of respondents cite placement of containment barriers to be the most frequently employed infection control measure.
- ▶ Other frequently employed infection control measures include negative pressure/air filtration, dust control, materials testing, and staff training.

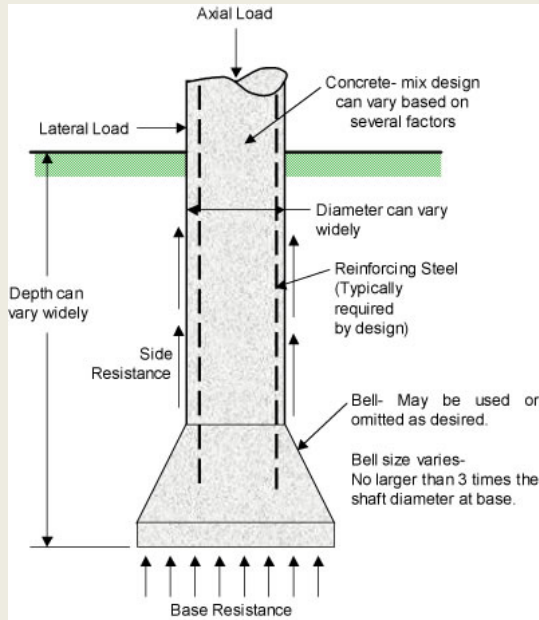
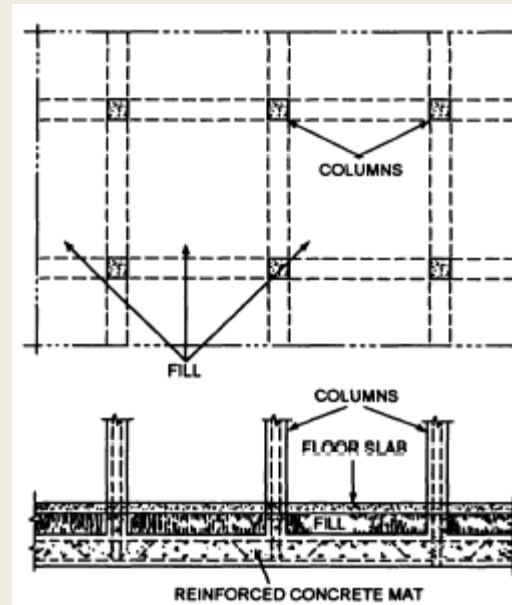
Drilled Shaft Foundation

Vs.

Mat Foundation

Advantages of Mat Foundation

- Cost (affordable)
- Construction Procedure (simple)
- Materials (mostly concrete)
- Labor (does not need expertise)

Disadvantages of Mat Foundation

- Settlement
 - Limit Capacity * Soil * Structure
 - Irregular ground surface (slope, retaining wall)
- Foundation subjected to pullout, torsion, moment
