Final Thesis Report:

Maintaining a Safe and
Functional Building
Environment

The Wilmer Eye Institute Outpatient Surgery & Laboratory Building Baltimore, Maryland

Construction Management

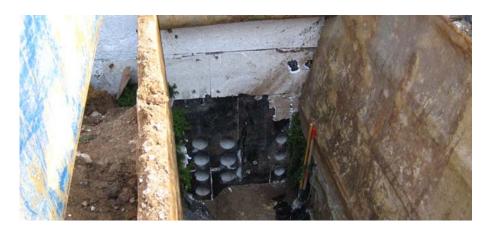
Looking east into the tunnel trench at utility connections to the adjacent Cancer

Research Building I

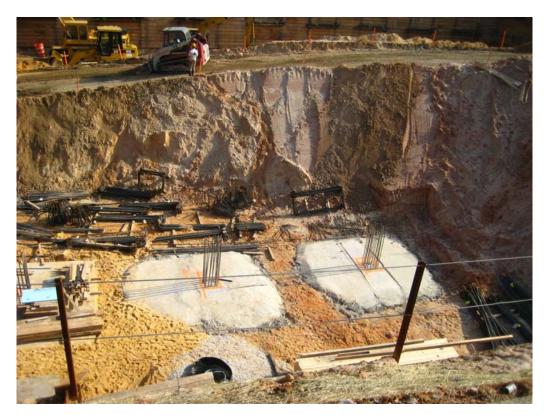
Completed column footings

The foundation work is scheduled to begin on the 24th of October, 2007. Spread footings will be excavated and concrete will be placed directly into the earth form. The installation of column footings and perimeter walls will immediately follow, and eventually waterproofing and backfilling. Tower cranes will also be erected during this time.

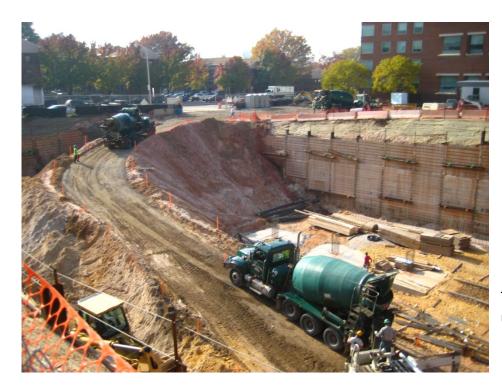
Temporary excavation ramp to be removed.

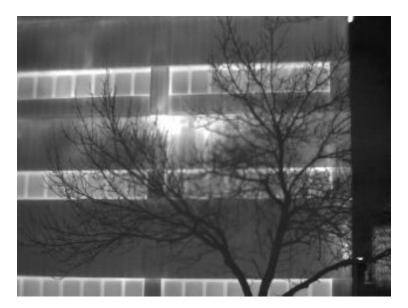
Unwanted water penetration in buildings can cause many problems. If water penetrates or condenses in the envelope it can saturate or deteriorate the elements that make up the wall, causing them to not function as designed. The picture below is infrared image of the outside of an office building. The white area of the wall is a hot spot where the insulation has become wet and is taking longer to cool than the rest of wall around it.

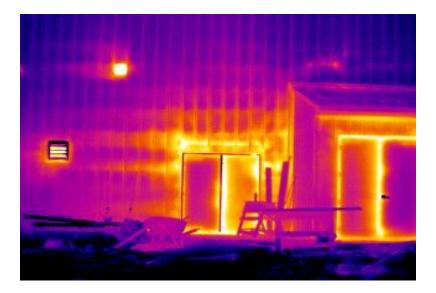
In general, any opening in the building is a large potential for air and water leakage if it is not designed and installed correctly. The infrared image below is a prime example of how heat (and in turn energy and money) can be lost due to leaks in the building envelope. Careful detailing is required to avoid such convective losses.

The doors and portions of the wall in this image show failures in the building envelope and missing insulation when viewed with a thermal imaging system.

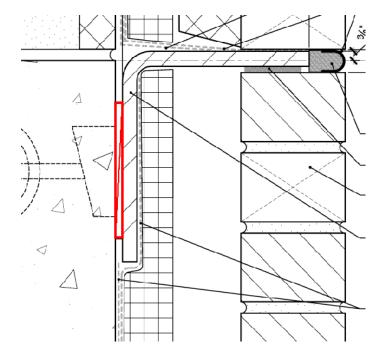
Thermal bridges can be defined as regions of relatively high heat flow conductance in a building envelope. The steel bent plate that supports the brick shelf is an area of concern because of the high heat transfer rate of steel and the fact that the item penetrates the vapor barrier. In extreme winter conditions, the steel could potentially transfer heat from the concrete floor slab supporting it, causing radiant heat losses due to a cold spot created on the floor area near the exterior walls.

Upon investigation of the typical brick shelf connection detail it was noticed that there is a material between the connection of the steel bent plate to the concrete floor slab, as seen in the image below. So long as this material is made of a some type of plastic or other material with a low thermal conductance it should act as a sufficient thermal break.

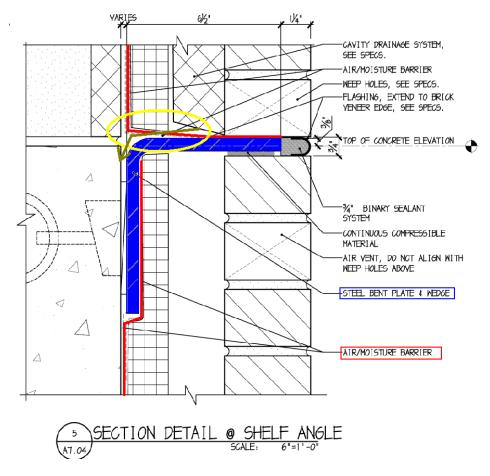
Another concern with this brick shelf detail is the orientation of the steel bent plate. The image below shows the current orientation of the brick shelf and the flashing/vapor barrier. The area inside the yellow oval represents a weak area, as there is a potential for water droplets to rest on the level steel bent plate, possibly weakening the bond of the waterproofing to the steel. If this happens, water could eventually seep into the wall (path of the dark yellow area) and cause mold growth problems or deterioration of wall elements.

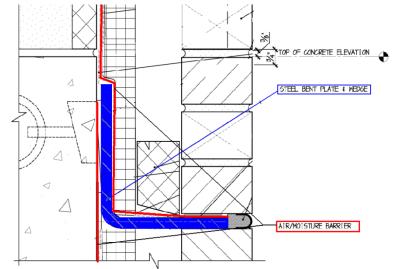
An alternative design is shown below that is visibly more effective, not only eliminating the weak area, but also allowing the vapor barrier to be run behind the steel angle, creating a back-up and more secure

The problem here is that this will not work with the current architectural design of the window system. If this was to be implemented, it would lower the brick shelf line, effectively interfering with the jackarches above the windows. This can be seen in the partial building elevation below. A decision such as this would have needed to happen much earlier in the design process.

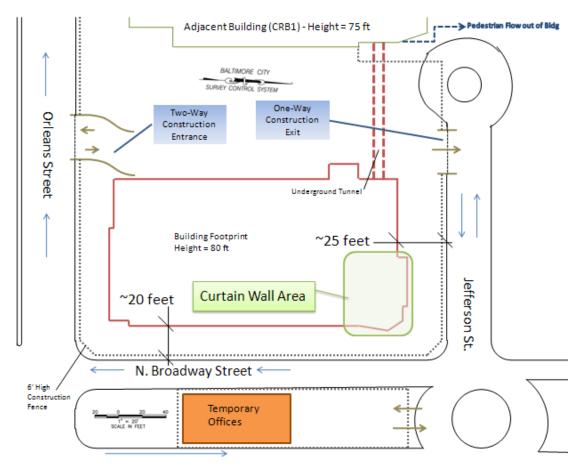
Another issue with using a crane is the fact that the orientation of the site would make it extremely difficult. Reference the site plan below. There not a very convenient area on site for a crane to do this job. It would need to be placed either on Jefferson Street, or in the slim areas between the building and the site fence on the north (right) or west (bottom) sides. Also, the delivery trucks would need an area to sit as the sections are taken off and put into place. Assuming Jefferson Street as the ideal place for this, the trucks would either have to traverse the site (enter from Orleans Street, exit by turning right onto Jefferson Street), or do a turnabout at the end of Jefferson Street. Note that there are also trees and a narrow sidewalk lining North Broadway Street. Any way you look at it, trying to work this out would be a pain and could potentially cause many issues with clogging up the site and restricting access for other machinery to maneuver in the already tight area.

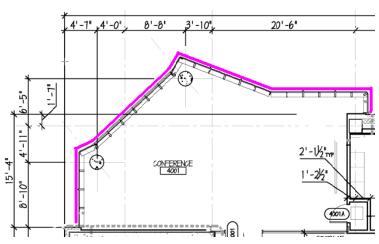
The other deciding factor revolves around the irregular shape of the northeast curtain wall. As seen in the illustrations below, the wall has many different shapes, including 118° and 160° angles and three large triangular sections. Attempting to fabricate this many irregular pieces in an offsite facility would be extremely difficult, and it would be likely that not every piece would fit correctly upon installation. If any items are fabricated too small, wrong angle, etc., they will have been wasted, and will have also created the need for another to be fabricated correctly and redelivered to site. Missing an essential piece could also hold up the rest of the installation, wasting even more time and money. So essentially attempting to unitize a wall of this complexity is very risky, as the smallest error could end up costing quite a bit of money and man-hours. When walls are stick-built on site, it is much easier for the workers to visualize what is being built, and they can take measurements and fabricate each piece to its exact

dimensions.

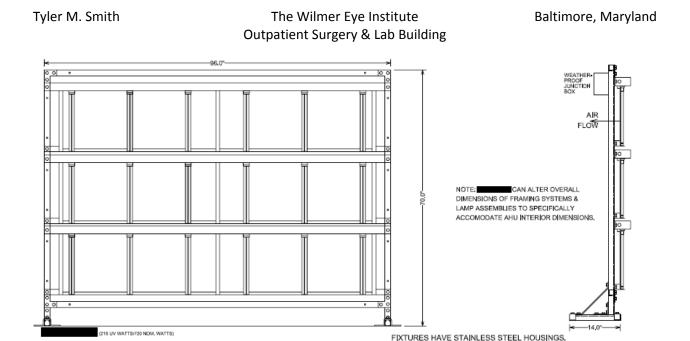
- Each AHU requires 18 Philips PL-L60WTUV lamps, 60 nominal watts, 18 UV Watts, high output and wind chill corrected for this application
- Ballasts are Advance PureVOLT UV lamp ballasts
- End-user list price of \$8250 per floor (per AHU)
- Installation requires about 4 hours per unit, figure 8 hours for the first unit. This installation should take 2 installers a total of 4 days, less the electrical connections.
- Project requires 156 Lamps; replacement cost is \$30 per lamp.
- Replacement intervals at 1 year allow for 15% depreciation in output. 2 year replacement must allow for 25% depreciation in output.

Systems are complete UV systems designed for Air and Coil Disinfection as described in the upcoming ASHRAE Handbook (Summer 2008, Chapter 16). Below is a diagram of elevations of the typical unit.
