TECHNICAL ASSIGNMENT THREE Alternative Methods Analysis November 21, 2008

The Scripps Research Institute Biomedical Research Building

Florida Atlantic University Jupiter, FL

Adam Houck

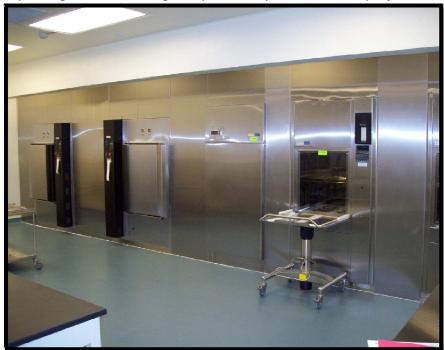
Sterilizers and Dryers with Stainless Steel Mod Wall and Epoxy Finishes

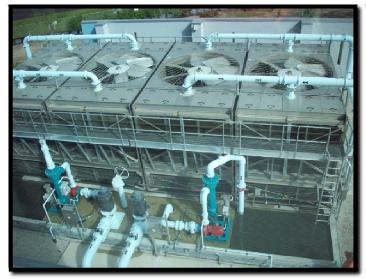
Cooling Towers in Mech. Yard

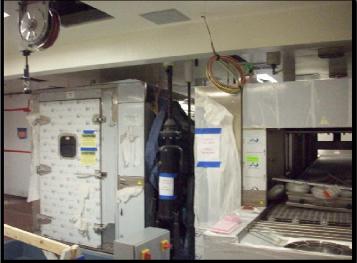
Bulk Sterilizer & Tunnel Washer

The delivery of equipment such as Emergency Generators, AHU's as well as lab equipment such as Fume Hoods, Sterilizers, Tunnel & Cage Washers and Biological Safety Cabinets are all major concerns on a project of this nature. These pieces of equipment are very technical in nature and have extensive lead-time requirements which are durations promised by manufacturers who often commit to production times under the actual to sell their product. In most cases those making the promises have nothing to do with the real production of the products in question so allowing additional time over that promised by the manufacturer must be done to ensure that the equipment is delivered in time to ensure that the project completion date is not compromised. When issues occur with the delivery of key pieces of equipment it has an effect on many trades, most notably the mechanical trades. These pieces of equipment require a significant number of connections and in many cases finishes cannot be completed in equipment areas until the equipment has been installed which in turn requires management to rework the sequencing of the project schedule to compensate for the late delivery. To make up for the late delivery will also incur costs of working overtime to prevent further delays to the schedule.

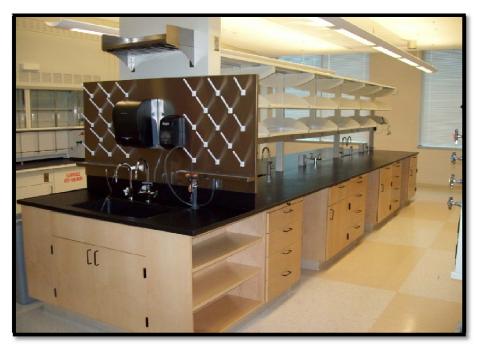
Lab Island with Epoxy Tops

A recurring issue throughout the project in each building was associated with MEP rough-in at the island casework in the laboratory areas. These issues caused delays which affected the finishing trades, in particular the casework installer. To remove this issue from the construction sequencing pre-fabrication could be used to research labs on the 2nd and 3rd floors. These floors critical path was largely driven by the Islands in the research labs. The installation of the Island Tube Supports followed the framing of the walls and installation of flooring under the areas to have casework. Once the tube supports were installed the Casework could be installed on one side of the supports and left open on the other for the MEP trades to rough-in the Laboratory services required at each island. This was a major hold up at many points throughout the project. The same problems were experienced with the overhead service carriers installed on this project. Whenever hold ups occurred with the rough-in of these islands the casework contractor was delayed in installing the other side of the island casework, leading to delays in setting the epoxy tops, sinks and metal shelving for each island. One option that may have helped to alleviate these coordination issues would be prefabricating the MEP rough-in with the Island supports, lifting them into the building, bolting them down and

installing the casework may have been a viable option for this system which could reduce cost and installation time as well as reducing the impact on the finishing trades.

The first analysis I would like to perform refers to the buildings Laboratory Islands from the problem identification section Island MEP Pre-fabrication. By pre-fabricating the MEP with the island tube supports for these islands. This analysis presents the opportunity to study schedule and cost impacts of employing prefabrication to this piece of the project.

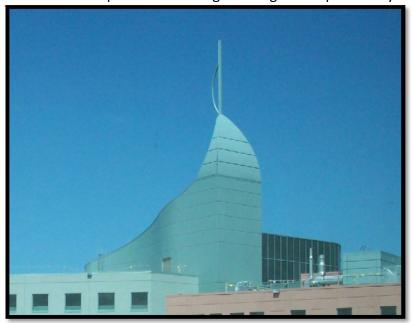
Building B Sculptural Spiral

The spiral assembly for Building B was very problematic for the construction team. This was mainly due to the design of the spiral. The design incorporated straight panels into a curved wall assembly. The most effective way to deliver this piece of the project would be having the design and construction of this spiral done through a design build process by the subcontractor.
