WestEnd25

1229-1231 25St. NW

Charles Miller – Construction Management

Technical Assignment III: Alternative Methods Analysis

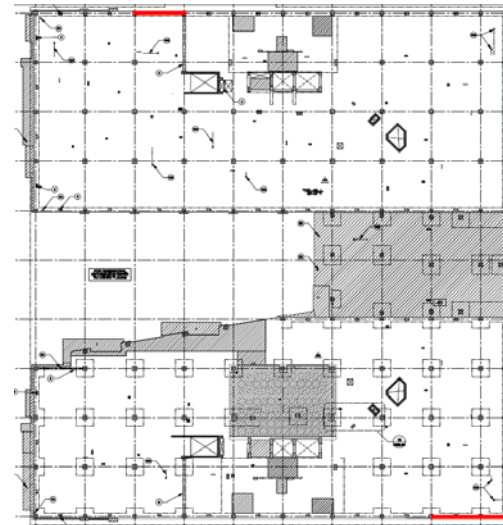
On the West façade the slab was extended to increase the building size and create protrusions in the architecture. The other parts of the building were not extended. However some existing slab edges are not perfectly straight across and are outside the face of sheathing. The illustration to the right indicates locations of this problem on the fourth floor. These locations are similar for the second through sixth floors. The variations range from .5" to 1 1/8" past the face of the sheathing. The slab edge extending past the face of sheathing affects the installation of the brick angle, windows, and waterproofing. The detail below illustrates the problem with the slab extending beyond the face of sheathing. The edges must be adjusted before façade work can commence, so the slab edges were cut back at the problem locations. This is affecting both the demolition budget as well as the schedule for the façade.

Areas of slab edge adjustments

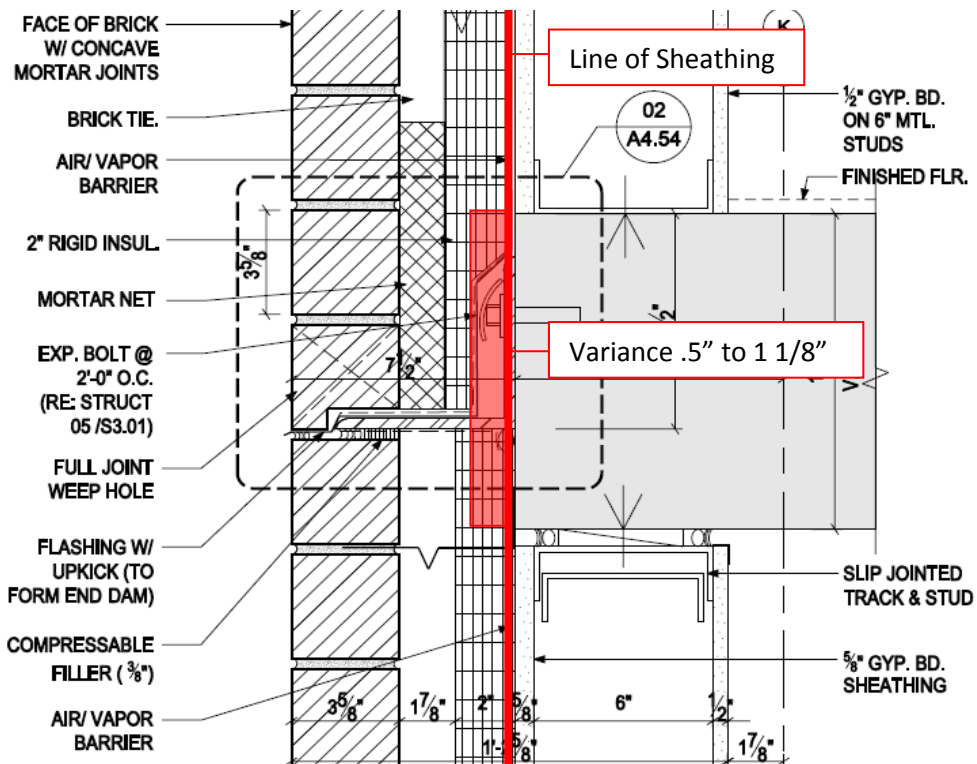
Façade detail of at existing slab edge

The existing façade for WestEnd25 was precast architectural panels. Brick will replace this façade. Brick is an aesthetically pleasing choice that has a relatively simple installation. The brick option is causing problems because the slab edges do not run in straight lines in some locations. In order to solve this problem extra work must be completed before installation can happen. If the existing precast was removed and replaced with a new architectural precast brick façade the slab edges would not be an issue. An analysis would look at the cost and schedule impacts from altering the façade type.

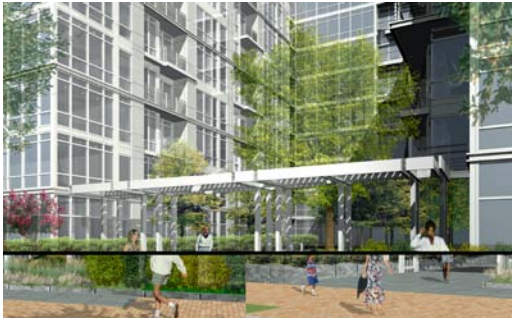
Entrance Colonnade

A prominent street feature is the entrance colonnade. This colonnade extends across the entire entrance of the courtyard. There are 75 individual pieces that comprise the colonnade. By alternating the material of those pieces from steel to wood would save \$60,000. Also, wood for the colonnade would be more constructible and have less of a lead time. The overall appearance will fit in with the naturalistic appearance of the entrance courtyard.

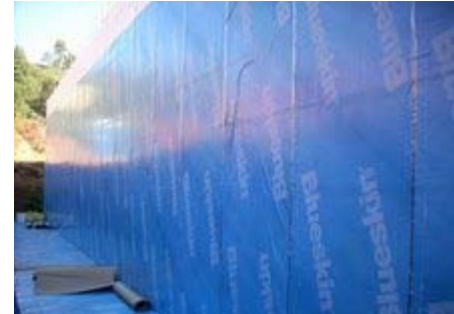
The initial thermal protection system was an air membrane and rigid board system. In order to save money the system was changed to a blueskin and cavity insulation system. By making this change the insulation cost was reduced in half from \$5/sf to \$2.5/sf which totals a savings of \$188,000 and the function of the system is not diminished.

Illustration of Blueskin System

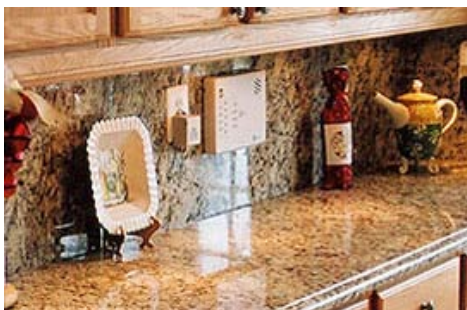
Kitchen Countertop

To take advantage of economies of scale the stone countertops for the entire building was standardized to only use one type. This will make delivery, coordination and installation easier for the project. With multiple types of stone tops the price was \$50/sf and with standard stone tops the price is \$40/sf which totals a savings of \$125,000. This change should not reduce the owner's ability to rent apartments.

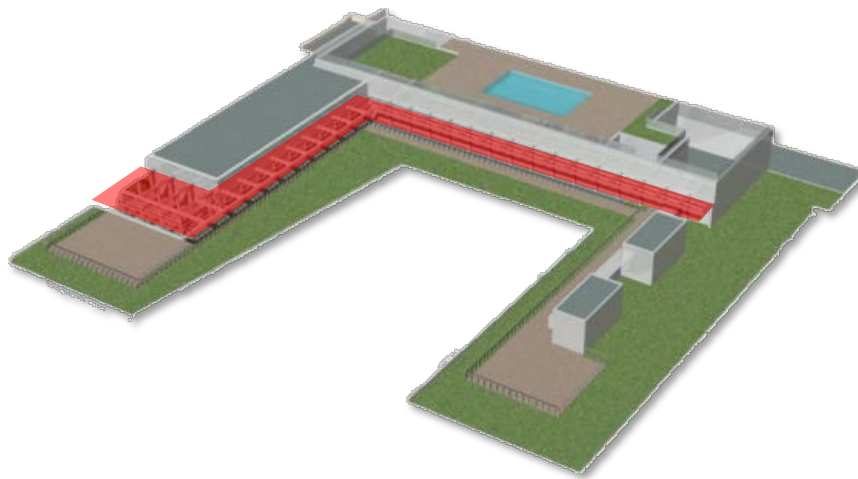
The roof trellis runs along the perimeter of the rooftop penthouse and is highlighted with red in the figure below. 6" x 6" steel posts at 16' on center support the 2" x 8" IPE wood purlins of the trellis. With the deletion of the trellis the project would save \$168,192. This cost savings suggestions was not accepted because the trellis is an integral part of the roof design that the owner and designers fought the Park Service and Planning Department to allow the trellis.

Location of Roof Trellis

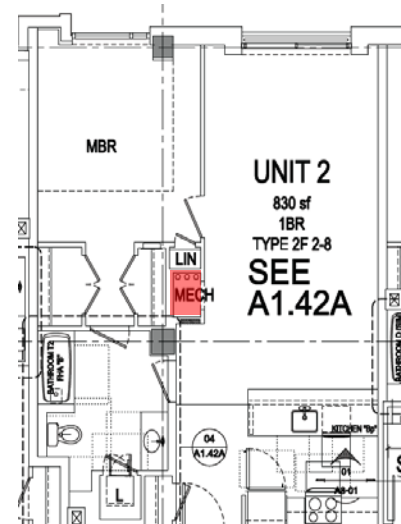
It would be possible for every apartment to have its own water heater, instead of a central system. If this system was originally chosen it would cost \$159,000 less. The figure to the left shows a typical apartment floor plan. The highlighted red section is the mechanical closet which houses the HVAC equipment for the apartment and has no room for a water heater. So, changing the system from the original design would require architectural redesigns to create space for the water heater to be located. Any savings in reduced piping and reduced equipment would be lost in design fees.

Limited space in typical floor plan

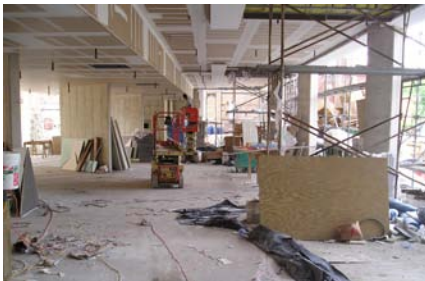
Flow of Trades

Trade stacking and flow is always a critical issue on a construction site. Often times this is an issue that is accepted and expected by subcontractors. However, this problem is worsened on WestEnd25 by the urban location and small footprint. If this problem is not addressed it may cause project delays and in turn lawsuits. Therefore, proper planning of trades and spaces for the duration of the project needs to occur to avoid the stacking of trades.

The curtain wall on WestEnd25 is a unitized system that will be installed from the interior of the building. Therefore the material storage, staging along with installation of the curtain will affect the other trades also working inside the building. To minimize the negative effects a plan to designate space at different times of the project must be developed and communicated to the subcontractors.

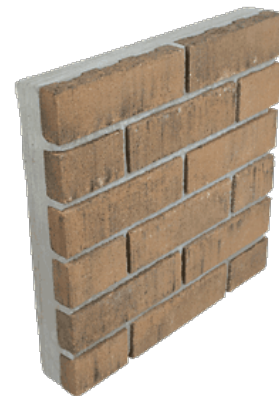
Precast Brick Sample

Installation of brick is a labor intensive activity. The masons are limited to the height they can place in a day. Therefore the amount of work, per crew per scaffold is limited per day. Precast would allow for more production and faster enclosure of floors. Furthermore, the existing structure is better suited for precast architectural panels since they were also the original façade.
