CHRISTOPHER R. STULTZ | CONSTRUCTION MANAGEMENT

PROJECT | CRYSTAL PLAZA II

TECHNICAL REPORT III | ALTERNATIVE METHODS ANALYSIS

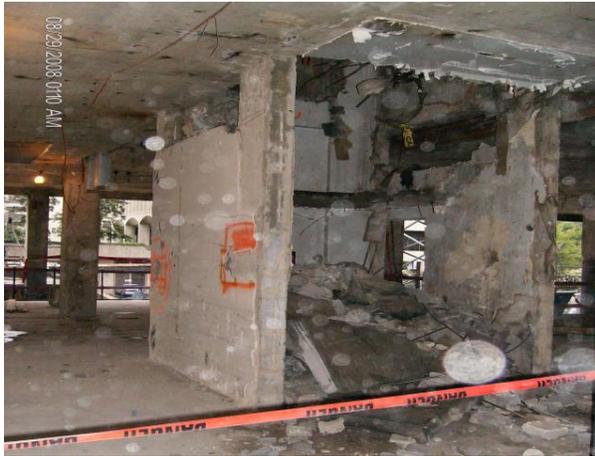
Demo of existing stair tower.

The other large openings posing issues were the new stairs and elevator shafts. After demolition of the existing stairs, the opening was enlarged and shifted to center the stair towers. The demolition included removal of upturned and regular concrete beams, thus requiring the need for additional structural support by means of W steel shapes, as seen below. The steel needed to be placed prior to the demolition and thus the need for proper sequencing becomes vital. The necessary process for installation of steel, inspections, demolition, and reconstruction needed to be detailed so as to not create a possible hazard or delay. A similar process was required for the elevator shafts.

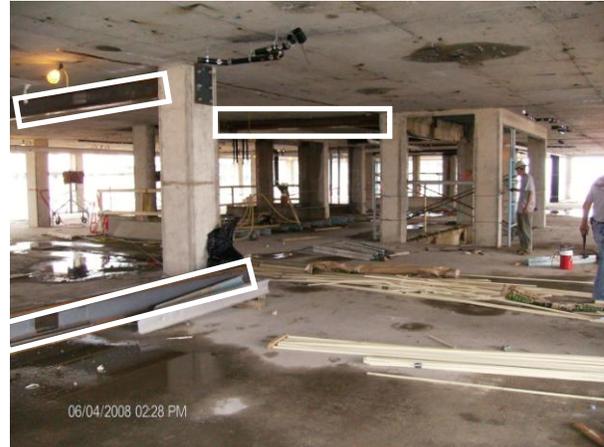
Structural steel reinforcing around stairs and elevator. Piece on lower left to be installed

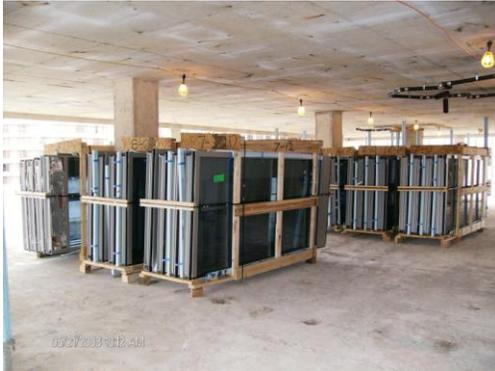
Stored and installed curtain wall panels.

As for the mechanical, electrical, and plumbing (MEP) systems, new riser spaces were needed to supply the individual apartment units. New pipe and duct risers needed cut and cored through the existing slab while detailed information about the removed pieces was needed to calculate the amount of additional structural reinforcing. Approximately 25 new slab openings for duct risers and about 300 slab penetrations for plumbing were required. Electrical distribution via bus duct required slab cuts, but not nearly as many as the system remained centralized. A floor plan of slab cuts for ductwork and bus duct can be seen at right. These openings required a large amount of coordination as the slab cuts, mechanical and plumbing core drillings, and electrical core drillings were all performed by different subcontractors. The sequencing was also a difficult challenge in that work below the cutting and coring operation was limited and the operation needed to be suspended multiple times because of the storage of curtain wall below the active slab.

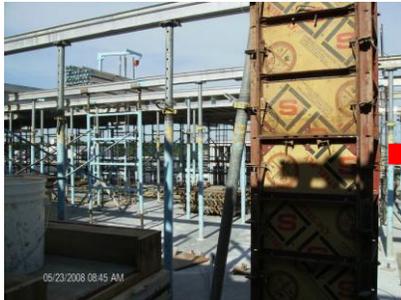
Step 1 Form area 1 with materials in area 2 below

- **Concrete Pour Sequence-** The sequence utilized by the concrete subcontractor used a two pour per floor sequence. This sequence allowed for work to continue on one side as material was stored on the other. The sequence, with pictures, is on the following page. Typically floors are broken into three or more pours to allow area for work, area for storage, and an area that is being poured. While the sequence on Crystal Plaza II did allow for finish ahead of schedule, would sequence flow better with a three pour breakup? Would this allow for a better layout that could increase efficiency and not require overtime makeup if a day is missed? Would this sequence allow for concrete placing everyday instead of every other with a few days between floors?

1. Form area 1, materials stored area 2 below on top of concrete
2. Continue forming into area 2, lay cables and imbeds in area 1
3. Pour area 1, lay cables and imbeds area 2
4. Pour area 2, form area 1

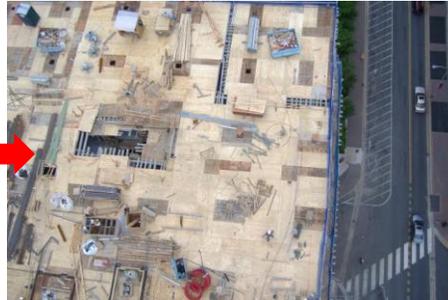
Step 2 Form area 2

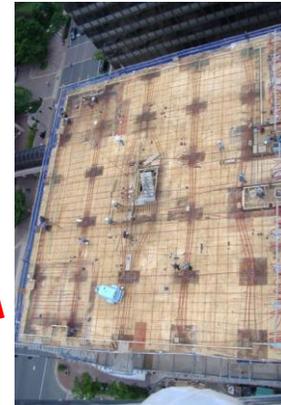
Step 2 Cable/imbed layout area 1

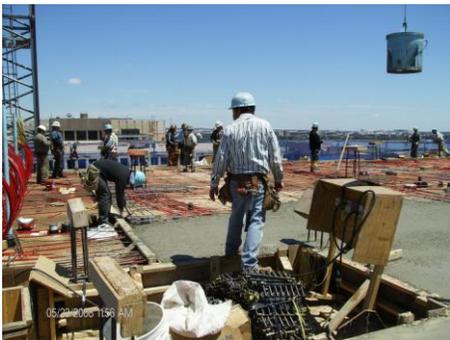
Step 3 Pour area 1, cable/imbed area 2

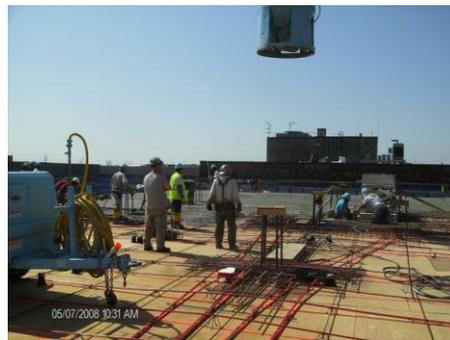
Step 3 Pour area 1

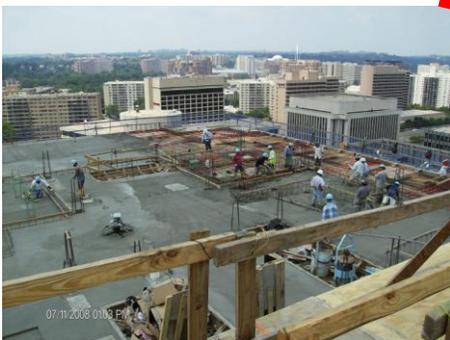
Step 4 Pour area 2, begin forming area 1 above
