Technical Report 3

Doctors Community Hospital | Lanham, MD

November 21, 2008

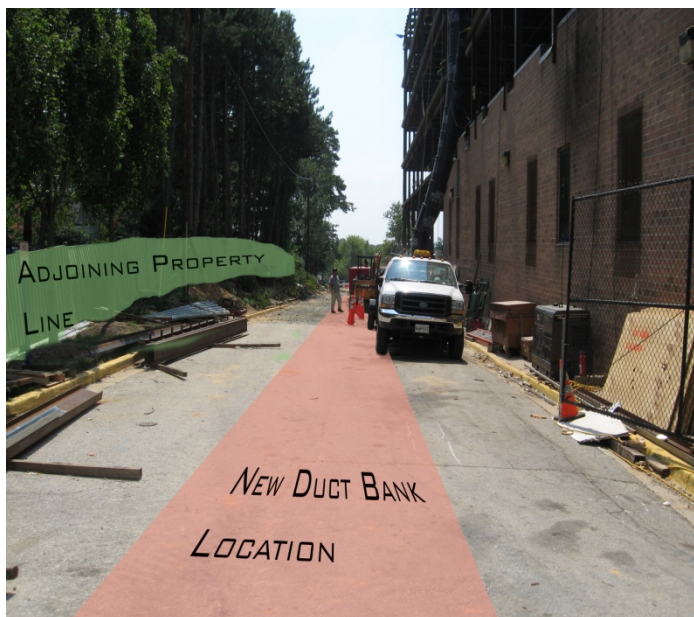
FIGURE 1- VIEW LOOKING FROM THE NORTH TO SOUTH OF THE ONLY ACCESS ROAD ON SITE

New ductbanks. New utilities are routed down the middle of this 30' wide access path shown at left in figure 1. This placement creates a coordination dilemma since as the road is opened up for installation of the utilities, it even further constricts the site access. Also located along this access road is the material hoist, which takes up space and further adds to the congestion as shown in figure 2. Not only does the hoist take up valuable space, but it also means that workers on site will be moving through the area which will put pedestrian traffic in extremely close proximity to vehicular traffic.

The DCH expansion project is especially challenging due to the very tight nature of the construction site. A private property adjoins the site directly to the west, whose property line is only about 30 feet from the edge of the building expansion footprint as shown below in figure 1. This narrow pathway is the main access to the site for almost all deliveries. Project deliveries on the north end are extremely limited since trucks larger than pick-ups have difficulty navigating the tight turns.

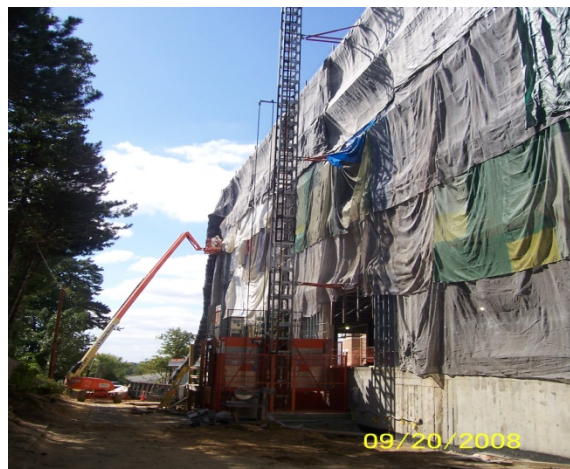
FIGURE 2- EAST ELEVATION WITH MATERIAL HOIST IN PLACE

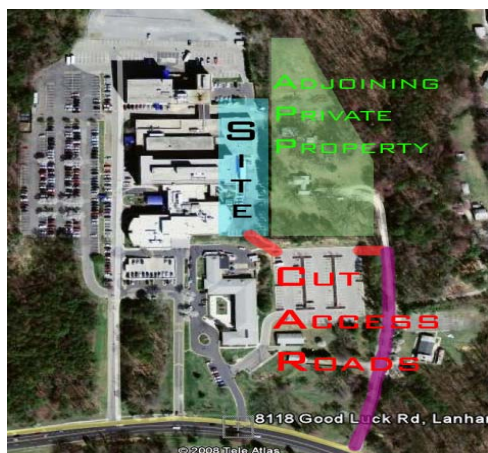
FIGURE 3- LOCATION OF CUT ACCESS ROADS

Access roads were cut to facilitate direct access to the main gate. These access roads, shown in figure 3, allowed trucks to come up Mallory drive (to the east, shown in purple), and not have to move through the Hospital campus, helping to alleviate congestion on campus and keep construction traffic separate from general hospital traffic. This access road is crucial to the success of the project and according to one project team member, "This project would be impossible without these roads."
