Technical Assignment 2

[Arena Stage]

Washington, DC

Joni Richelle Anderson
Construction Management
Dr. John I. Messner
Friday, October 24, 2008

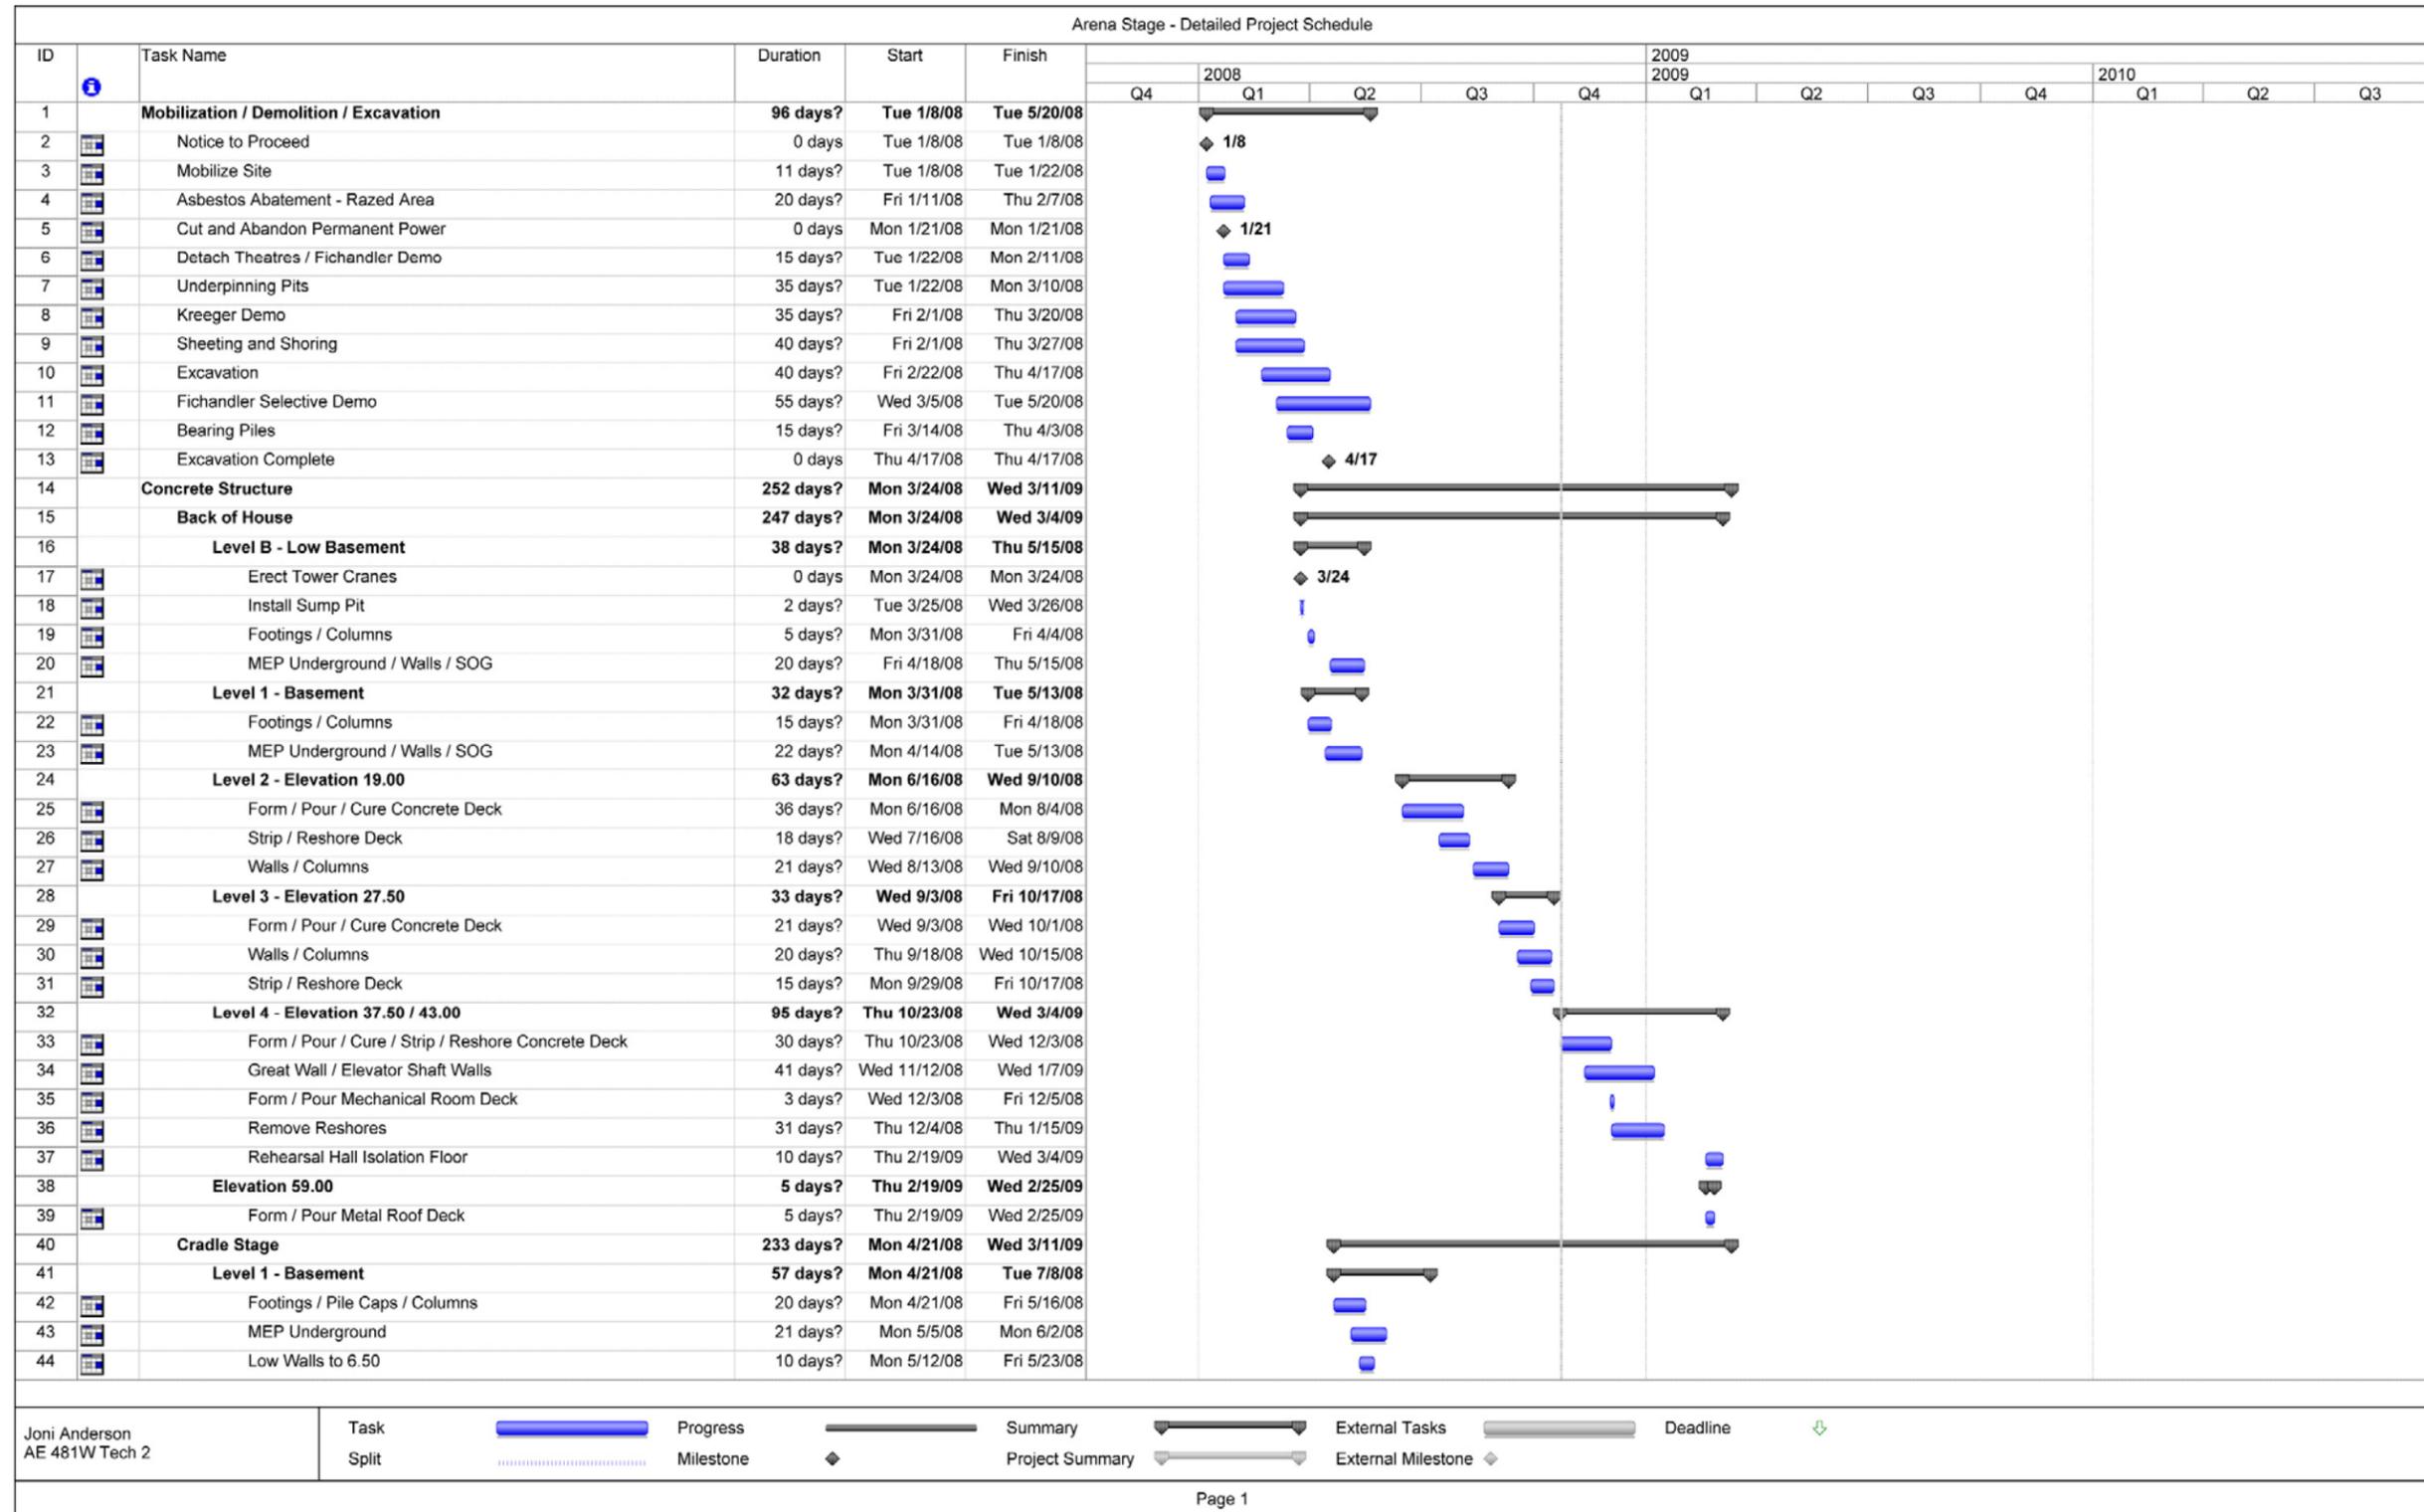
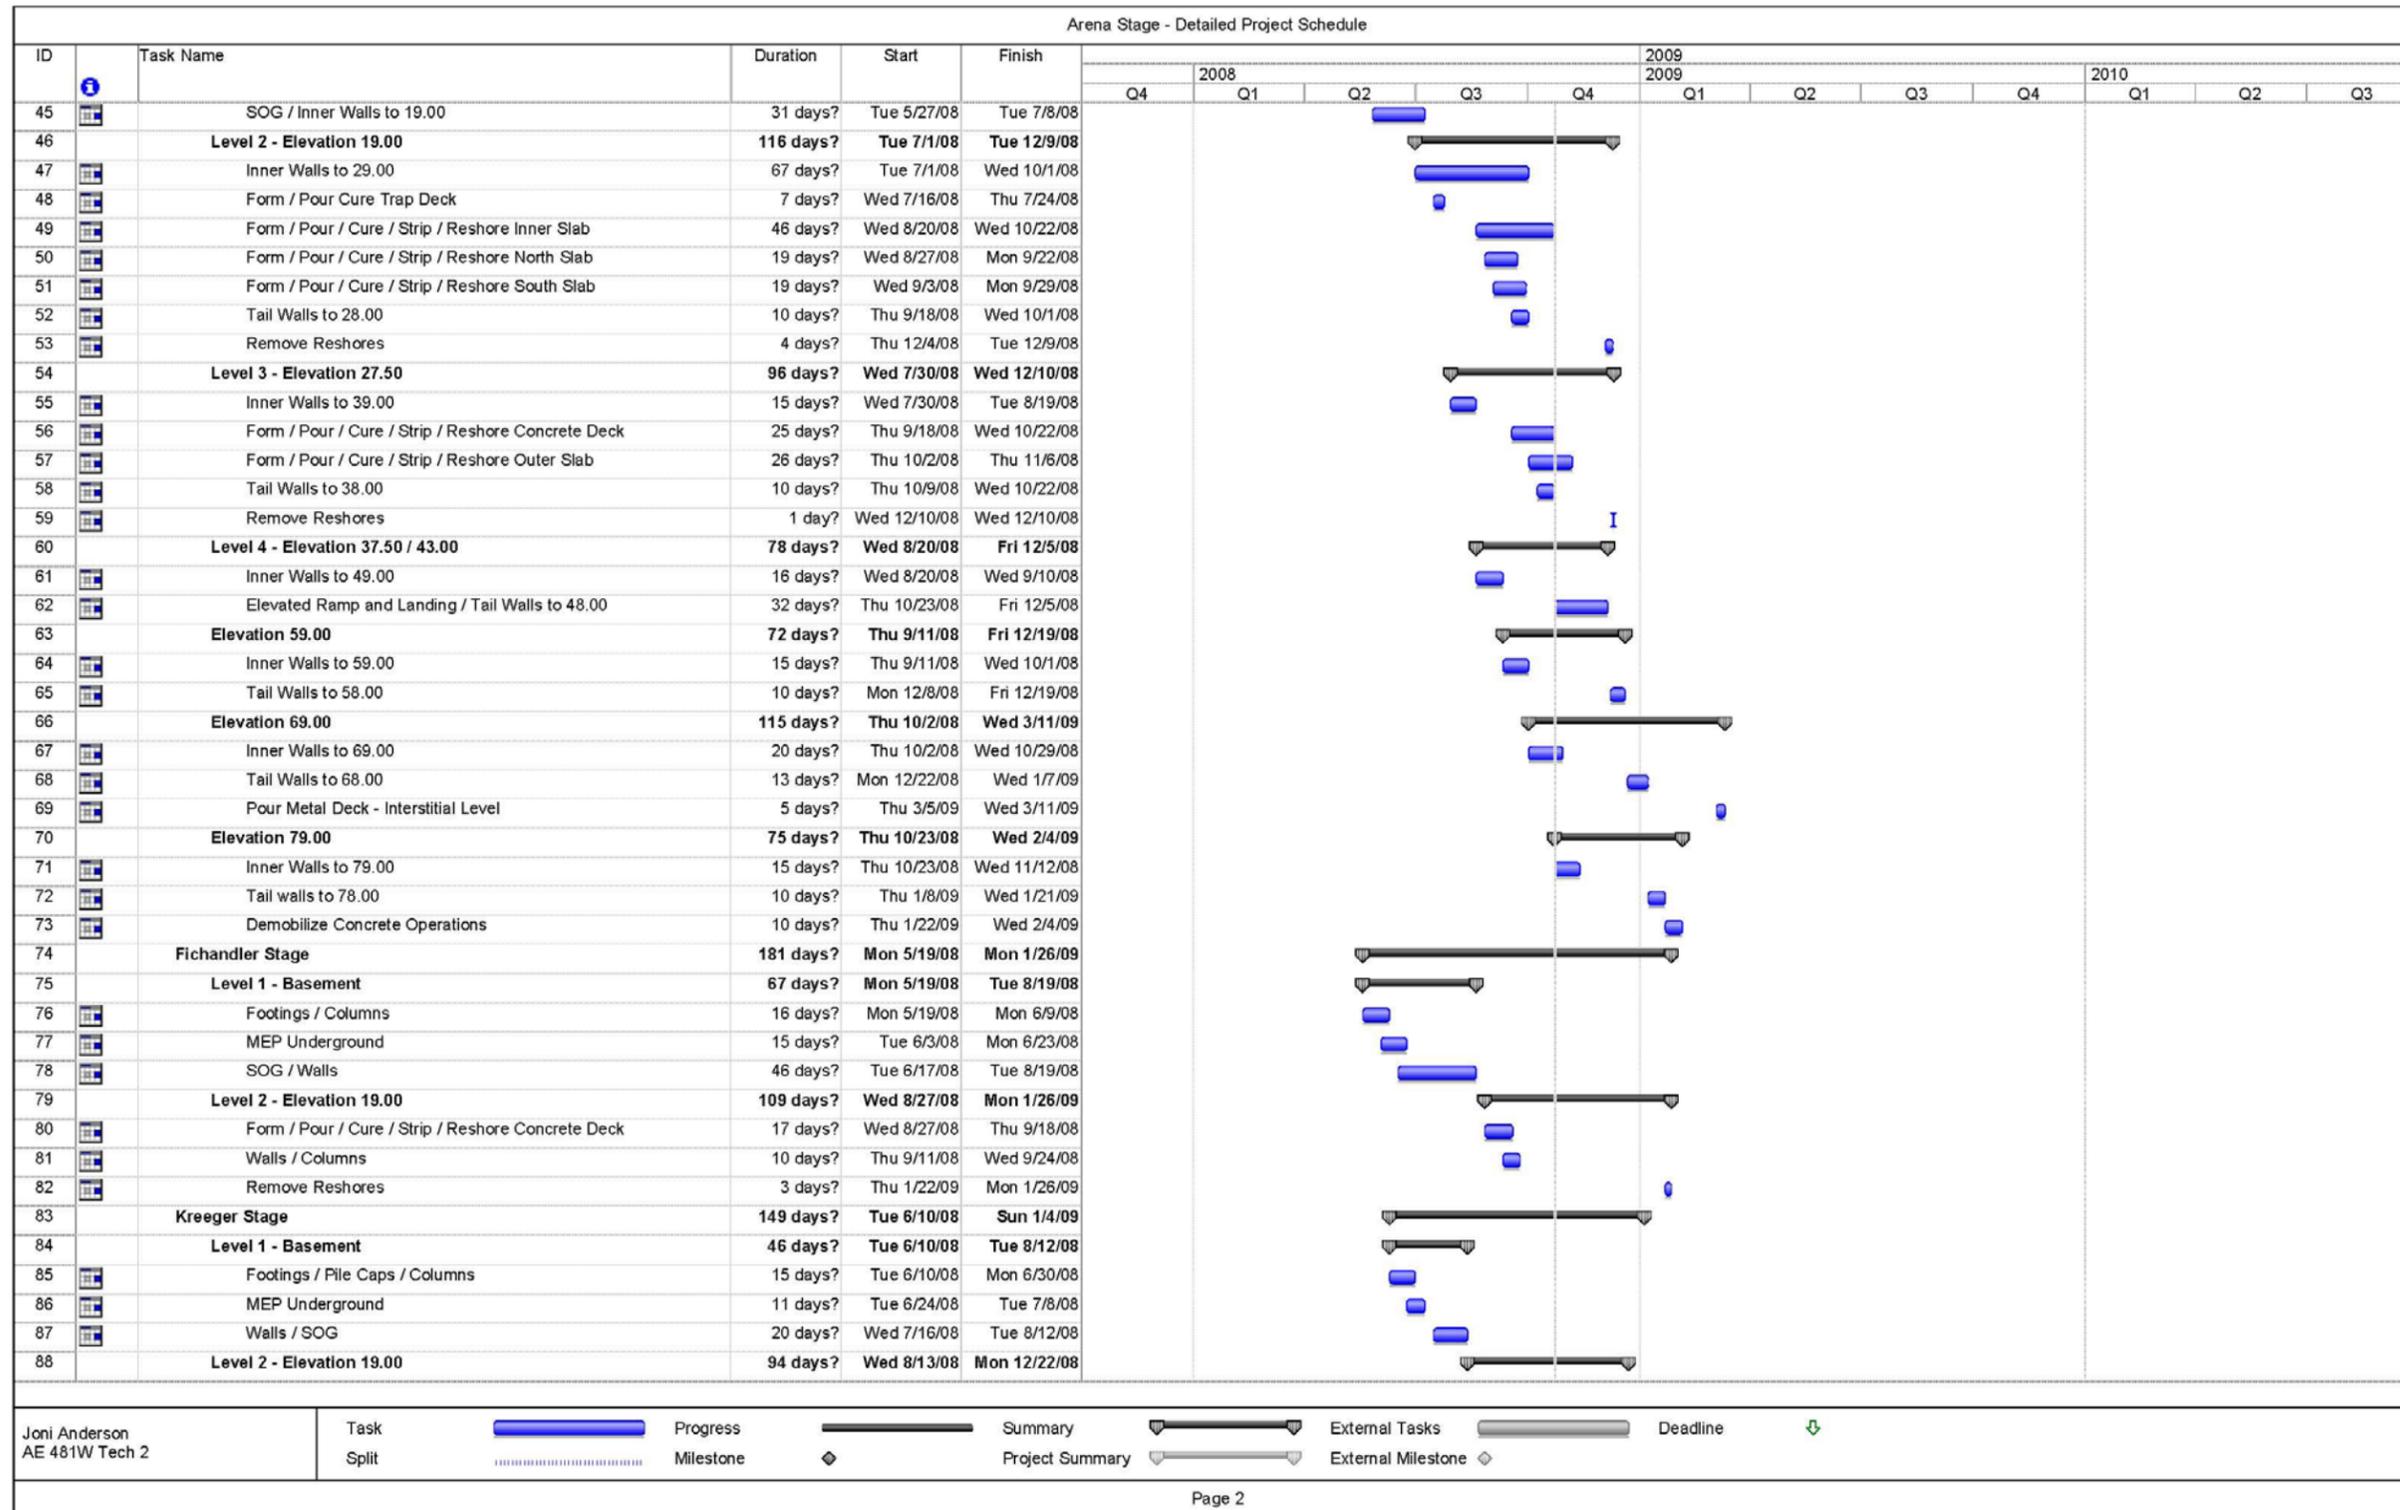
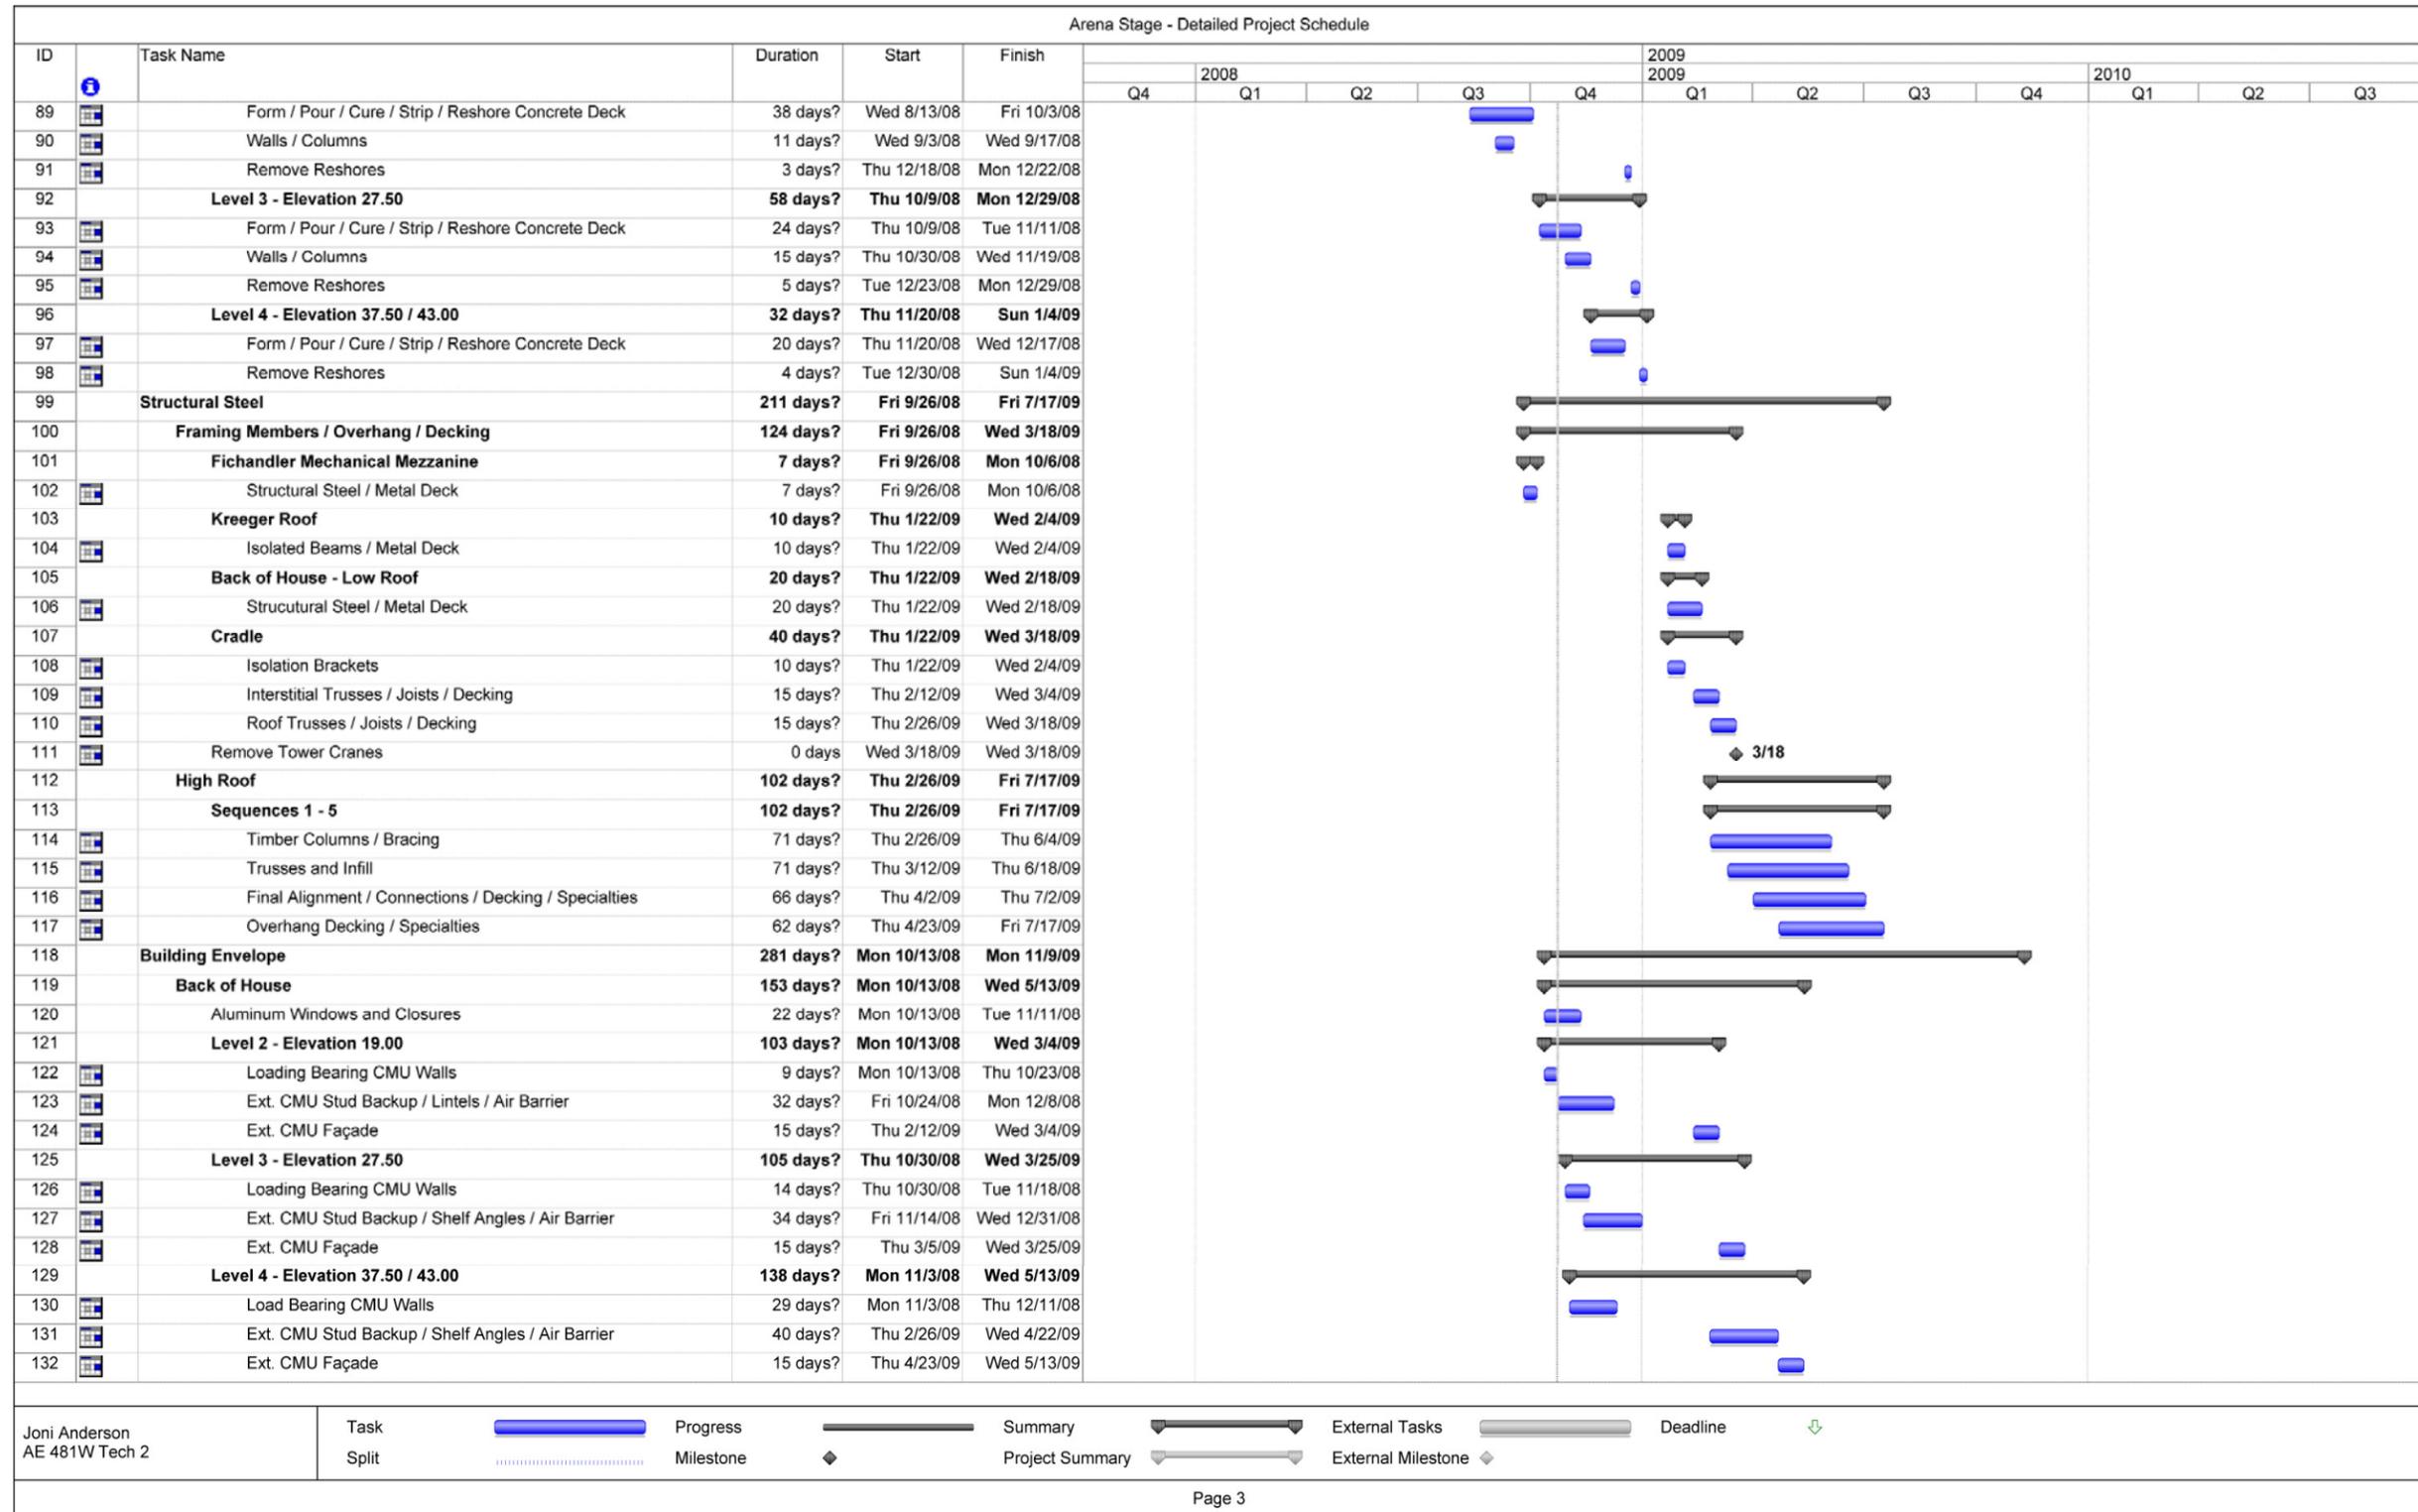
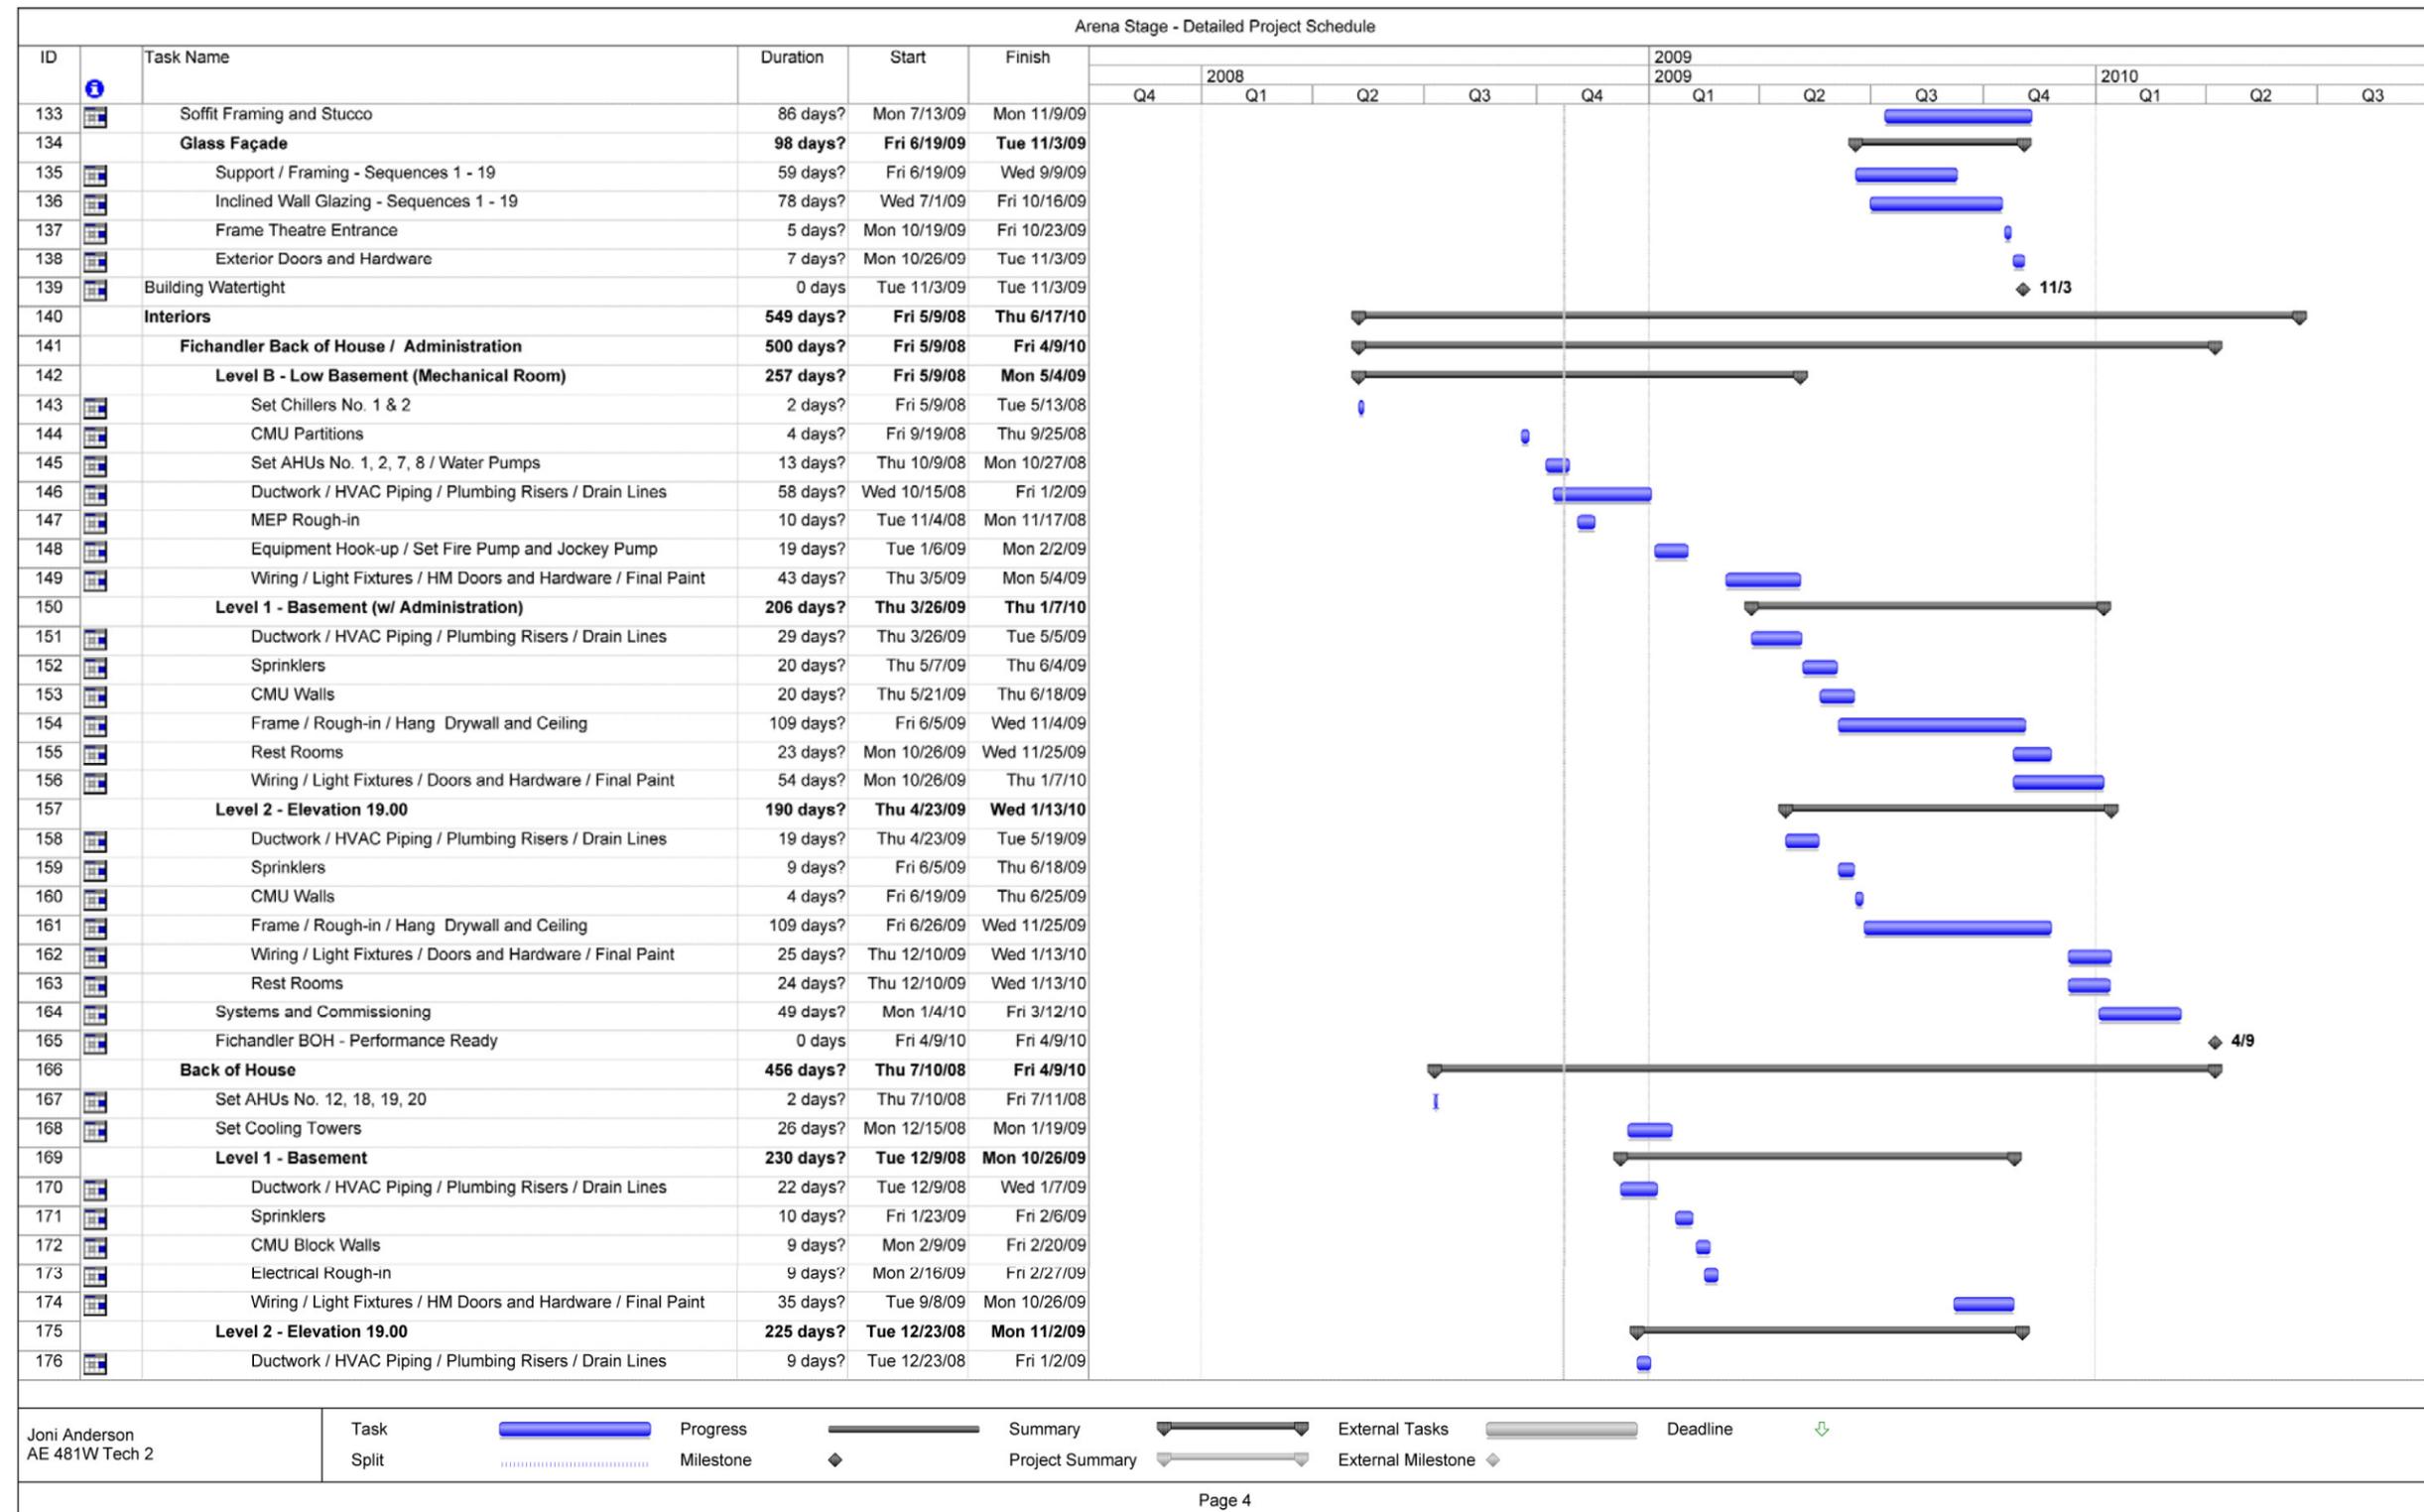
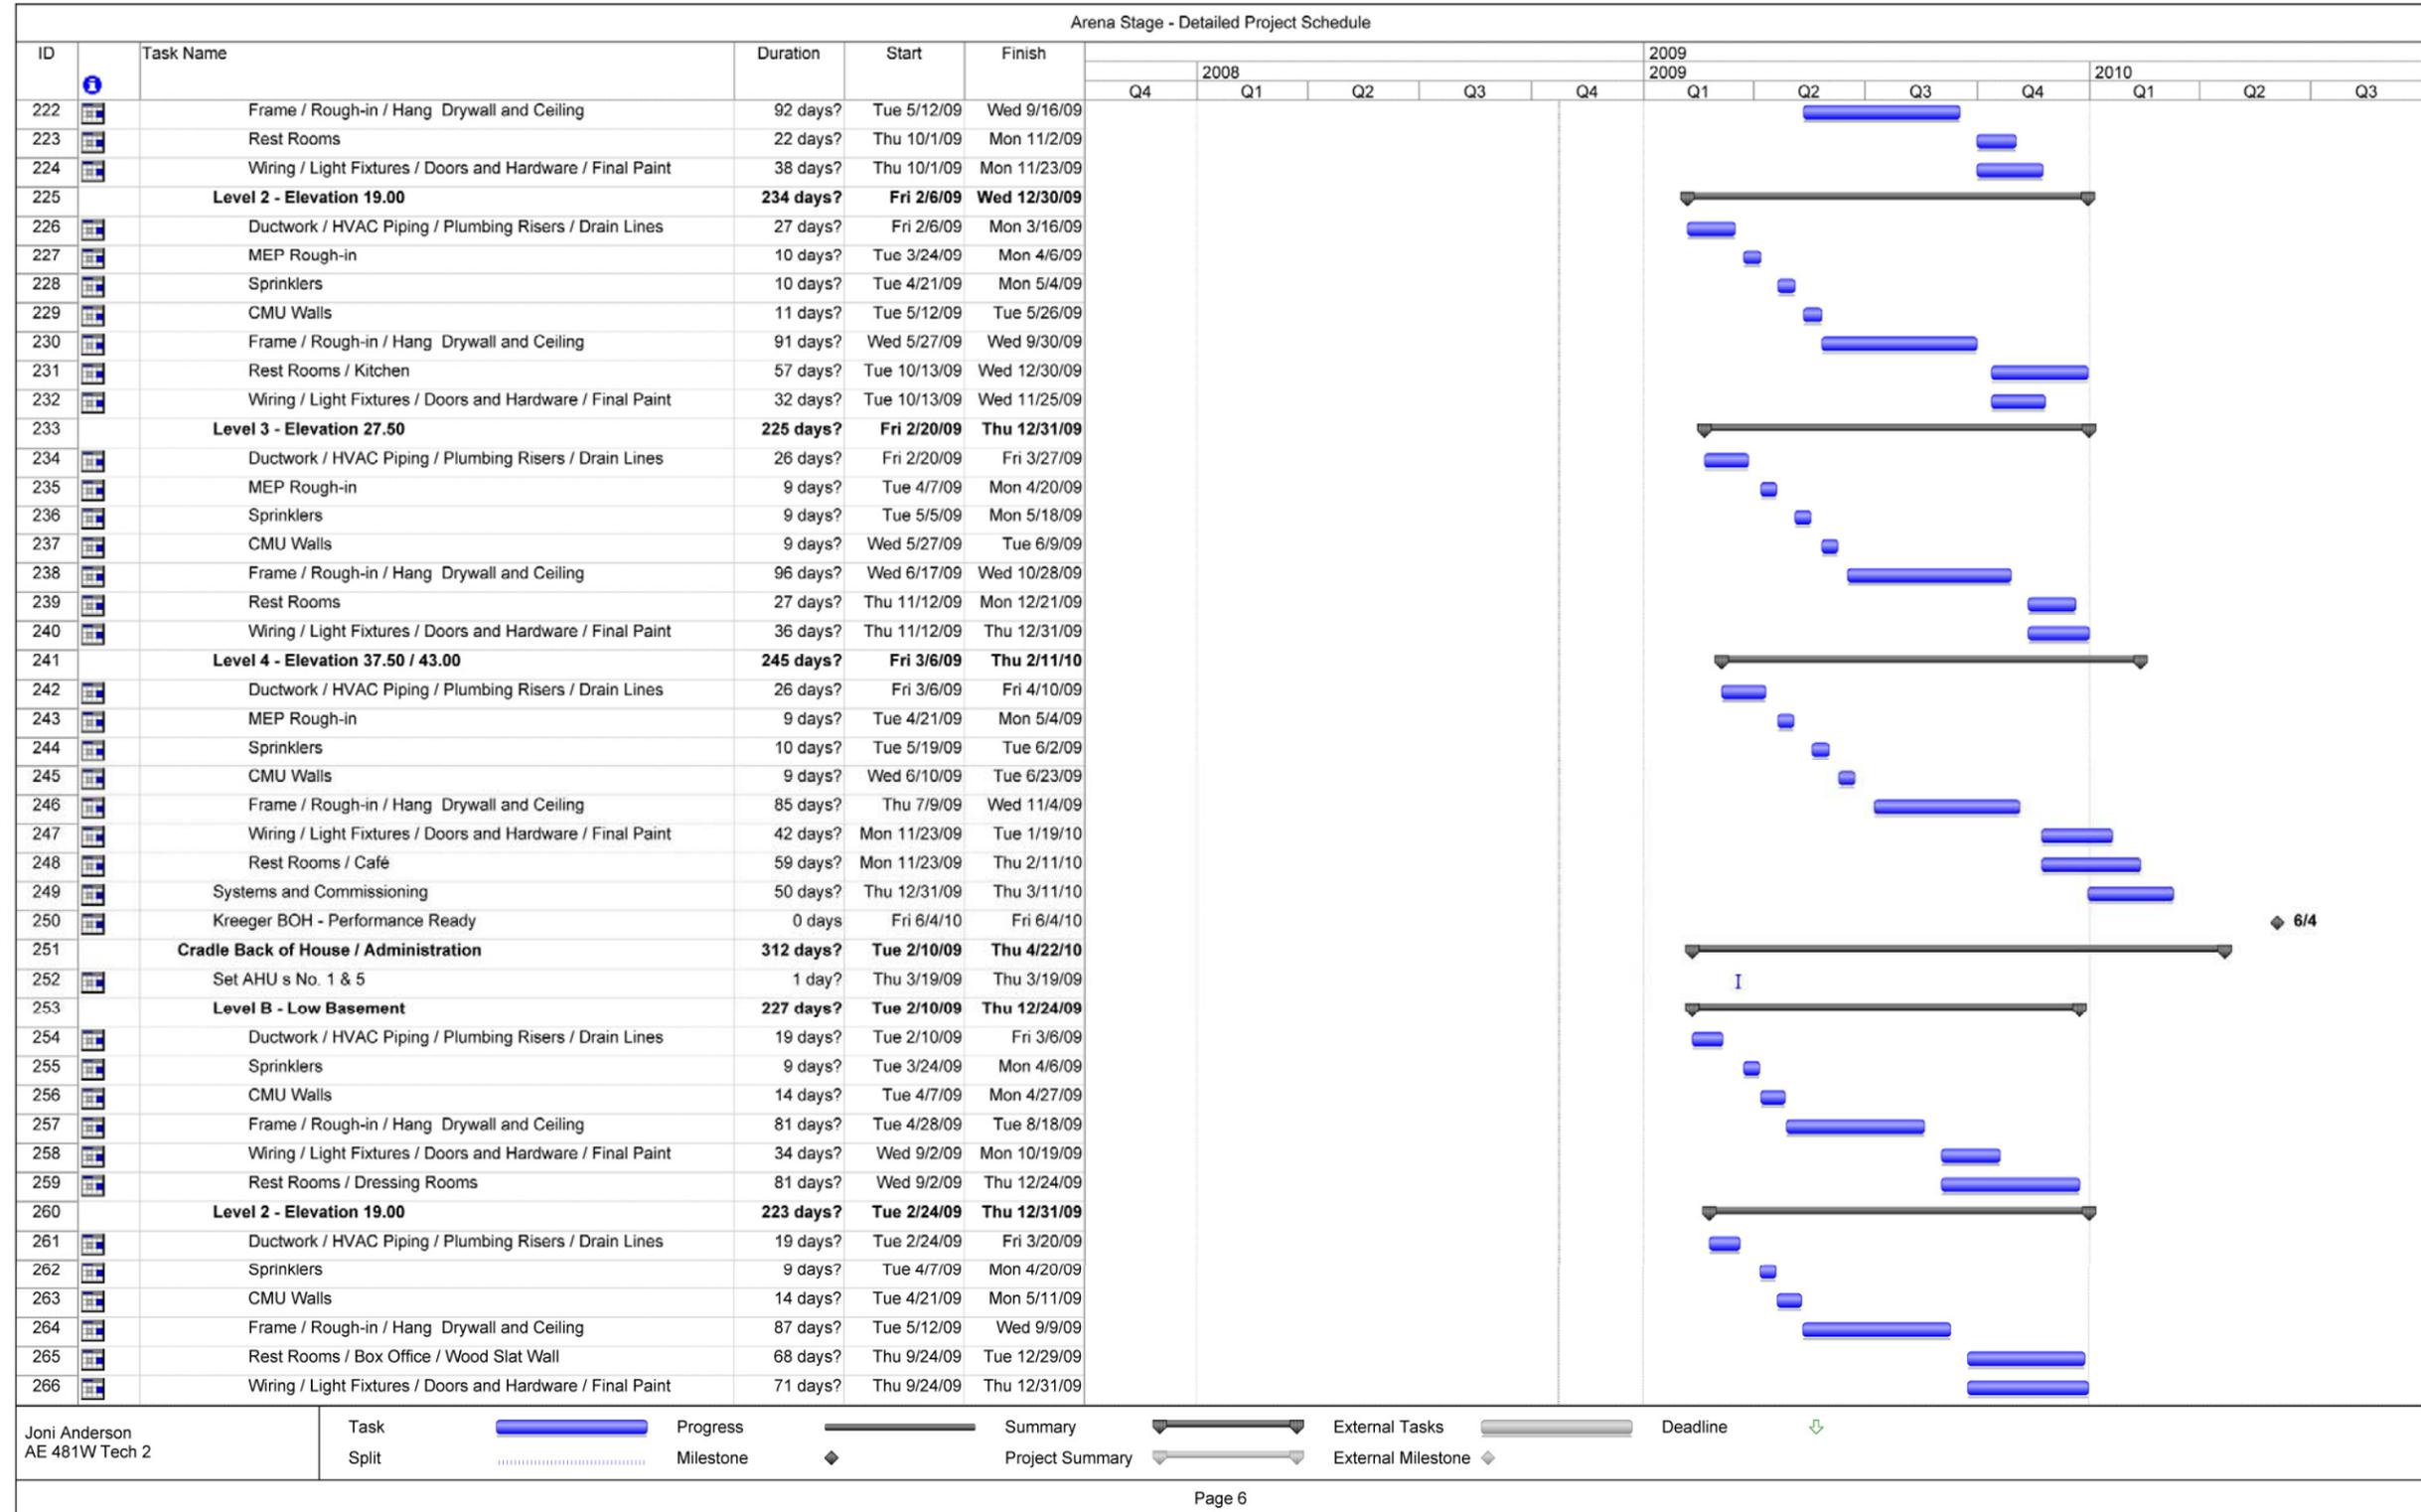
The Detailed Project Schedule for Arena Stage, which can be found on pages 5 through 11 of this technical report, is 313 line items. Since 66 of these line items are headings that indicate the zone and/or elevation of the building, the schedule only actually consists of 247 activities.

Table 1 is a summary of the project schedule showing each of the major activities mentioned above. Starting with the Notice to Proceed on January 8, 2008, the schedule begins with the Mobilization/Demolition/Excavation phase. This portion of the project consisted of underpinning, sheeting and shoring, asbestos abatement, major and selective demolition, and site excavation. Although the site excavation ends on April 17, 2008, the selective demolition of the Fichandler and the Kreeger continues on through May 20, 2008.

Next, the activities turn to the Concrete Structure phase. The 2 tower cranes are erect on March 24, 2008 and concrete operations begin on the same day at the Back of House (BOH) parking deck. It then moves clockwise around the site going from the Cradle to the Fichandler to the Kreeger. With the Cradle being the most extensive portion of the concrete work, its completion on March 11, 2009 denotes the end of the concrete operations.

On September 26, 2008, six months after the start of the concrete work, the structural steel makes its way into the schedule. This phase of the work is broken into two categories: Framing Members/Overhang/Decking and High Roof. The first phase contains the structural steel and metal deck of the Fichandler mechanical mezzanine, Kreeger roof, BOH low roof, and the Cradle roof. After the completion of the first phase on March 18, 2009, it is important to note that the tower cranes are removed. From this point on in the schedule, a mobile crane will be used to perform steel work and other heavy lifts. The High Roof phase consists mostly of the

trusses for the cantilever and the PSL timber columns that support the curtain wall. This portion of the work is not complete until July 17, 2009.

Once the PSL timber columns are in place, Arena Stage is ready for the installation of the Building Envelope. While the BOH is a stucco finish, the glass façade is the more notable portion of this installation. Starting on May 19, 2009, 19 sequences of the support and framing are put into place, which are quickly followed by the 19 respective glazing sequences. Finishing with the theatre entrance and the exterior doors, the building achieves watertight status on November 3, 2009.

The Interiors phase began on May 9, 2008 which is uncharacteristically early seeing as it is prior to the building being watertight. This is due to the fact that the existing Fichandler and Kreeger theatres have the opportunity to undergo some interior work during the erection of the steel and building envelope. However, interior finishes are not scheduled to begin until *after* Arena Stage is watertight. During this phase, all interior operations occur from the MEP rough-in and wiring to the dry wall installation and final finishes. Lasting 549 days, this is the longest portion of the schedule.

Occurring simultaneously with the interiors are the site work and the final testing, inspections, and commissioning. The interior of the building is scheduled to finish on June 17, 2010 and Arena Stage is expected to reach substantial completion on June 21, 2010.

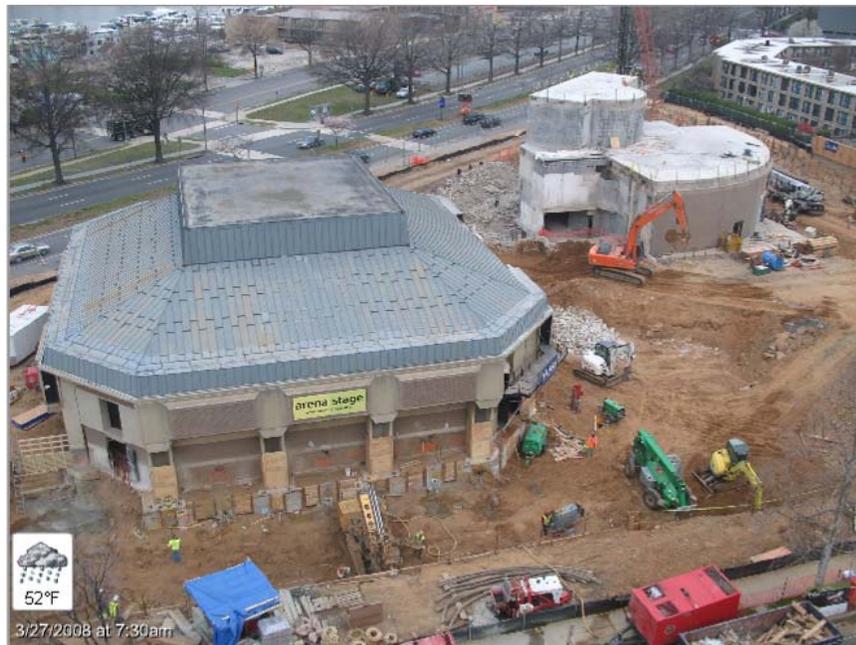
Figure 1: Arena Stage during excavation in March 2008
(Provided by Clark Construction WebCam)

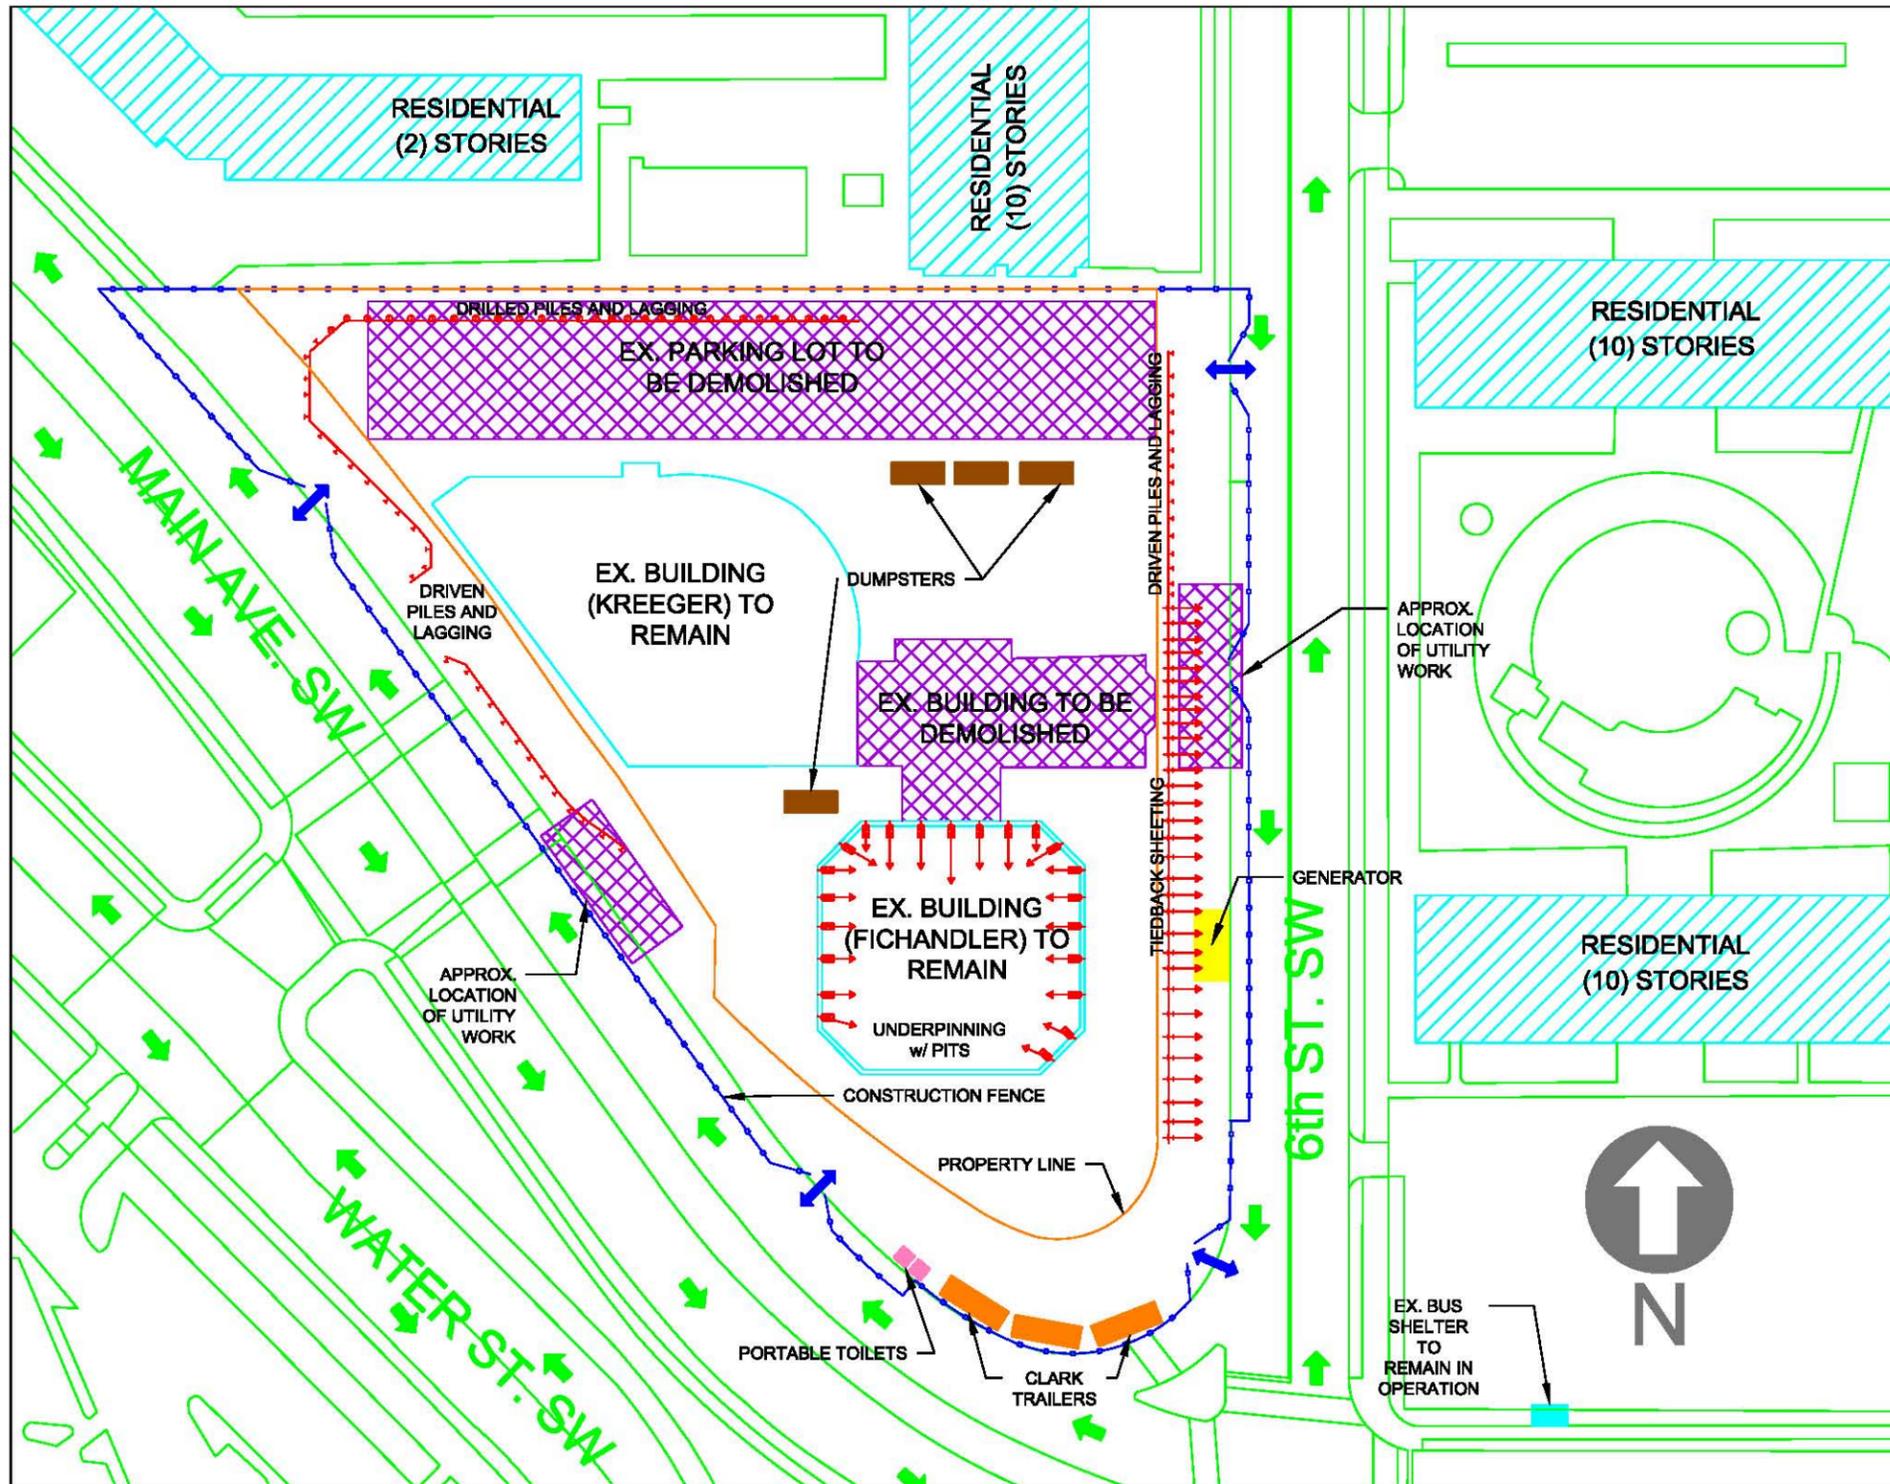
EXCAVATION /
DEMOLITION SITE PLAN

This phase of the project primarily consists of the partial demolition of the existing Arena Stage facility, as well as razing the adjacent parking lots and hardscaping. The site fence, which changes only slightly throughout construction, surrounds the perimeter of the triangle-shaped block and extends out onto both Main Avenue SW and 6th Street SW.

Due to its awkward shape, the south corner of the site was chosen to house the Clark site trailers and the portable toilets. That location allows Clark to monitor the traffic flow of the site and it is an area that is rarely disturbed by construction. Dumpsters are strewn around the site to collect the massive amounts of debris from the building and hardscaping demolition.

During excavation, the surrounding site, utility lines, and the Fichandler theatre had to be supported. Using both temporary and permanent supports, the base of the Fichandler was underpinned and the perimeter of the site contains several runs of driven or drilled soldier piles and lagging. At this point in the construction process, the entire site is free-range for the excavation equipment with the exception of some areas, which begin to take form as lay down spaces for the superstructure material deliveries.
