Technical Assignment 2

[Arena Stage]

Washington, DC

Joni Richelle Anderson
Construction Management
Dr. John I. Messner
Friday, October 24, 2008

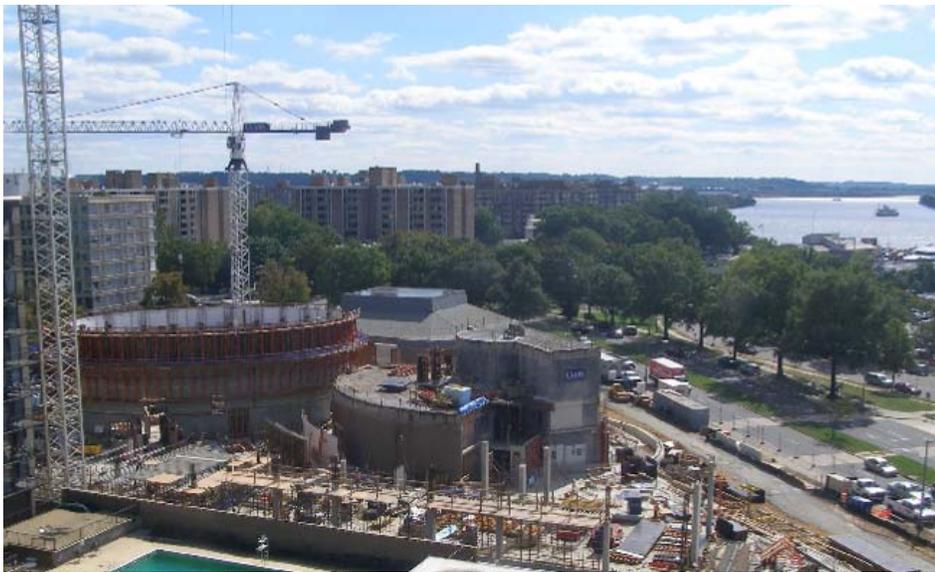
Figure 2: Arena Stage during construction of the superstructure in October 2008
(Provided by Clark Construction WebCam)

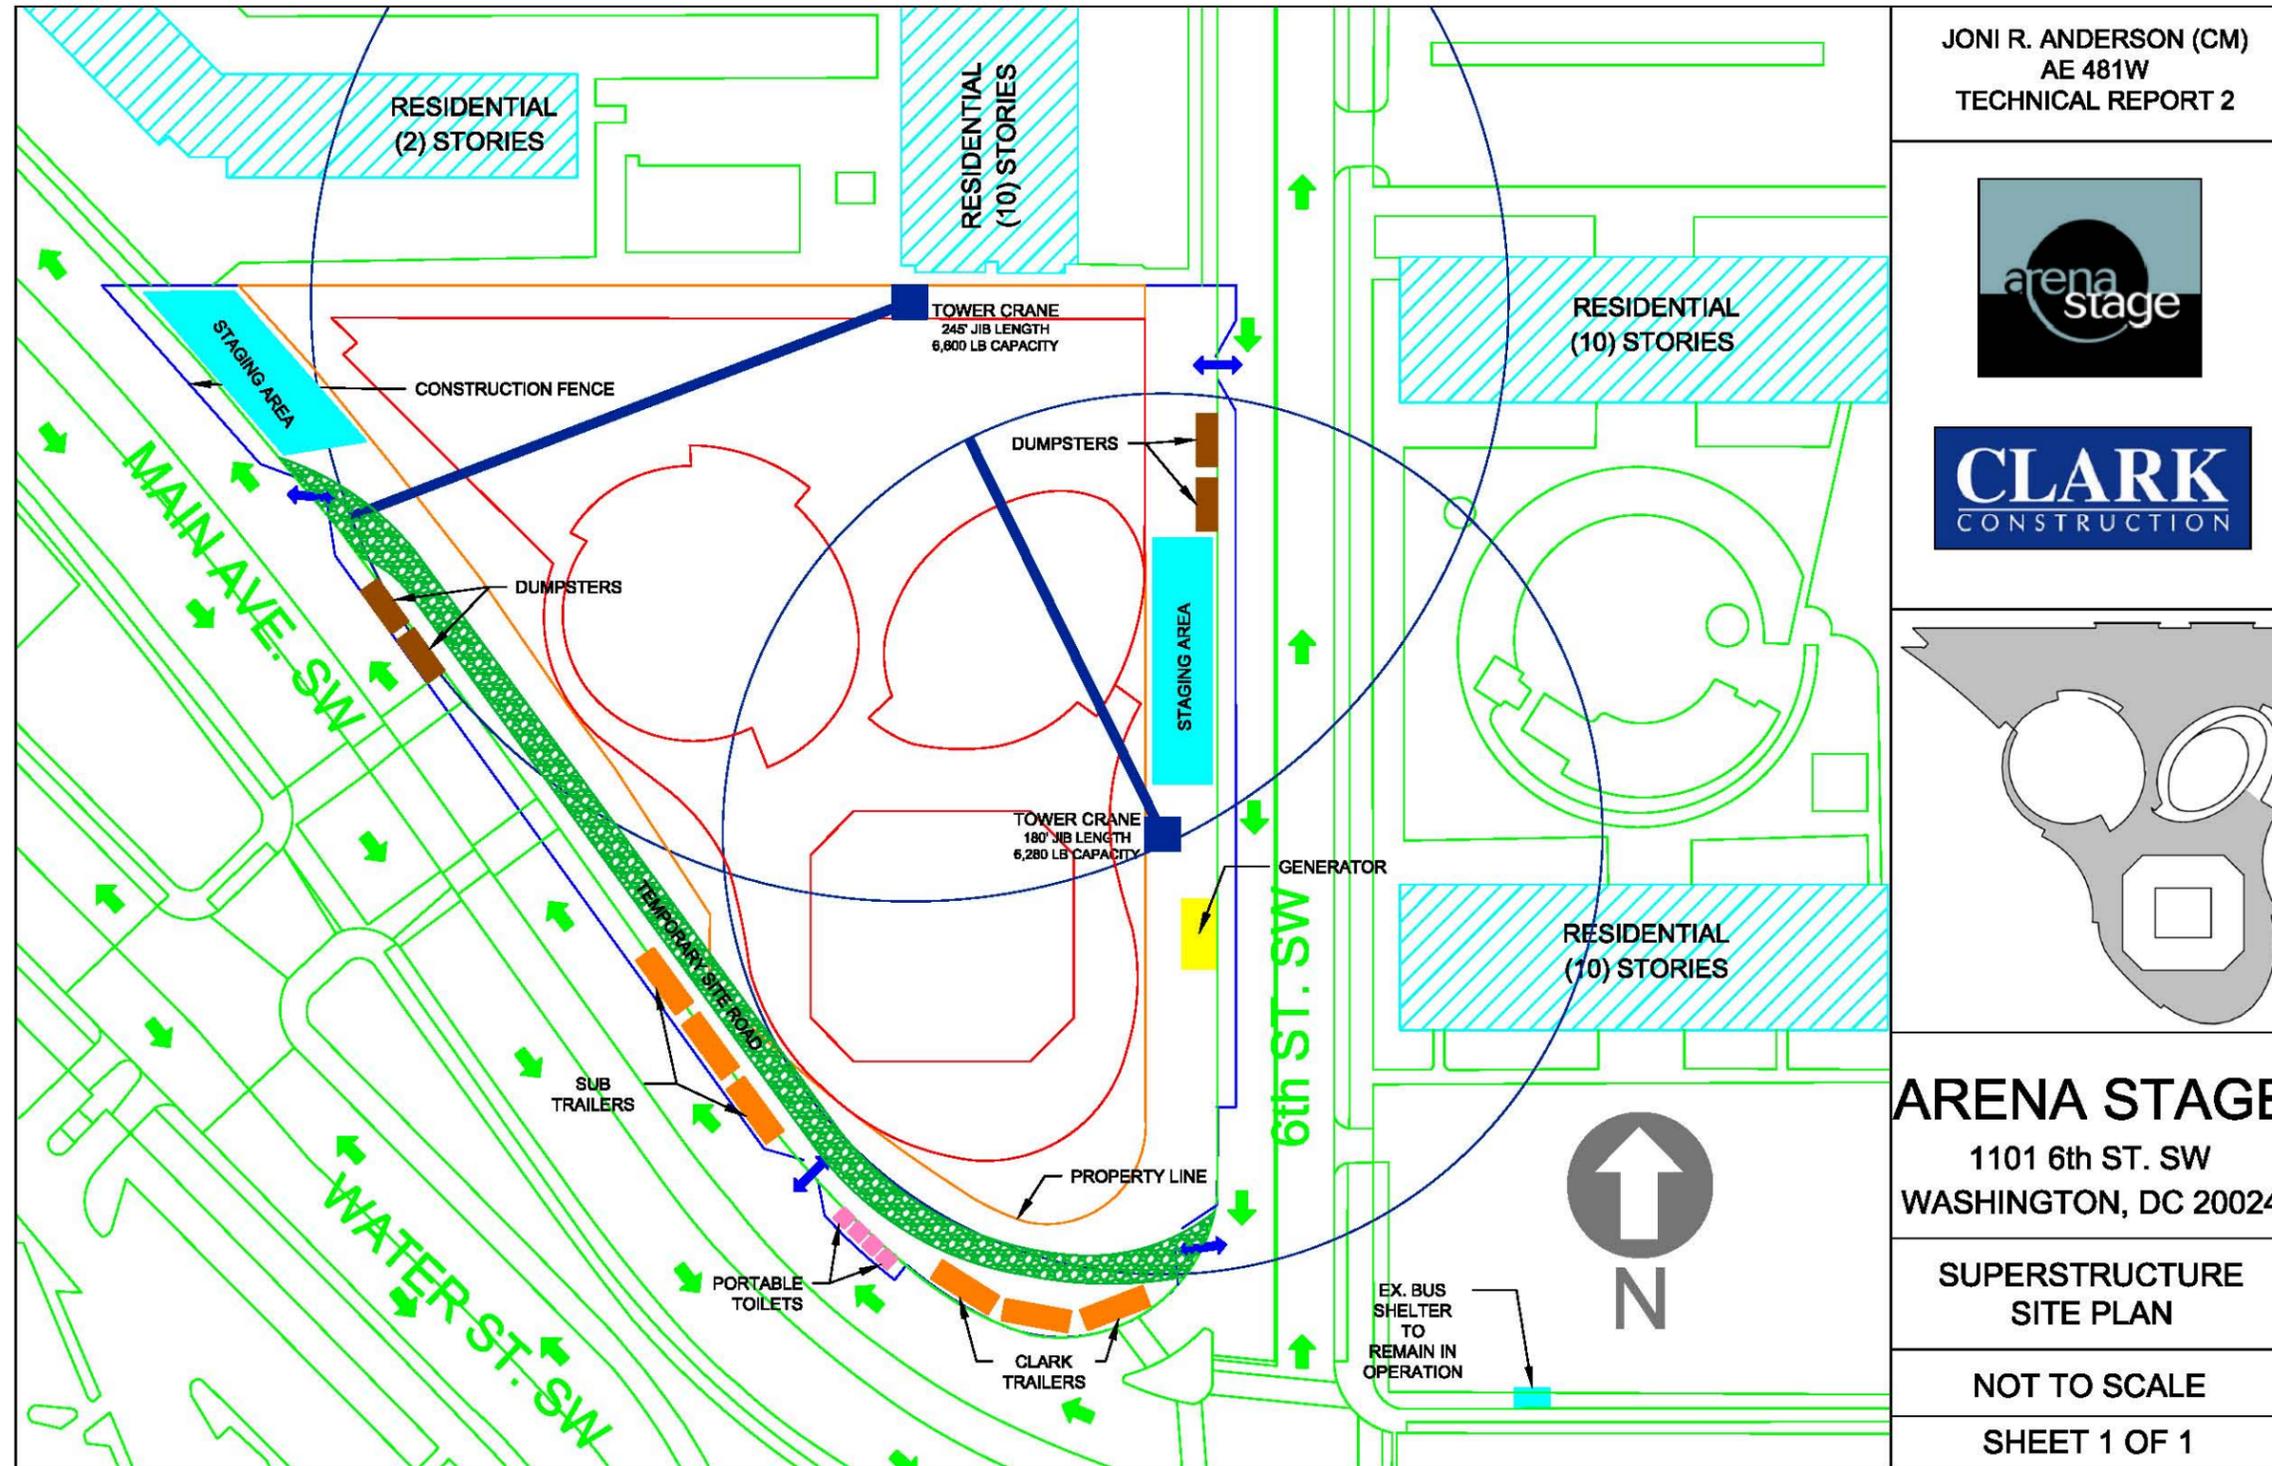
SUPERSTRUCTURE
SITE PLAN

In order to facilitate the lift requirements of the concrete and steel operations, two tower cranes were erected on site. One is located on the east side of the Fichandler theatre and the other is nestled in between the BOH and a neighboring apartment building. The generator is located on higher ground along 6th Street SW next to the Fichandler. Once work started on the common areas between the theatres, a temporary two-way road was installed to direct traffic around the building footprint. Entry to the site can be made from either Main Avenue SW or 6th Street SW.

Since this phase of construction causes the site to become very congested, everything temporary is pushed out to the open areas around the perimeter of the property. Subcontractors mobilize their trailers along the southwest perimeter fence, additional portable toilets are brought in, and the dumpsters are placed in more strategic locations for ease of haul away. Large staging areas are located on either side of the site to store the extensive Cradle formwork, reinforcing, and structural steel.

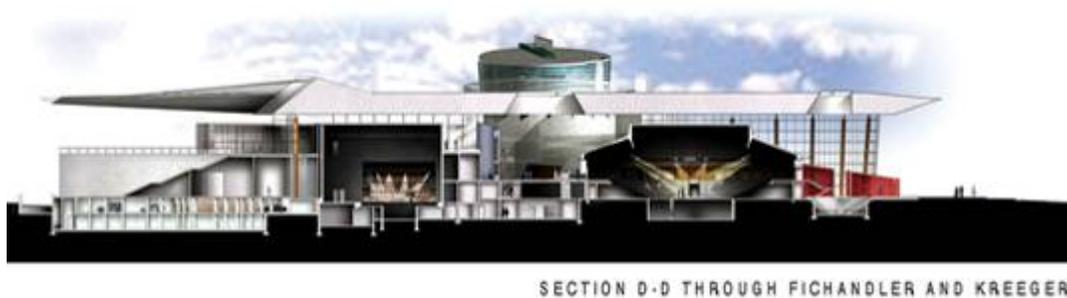
Figure 3: Section of Arena Stage showing the interior of the Fichandler and Kreeger theatres
(Provided by Bing Thom Architects)

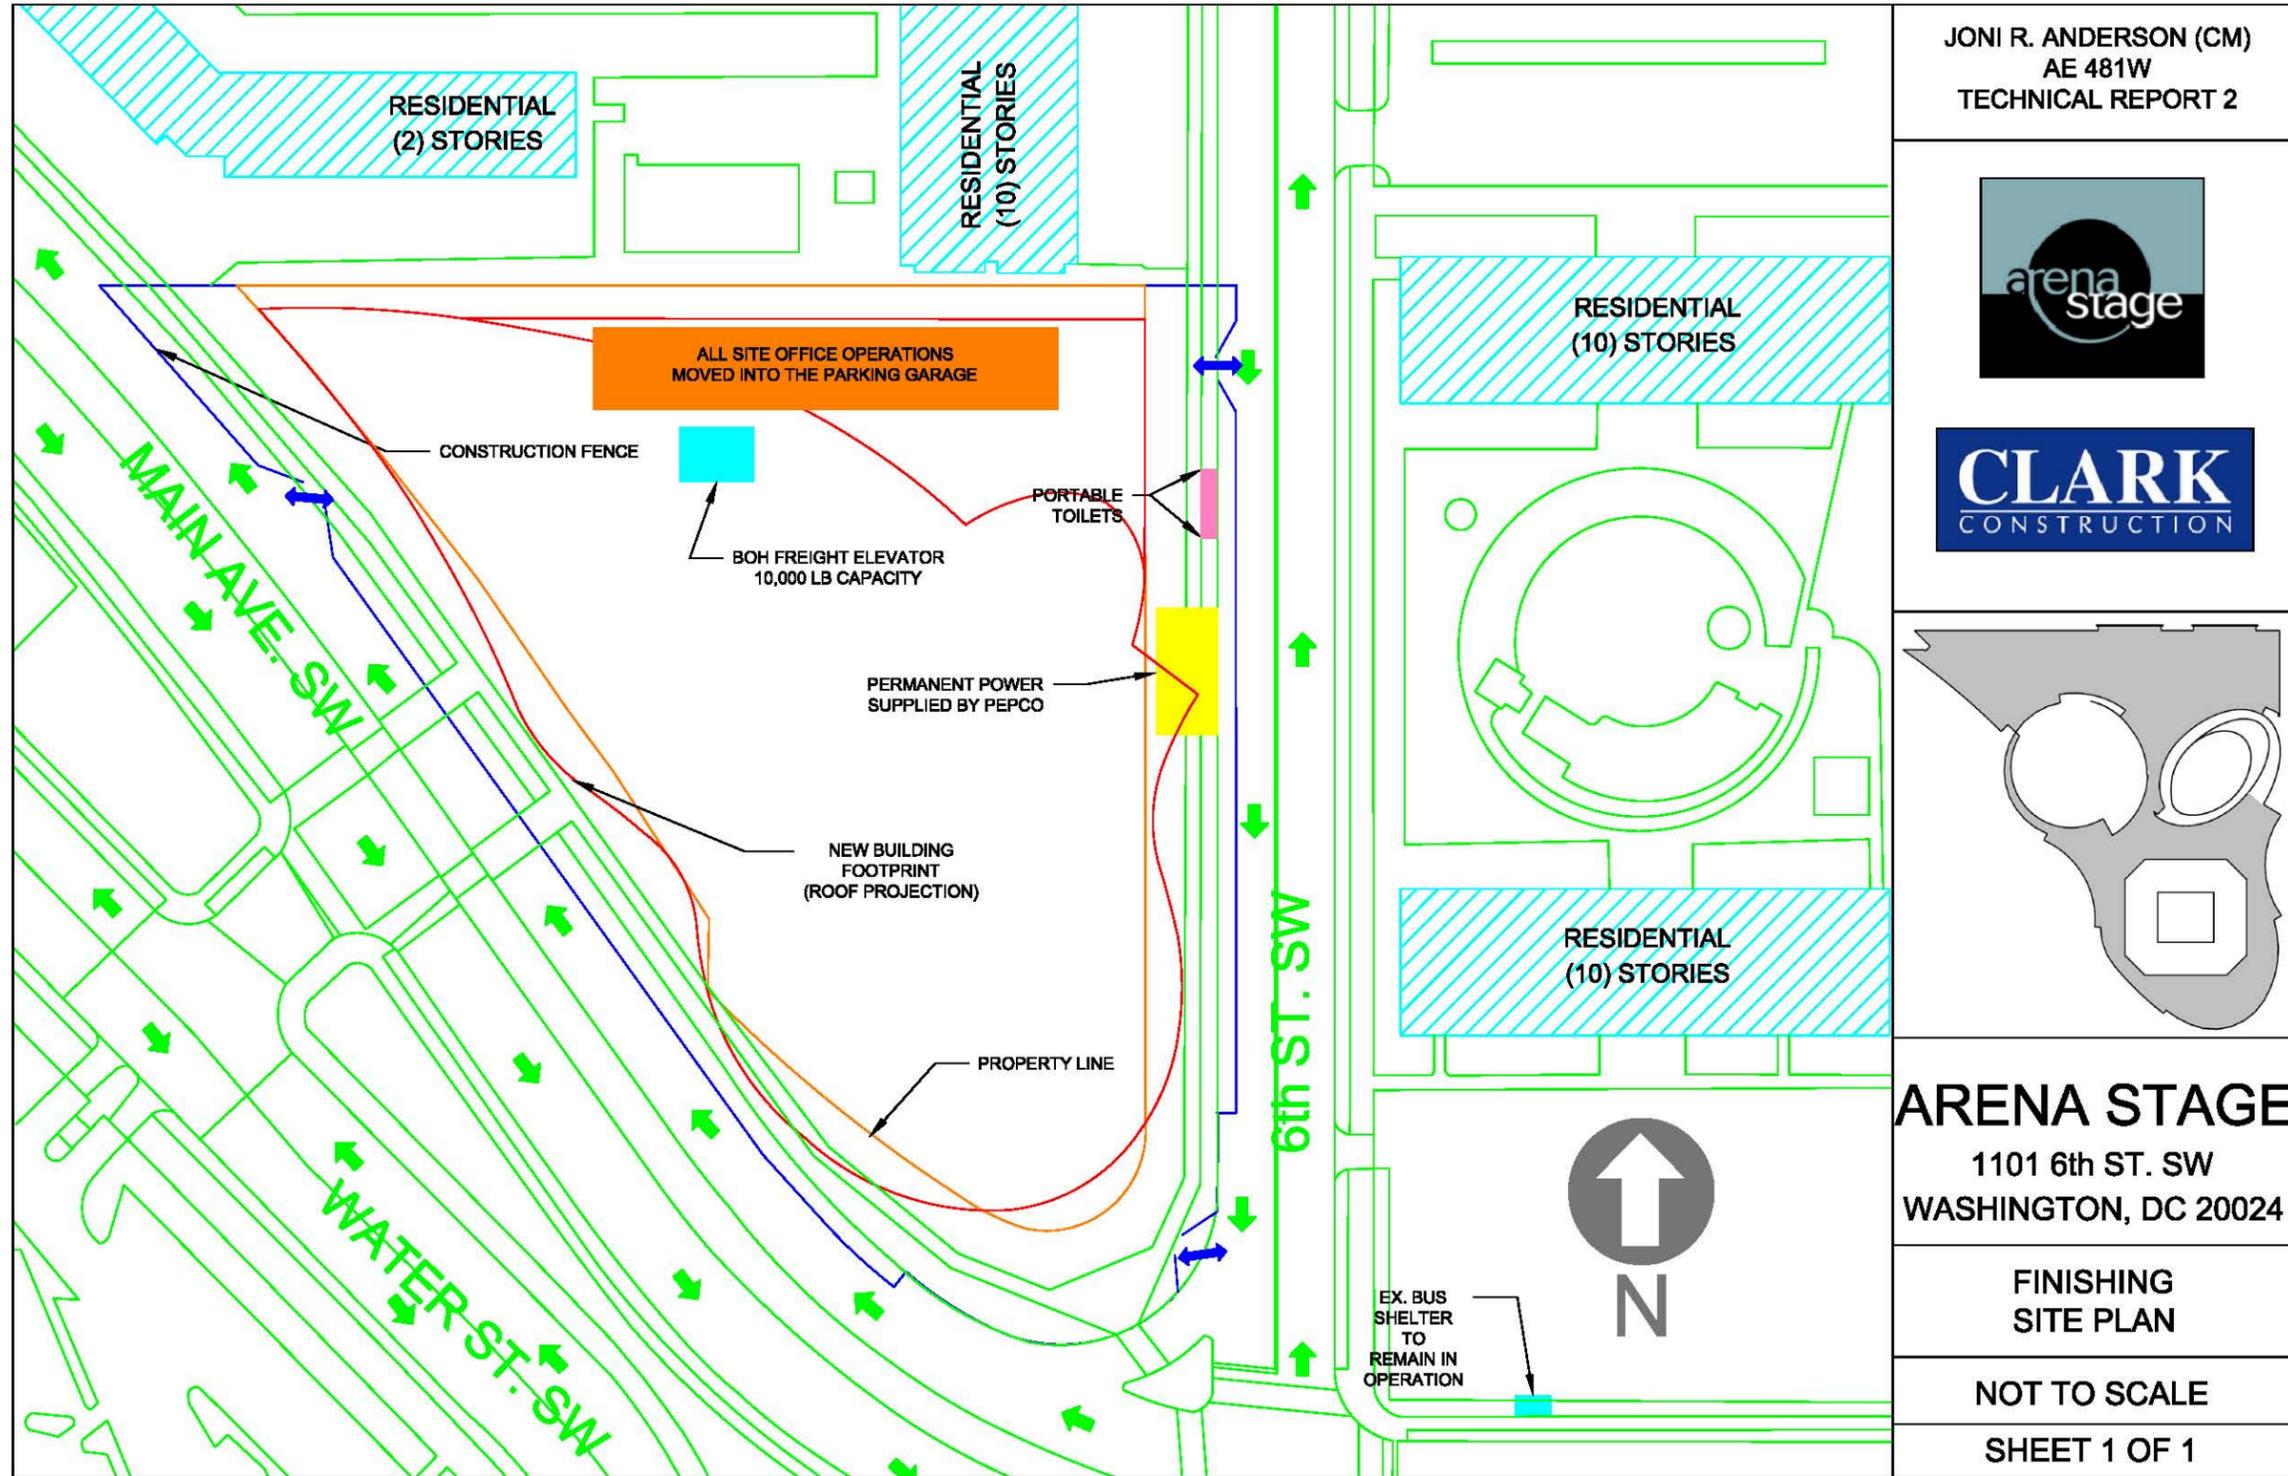
As the heavy construction work at Arena Stage comes to an end, the site begins to clean up and operations move into the new building. All of the jobsite trailers are removed from site and the office personnel are moved into the ground floor of the BOH parking garage. Permanent power is set up by Pepco Supply and material deliveries are brought into to parking garage and distributed throughout the building via the permanent freight elevator in the BOH. It is a conventional holed hydraulic elevator with a 9' cab height and a 10,000 pound lifting capacity.

Final building inspections and commissioning take place inside the building during the execution of the interior finishes. New hardscaping is laid out around the perimeter of the building and tied back into the neighboring sidewalks. The land around Arena Stage is designed to be pedestrian friendly and provide passers-by with an opportunity to marvel at the beauty of the new complex.

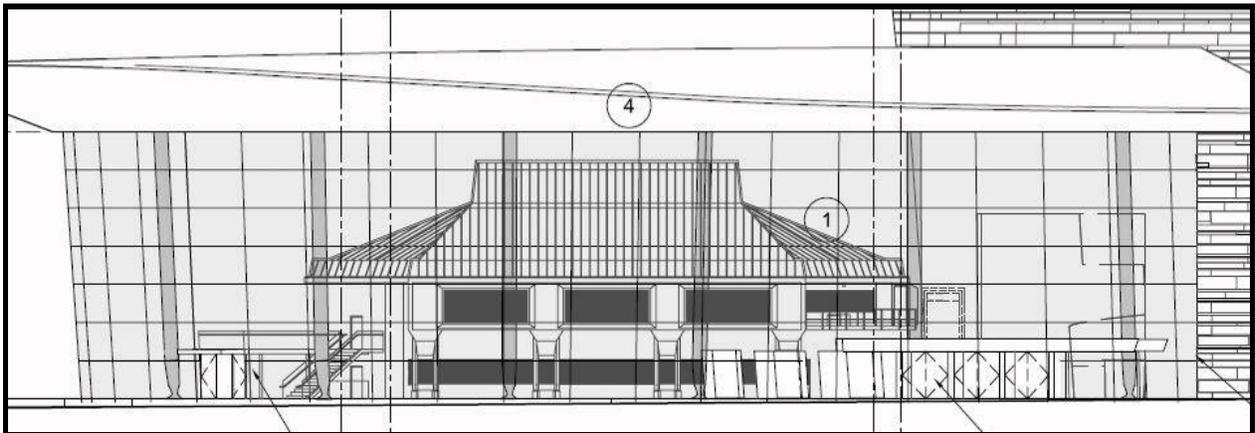
Figure 4: Architectural Elevation showing the faces of the façade with glazing runs at 7 frames high

Primarily, the curtain wall consists of two components: the glazing and the structural system. The glazing follows a serpentine path along the outside of the three theatres and sits on a 4 degree inclined slope. It is sectioned off into 7/8"-thick insulated glass frames that are custom cut to achieve the architectural curve of the façade. To do this, each face of the façade is 7 frames high and is a combination of rectangular and trapezoidal pieces.

A general take-off was performed by scaling the 52 faces of the façade off of the architectural plans. Once the widths of the faces were recorded, an average approximate height of the panels was calculated at 6'-4". This value was applied to all of the frames in lieu of trying to determine the custom heights of each panel. It was determined from mock-up drawings that were provided by Icon Exterior Building Solutions. The square footage of each face was then multiplied by 7 to account for the 7 frames that make up each of the 52 faces. These calculations revealed that approximately 27,411 square feet of glazing make up the façade in the form of 364 custom cut frames.

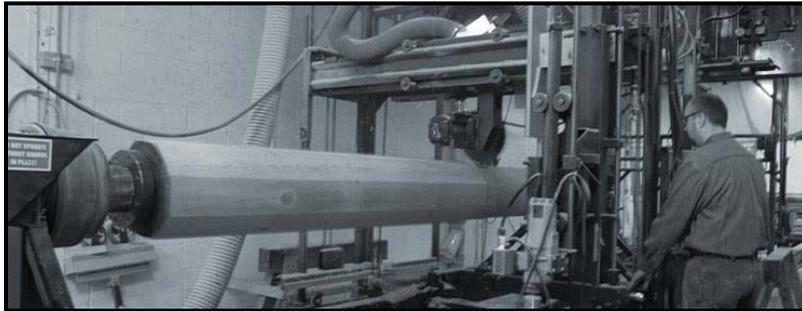
Figure 5: Shaping the PSL timber columns on the lathe
(Provided by StructureCraft Inc.)

Parallel strand lumber (PSL) timber columns provide the support for the entire curtain wall system. These solid wood columns, ranging from 48' to 58' tall, are shaped into ellipses on a lathe. To provide enough support for the glazing, 18 columns, sitting 3' off the glass, are placed 36' on center along the perimeter of the building.

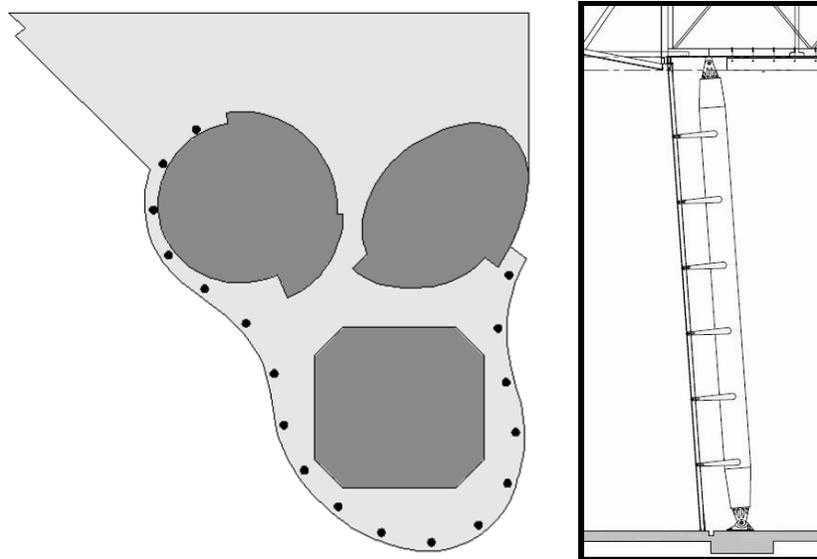
Figure 6: Plan view of the 18 columns (left) & an elevation of a column showing the 6 rows of support arms tying into the glazing (right)

The columns support the glazing through a series of structural components. Each column has a cast ductile-iron base and top, 12 wooden support arms, 12 wooden muntins, 12 aluminum plates and 2 stainless steel cables ranging in length. After discussion with a representative from StructureCraft Inc., a rough unit cost was determined for each of these components.
